FIELD REPORT #003

Date:	July 16, 2020	Project #:	2018-046	Page 1 of 3
To:	Michael Cahalane Town of Effingham 68 School St. Effingham, NH 03882	Project:	Elm Street Bridge Preservation	
Email:	effingham@roadrunner.com	Location:	Effingham, NH	
Prepared By:	Jonathan K. MacDougall, PE	Owner:	Town of Effingham	
Reviewed & Approved By:	Christopher R. Fournier, PE	Contractor:	Hansen Construction	
		Weather Conditions:	Mostly Sunny 60's°F

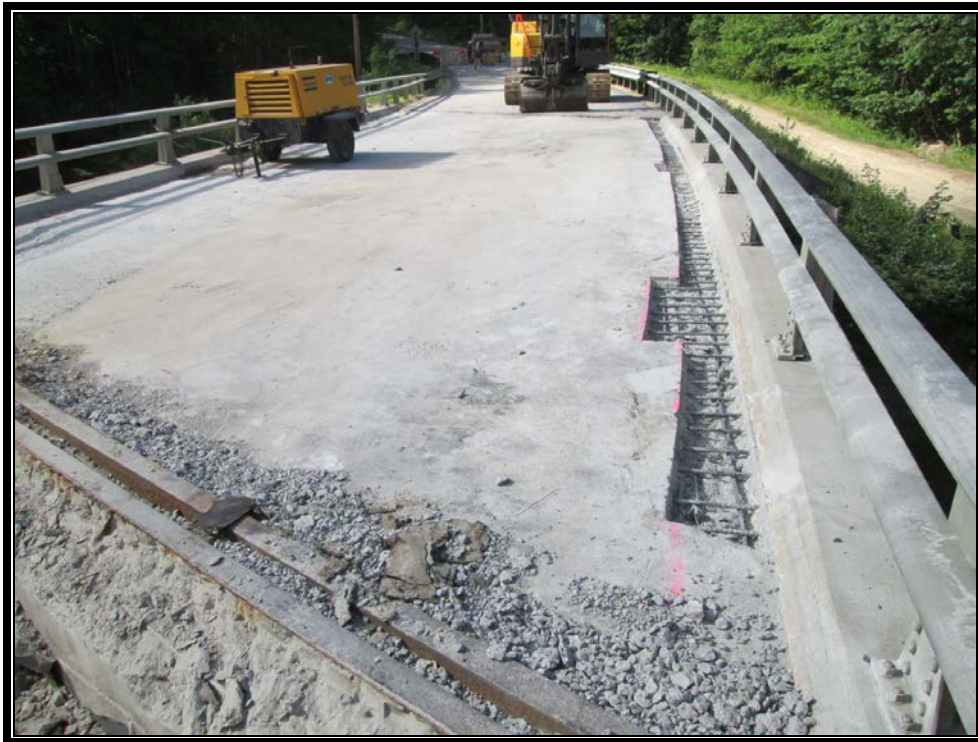
- Contractor saw-cut concrete deck on the limits of deck repair along the west curb line and along the limits of deck repair at the middle of the deck. Contractor chipped the concrete along the west curb line. The northern portion has been completed along the curb line had been completed to roughly $\frac{3}{4}$ inch below the upper mat of reinforcing steel.

Photo 1: Concrete deck chipped out along the west curb.

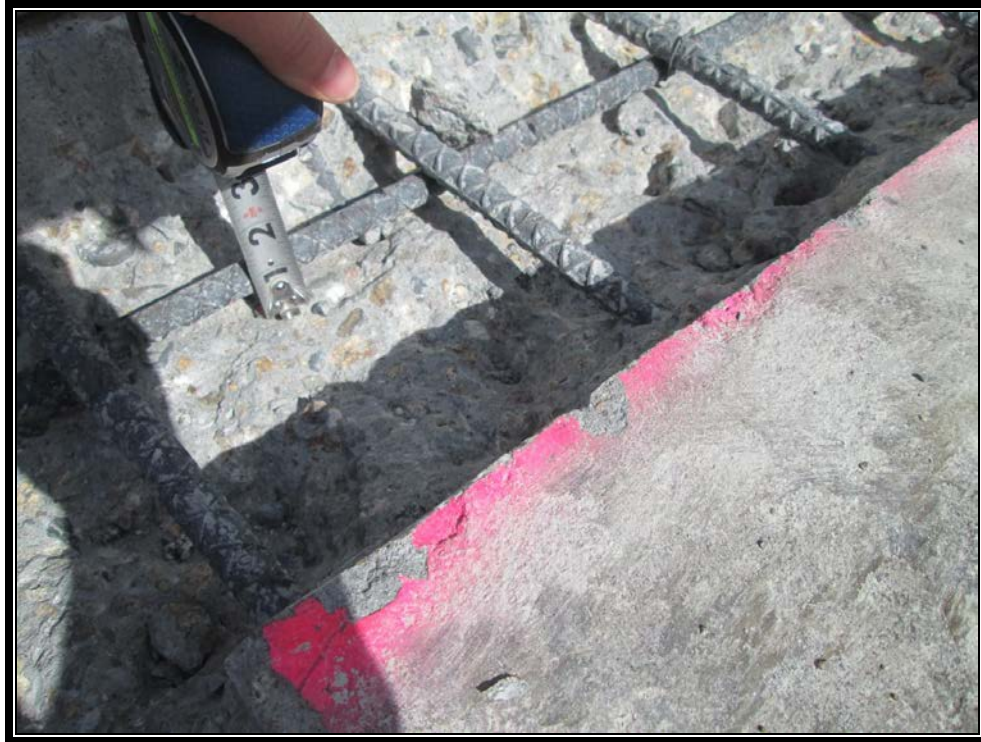
- Contractor said that the concrete felt really hard once they got below the surface of the concrete.
- The reinforcing steel all looks to be in good condition where exposed along the west curb.

Photo 2: Exposed reinforcing steel along the west curb.

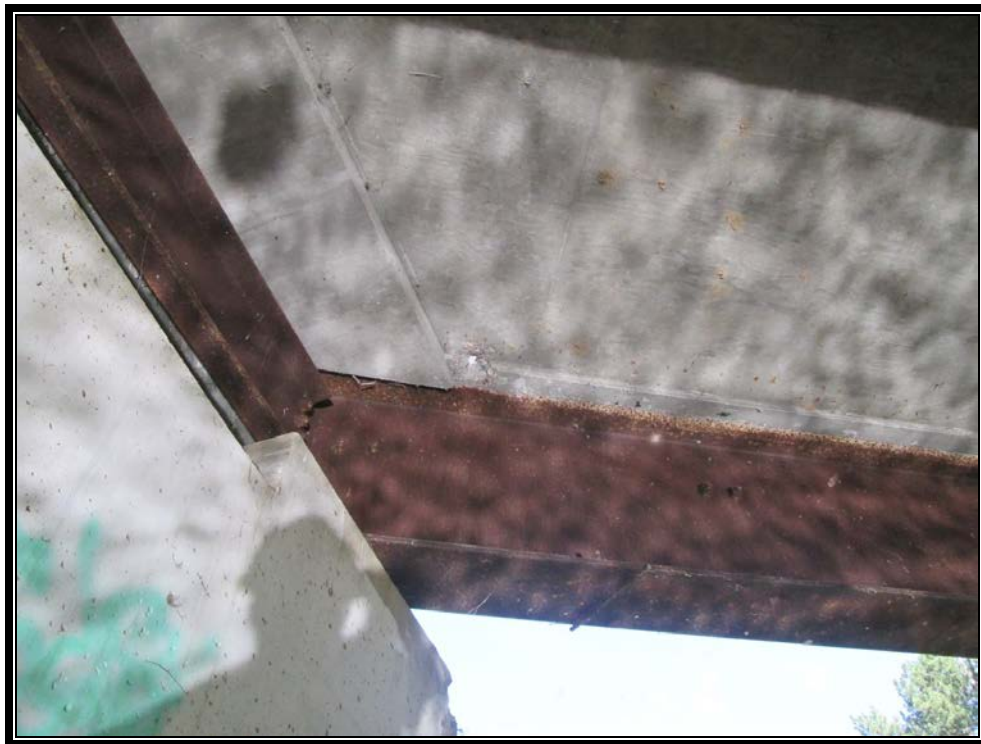
- Contractor noted they broke through the deck in one location along the curb. The depth of the concrete appeared to be approximately 8 $\frac{1}{4}$ -inches as noted on the original construction drawings. This area is not considered a full depth repair location and will be paid as partial depth. Contractor should take care to not demo concrete too far below the top mat of reinforcing steel to prevent further locations of breakthrough. Smaller chipping hammers may be required to prevent further holes through the deck.

Photo 3: Spall at bottom of deck where Contractor broke through.
