FIELD REPORT #007

Date:	July 27, 2020	Project #:	2018-046	Page 1 of 4
To:	Michael Cahalane Town of Effingham 68 School St. Effingham, NH 03882	Project:	Elm Street Bridge Preservation	
Email:	effingham@roadrunner.com	Location:	Effingham, NH	
Prepared By:	Jonathan K. MacDougall, PE	Owner:	Town of Effingham	
Reviewed & Approved By:	Christopher R. Fournier, PE	Contractor:	Hansen Construction	
		Weather Conditions:	Mostly Sunny 90°F

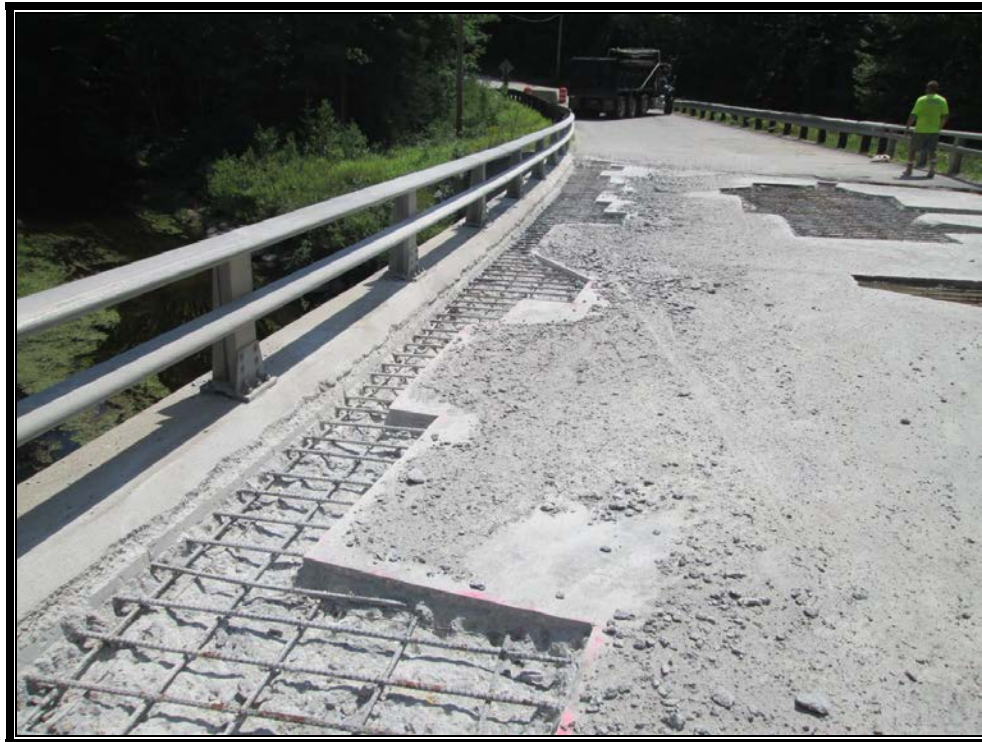
- Contractor completed chipping concrete along the east curb line (see Photo 1).
- Contractor continued chipping concrete at the back wall and expansion joint (see Photo 2).

Photo 1: Concrete removed along the east curb.

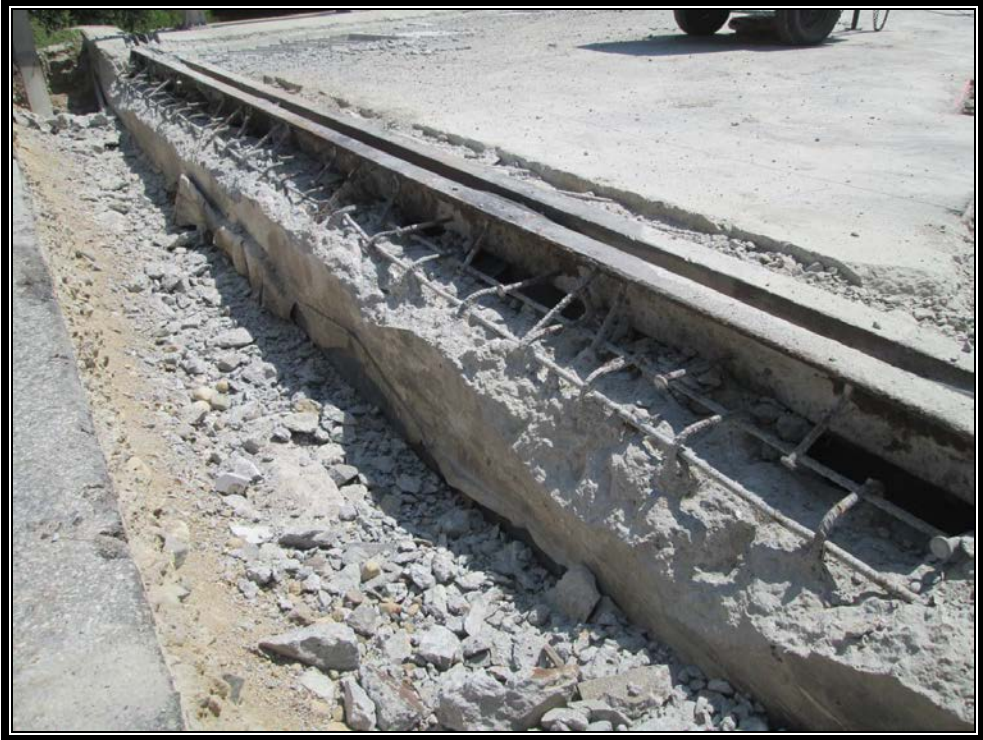
Photo 2: Backwall chipped out to remove the expansion joint.

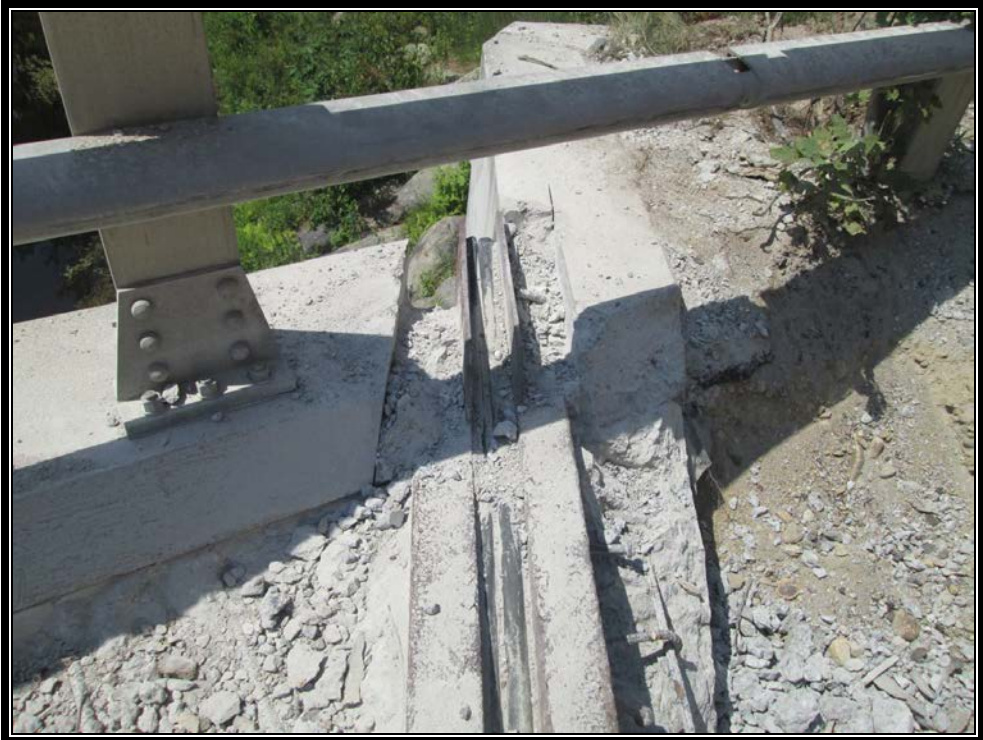
- Contractor removed most of the concrete from the backwall below the expansion joint and appears to have removed all the loose and deteriorated concrete. Contractor saw cut the top of the curb and began to chip out the concrete in those area (see Photo 3). Contractor is planning to sawcut the side face of the curb to complete chipping out the joint. Contractor and Engineer reviewed the connection of the new expansion joint.

Photo 3: Sawcut and demolition at the curb.

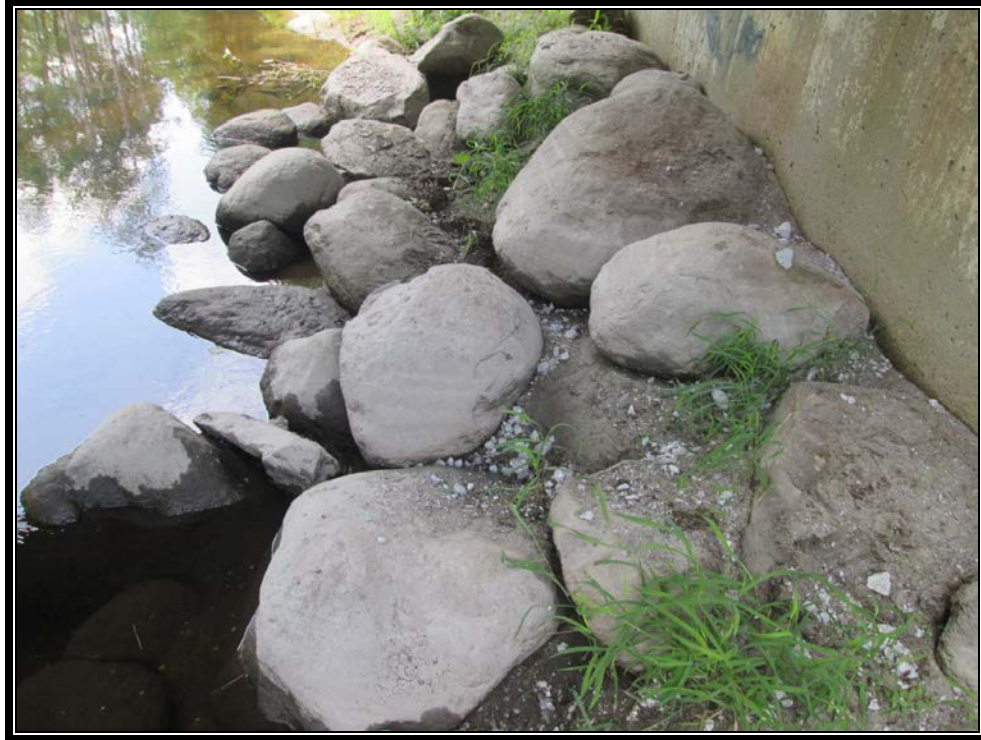
- No containment has been installed to prevent concrete debris from the expansion joint removal from falling into the river. Engineer discussed with the Contractor the need for containment before they proceed with full depth deck demolition. Concrete debris is present along the bank of the stream and in the river (see Photo 4). Containment will also be required for cleaning of the structural steel below the deck.
- Contractor said they will likely place the concrete deck prior to installing the expansion joint. The Contractor needs the deck to cure before they can get a snooper truck on the bridge and clean the steel below.
- Engineer noted the loose block of concrete at the north abutment is considerably larger than during initial observations in 2018 (see Photo 5). More concrete may require removal than originally assumed and less epoxy crack filler may be required.

Photo 4: Concrete debris along the riverbank and in the river.

- Install containment to prevent demolition debris from falling in the river.

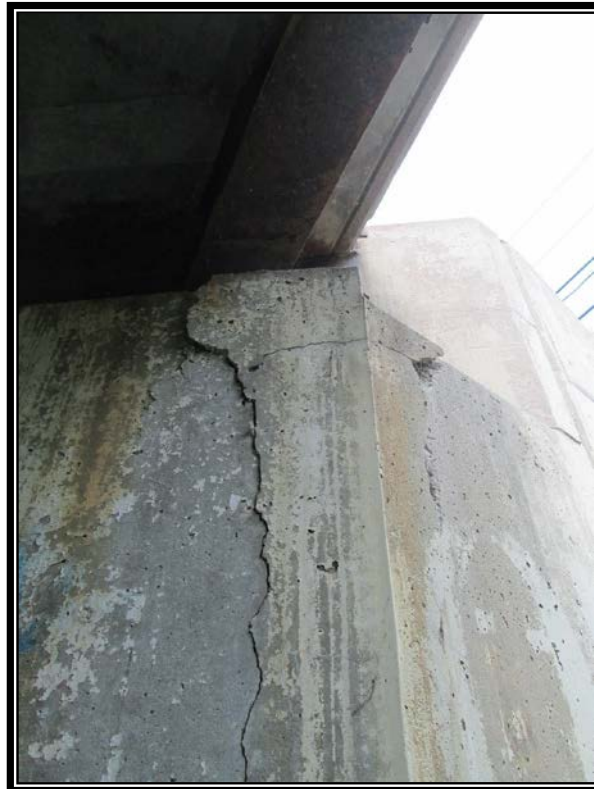
Photo 5: Loose concrete at the north abutment.
