FIELD REPORT #012

Date:	August 11, 2020	Project #:	2018-046	Page 1 of 4
To:	Michael Cahalane Town of Effingham 68 School St. Effingham, NH 03882	Project:	Elm Street Bridge Preservation	
Email:	effingham@roadrunner.com	Location:	Effingham, NH	
Prepared By:	Jonathan K. MacDougall, PE	Owner:	Town of Effingham	
Reviewed & Approved By:	Christopher R. Fournier, PE	Contractor:	Hansen Construction	
		Weather Conditions:	90°F, sunny

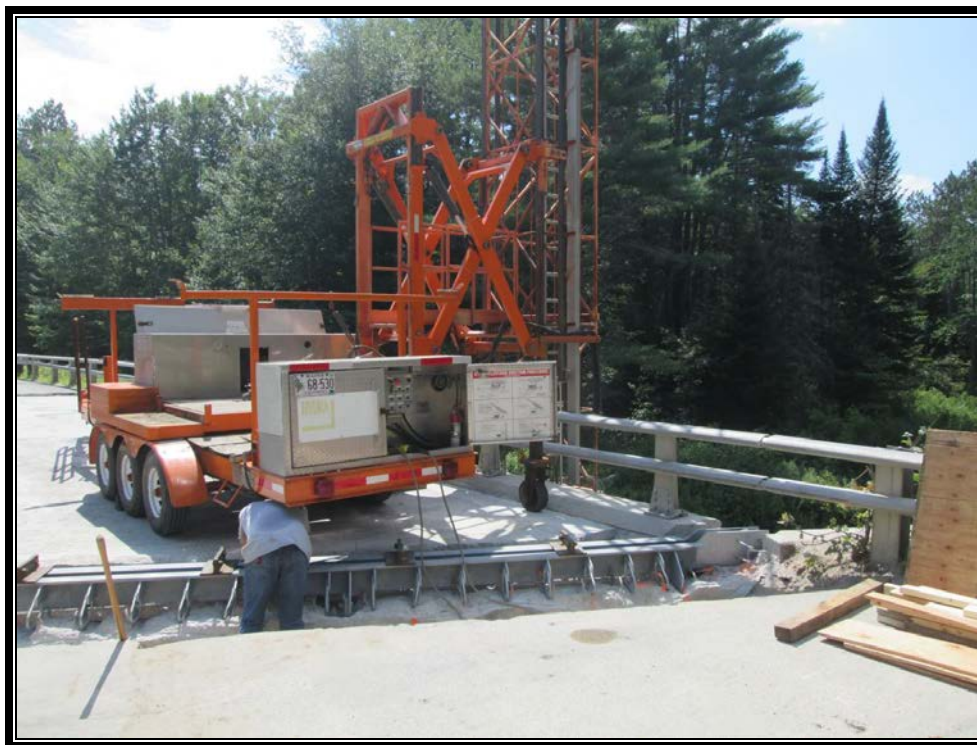
Photo 1: View of snooper truck.

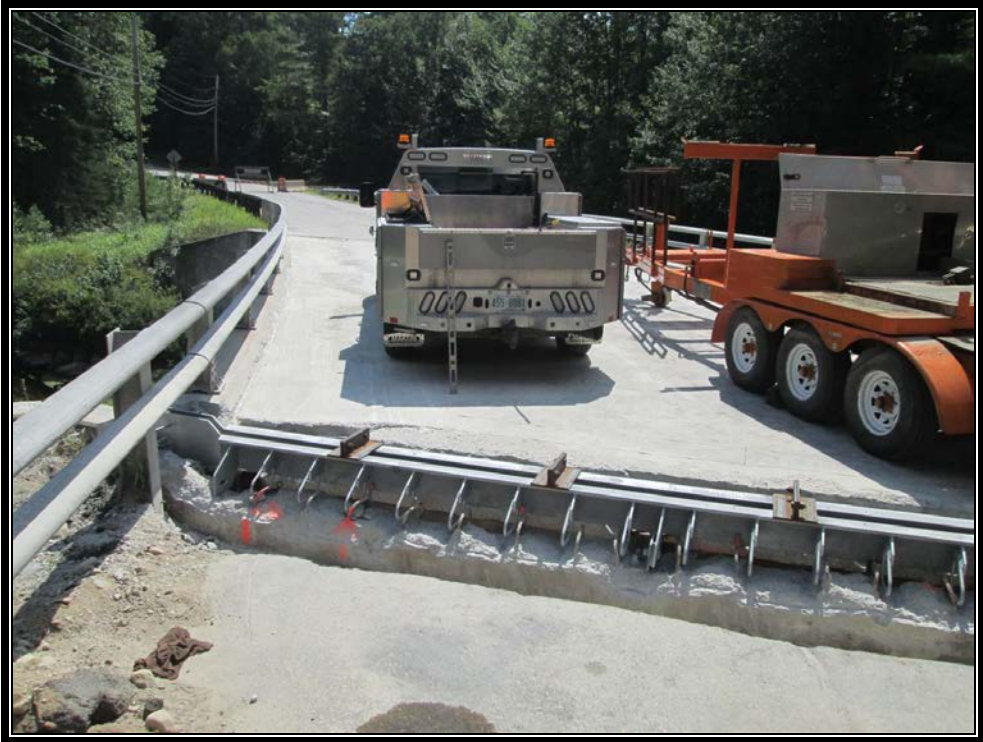
Photo 2: Expansion joint in place with new anchor rods into backwall.

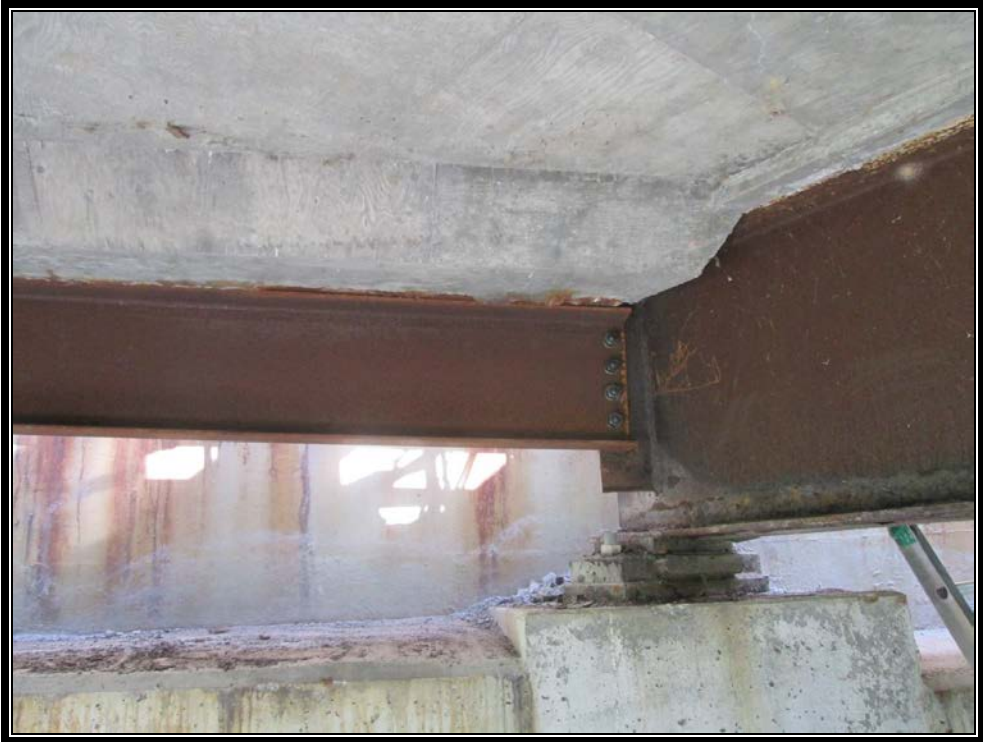
Photo 3: New diaphragm installed.

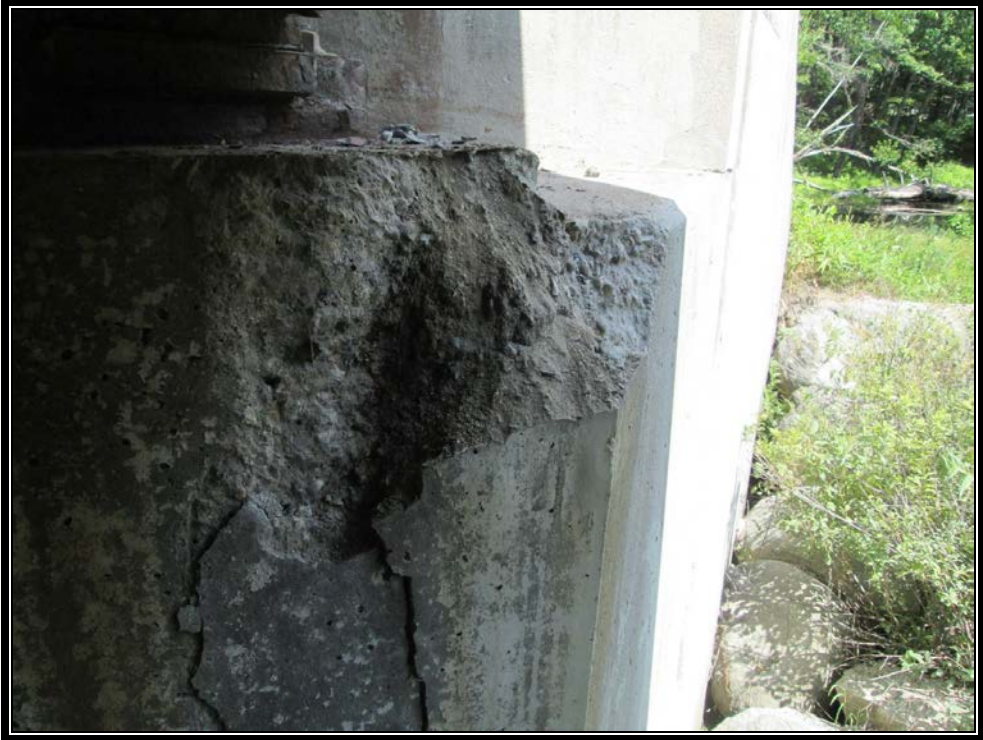
- Contractor was installing forms for the backwall.
- The loose block of concrete at the top of the abutment were removed (see Photo 4).

Photo 4: Deteriorated concrete behind location of loose block.

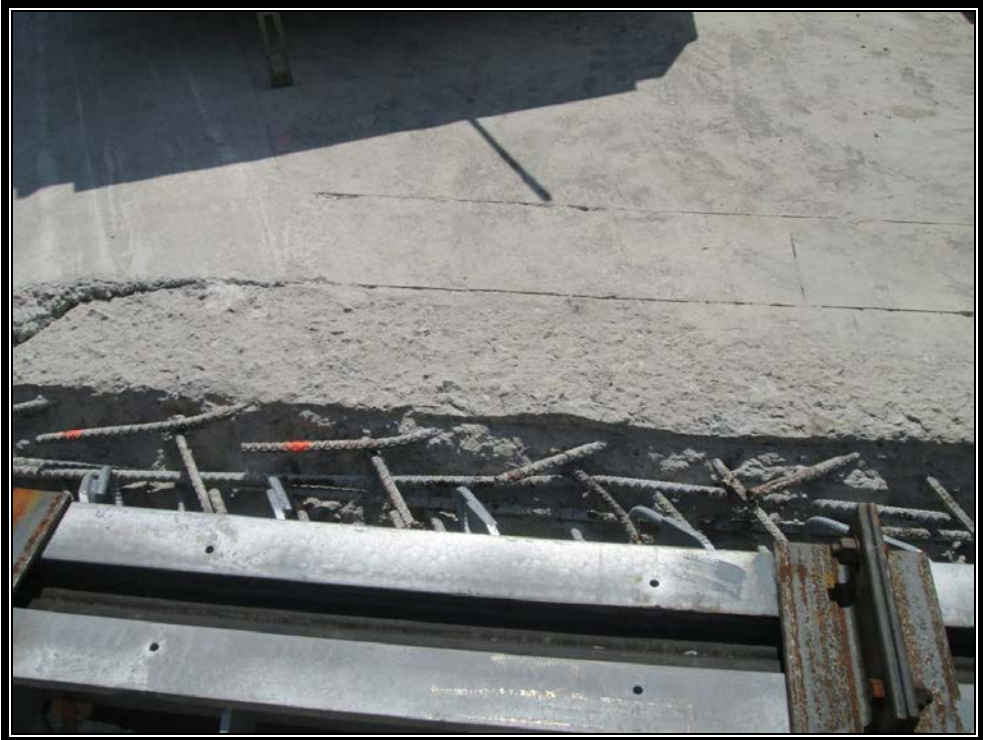
Photo 5: Deteriorated concrete at end of deck.

- Engineer noted that the deteriorated concrete at the deck end must be cut back further where there is exposed concrete (see Photo 5). Contractor must sawcut around the areas to repair or can use the existing sawcut in the deck. Engineer said it would be acceptable to only demo to 1 ½ inches below the proposed top of concrete and will not require down below the reinforcing because the concrete appeared to be in good condition with what remained.
- The joint opening was measured to be 3 ¼-inch between the steel angles.
- Contractor said they installed the top of joint to be 2¼-inch above the deck elevation.
