FIELD REPORT #016

Date:	August 19, 2020	Project #:	2018-046	Page 1 of 3
To:	Michael Cahalane Town of Effingham 68 School St. Effingham, NH 03882	Project:	Elm Street Bridge Preservation	
Email:	effingham@roadrunner.com	Location:	Effingham, NH	
Prepared By:	Jonathan K. MacDougall, PE	Owner:	Town of Effingham	
Reviewed & Approved By:	Christopher R. Fournier, PE	Contractor:	Hansen Construction	
		Weather Conditions:	70°F, sunny

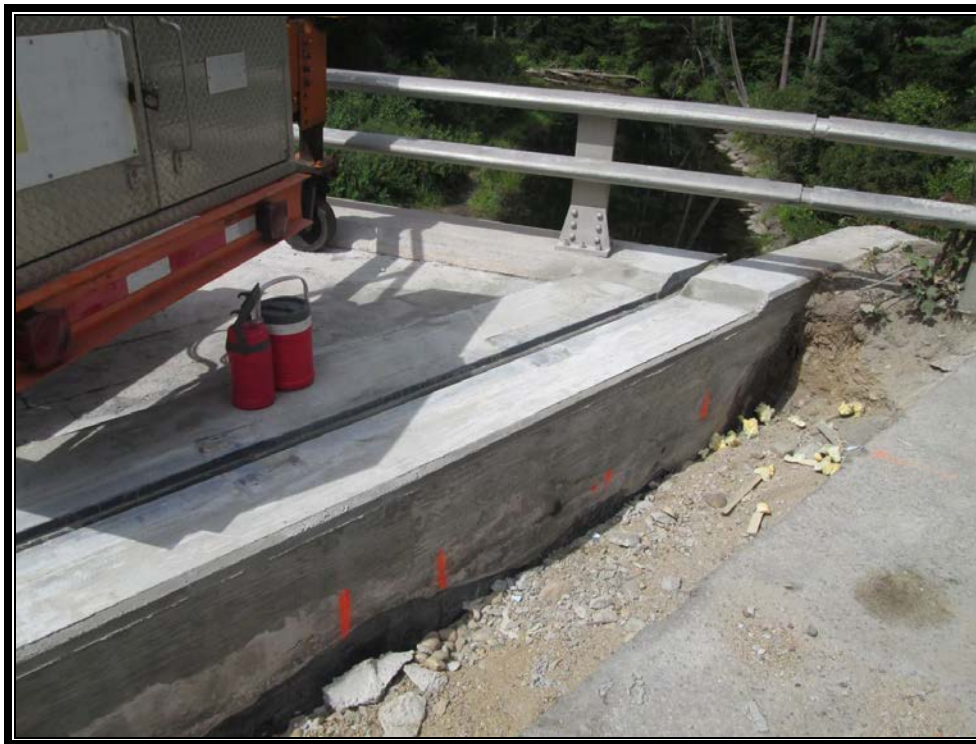
- Contractor began removed concrete forms at deck end (see Photo 1).
- Contractor began cleaning surface of steel beams and shoes.

Photo 1: Backwall with forms removed.

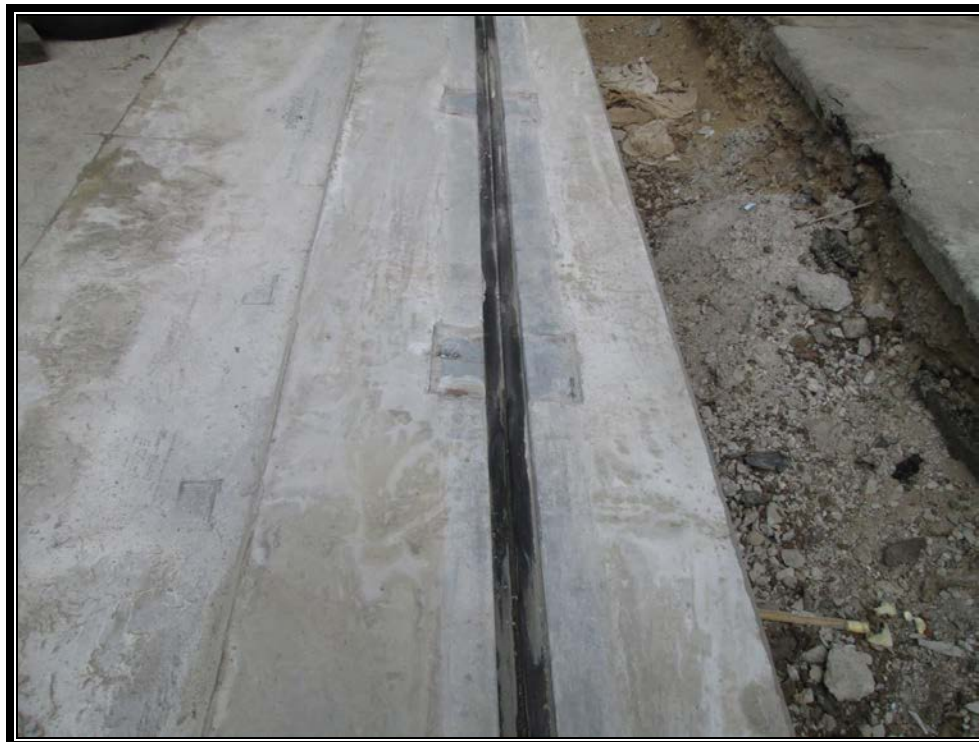
- Contractor said they would use a grinder to clean of rough corners of the concrete placement and temporary welds (see Photo 2). Engineer noted that there are some locations at the curb and at the deck end step where the concrete was not consolidated well. Bridge membrane installer should install additional mastic in these locations.
- Contractor began to remove loose rust and debris from the girders and bridge shoes. They said they used a pneumatic needle scaler. In general, the needle scaler appeared to be working on the girders with the exception of along the interior corner of the bottom flanges where additional loose rust was still present. Contractor to remove additional loose rust where found, particularly along the upstream girder. Engineer noted the downstream girder did not appear to have significant loose rust and does not need to be scaled. The

Photo 2: Rough concrete and welds to be grinded clean.
