FIELD REPORT #019

Date:	August 24, 2020	Project #:	2018-046	Page 1 of 6
To:	Michael Cahalane Town of Effingham 68 School St. Effingham, NH 03882	Project:	Elm Street Bridge Preservation	
Email:	effingham@roadrunner.com	Location:	Effingham, NH	
Prepared By:	Jonathan K. MacDougall, PE	Owner:	Town of Effingham	
Reviewed & Approved By:	Christopher R. Fournier, PE	Contractor:	Hansen Construction	
		Weather Conditions:	80°F, sunny

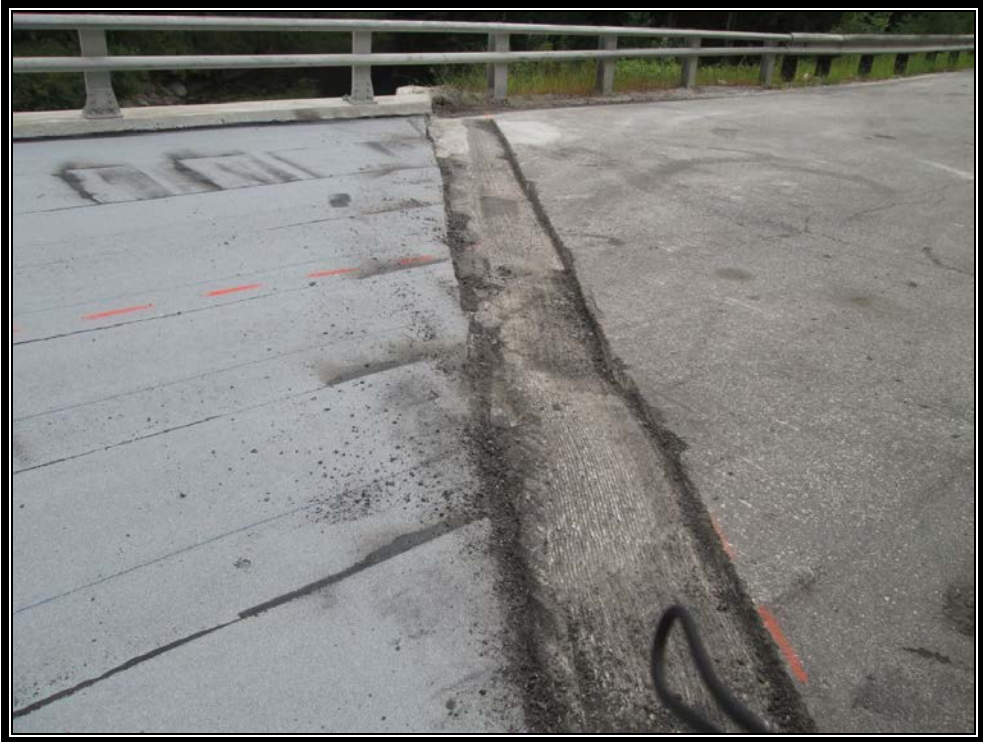
Photo 1: Milled pavement at south approach.

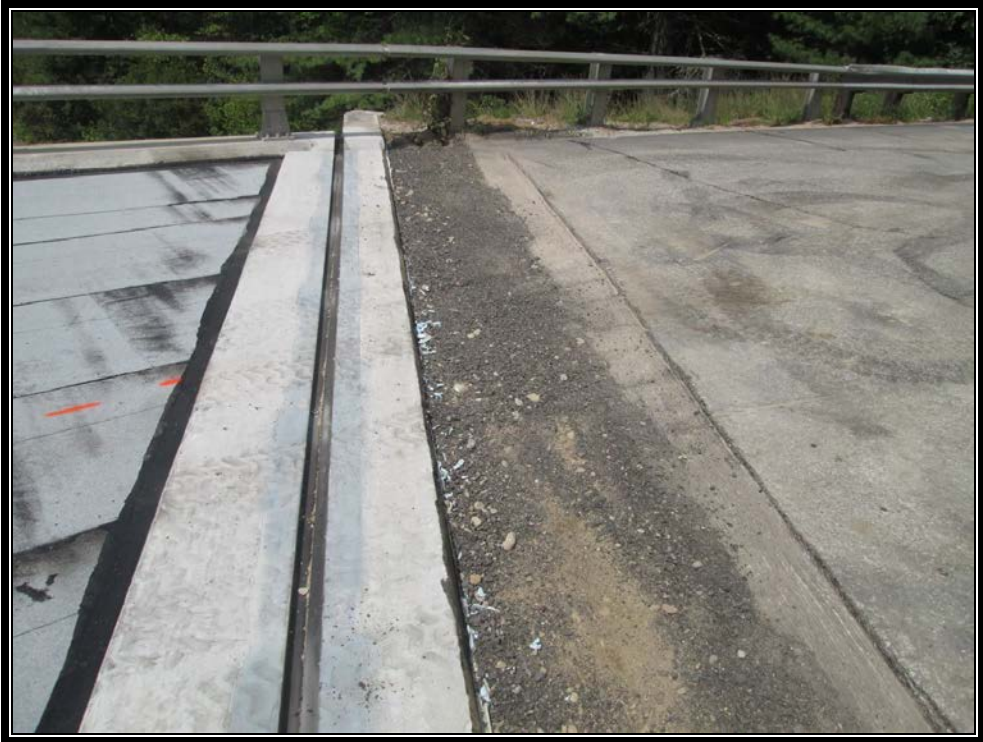
- Contractor and Engineer reviewed the pavement at the approaches. At the north approach the Contractor milled 12 inches back from the sawcut line of the pavement to create a transition from the old pavement to the new pavement (see Photo 2). At the south approach the existing pavement tapers from about 2 inches above the deck elevation at the downstream side to nearly flush with the deck at the upstream side (see Photo 1). Contractor and Engineer agreed the best solution to match in the bridge pavement and be able to install the asphaltic plug joint would be to pave completely past the end of the deck about 2 feet. The contractor milled in an 18-inch-wide strip, ending 2 feet off the end of the bridge, where the pavement can be tied in.
- Contractor swept and blew debris off the deck prior to paving.

Photo 2: Milled pavement at north approach.

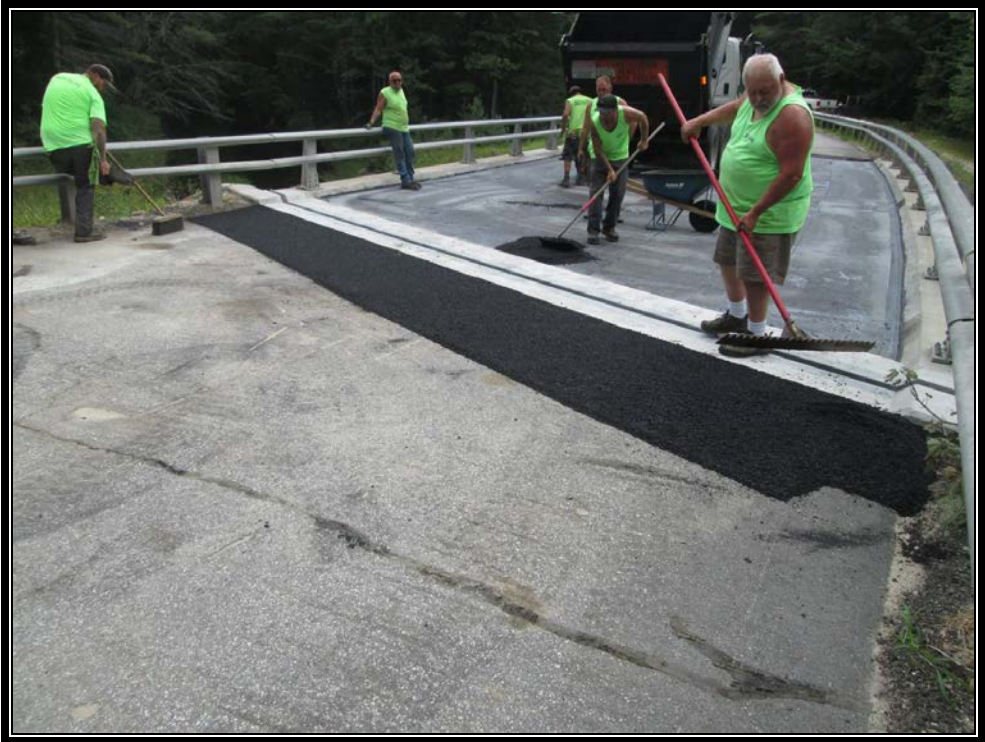
- Contractor installed pavement by hand at the north approach ending at the backwall, and compacted with a vibrating plate compactor (see Photo 3). Contractor also installed pavement by hand at the north downstream corner of the bridge where the paver could not access due to the skew of the bridge.

Photo 3: Hand paving at north approach.

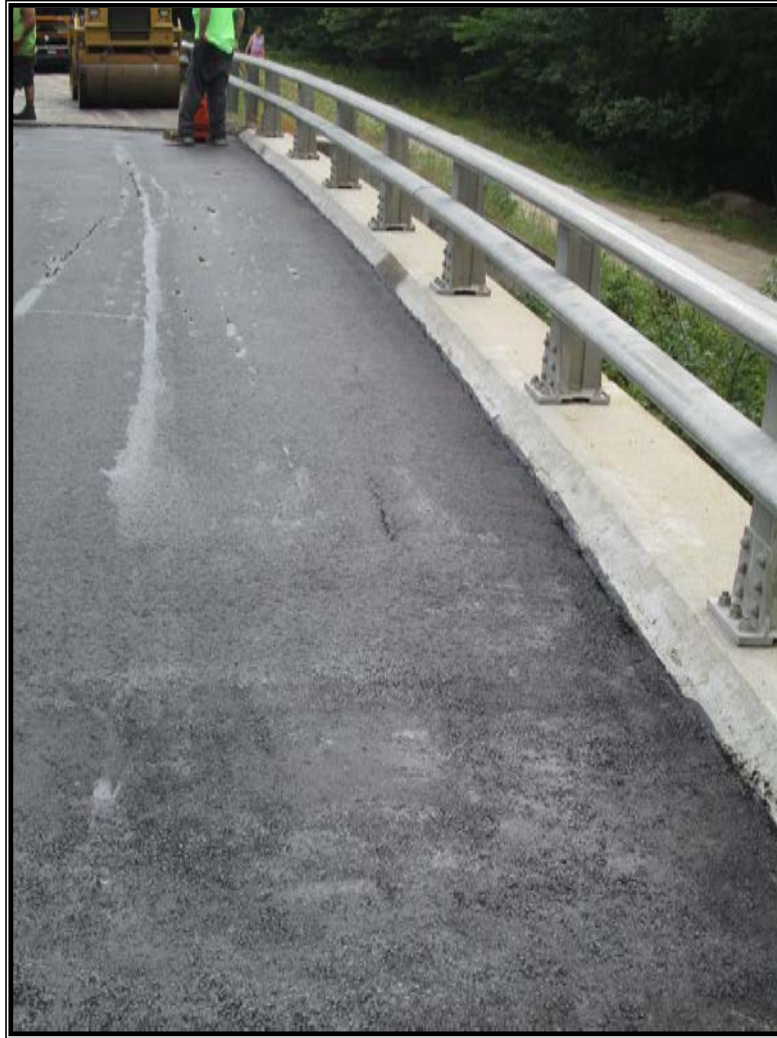
- Engineer noted there was a bubble in the base course from the membrane in two locations on the deck the translated through to the base pavement: one above 3 feet long and 6 inches wide located approximately 10 feet from the north end of the bridge and 2 feet in from the downstream curb, the other located approximately 12 feet from the south end of the bridge in the middle of the upstream lane (see Photo 4). Contractor contacted AD Rossi (membrane installer) and they recommended cutting a small hole in the membrane at these locations to release the air in the bubble which is what the Contractor did. AD Rossi said the heat from the pavement should melt the membrane and reseal the small holes. Once popped the bubbles went away.

Photo 4: Bubble in membrane translating through pavement at north end of bridge.

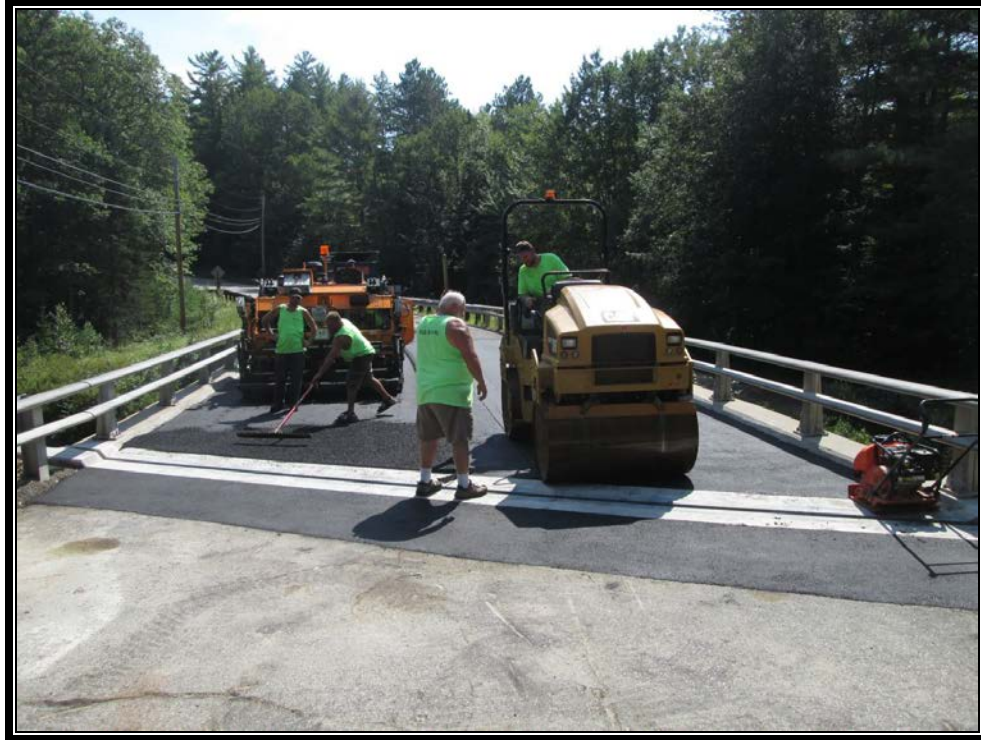
- Contractor paved the deck with the paver using a 9.5mm (3/8-inch) mix in two courses, initially with a 1-inch bridge base, and then the remainder ~1¼ inches. The deck was compacted with the drum roller without the use of the vibrations (see Photo 5 & 6).

Photo 5: Compacting wearing course.

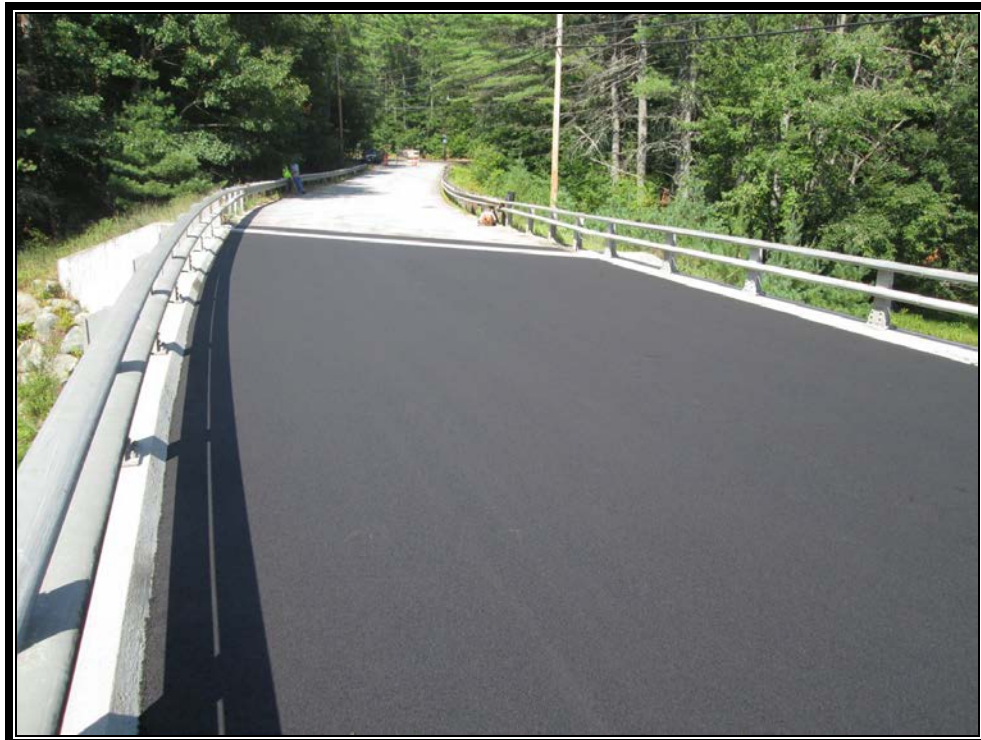
Photo 6: Finished pavement on bridge deck.
