FIELD REPORT #022

Date:	November 16, 2020	Project #:	2018-046	Page 1 of 3
To:	Michael Cahalane Town of Effingham 68 School St. Effingham, NH 03882	Project:	Elm Street Bridge Preservation	
Email:	effingham@roadrunner.com	Location:	Effingham, NH	
Prepared By:	Jonathan K. MacDougall, PE	Owner:	Town of Effingham	
Reviewed & Approved By:	Christopher R. Fournier, PE	Contractor:	Hansen Construction	
		Weather Conditions:	Partly Sunny, 50°F

SITE VISIT

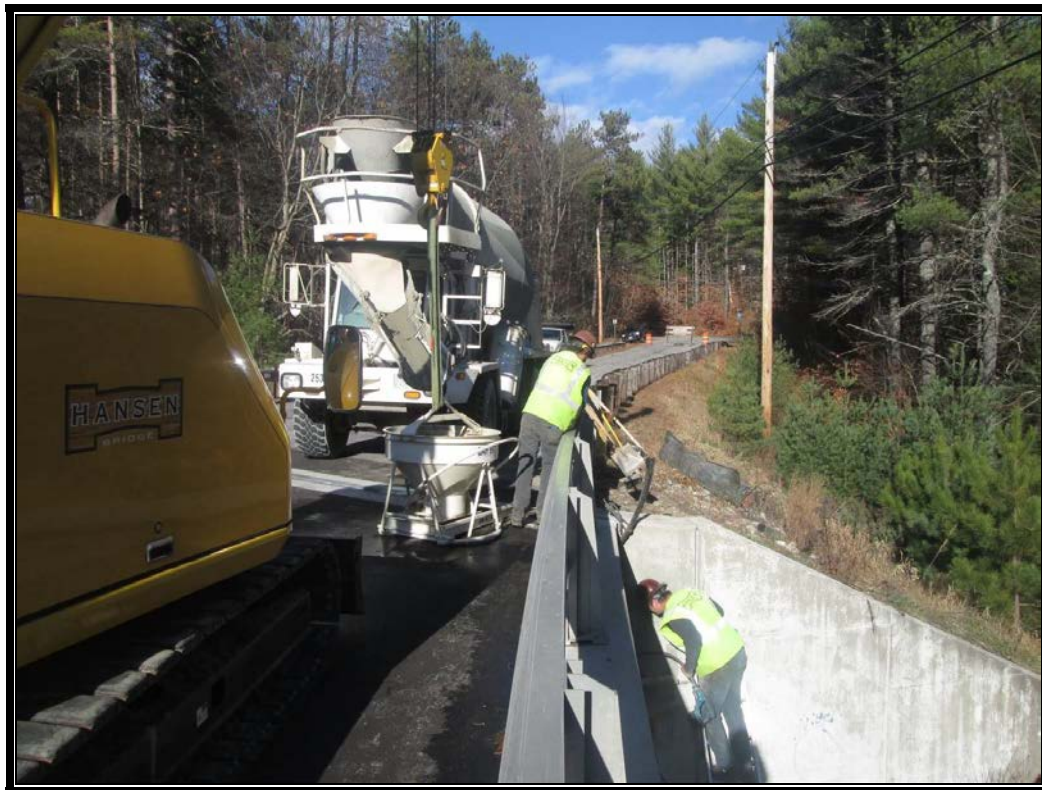
Photo 1: Truck placing concrete in bucket.

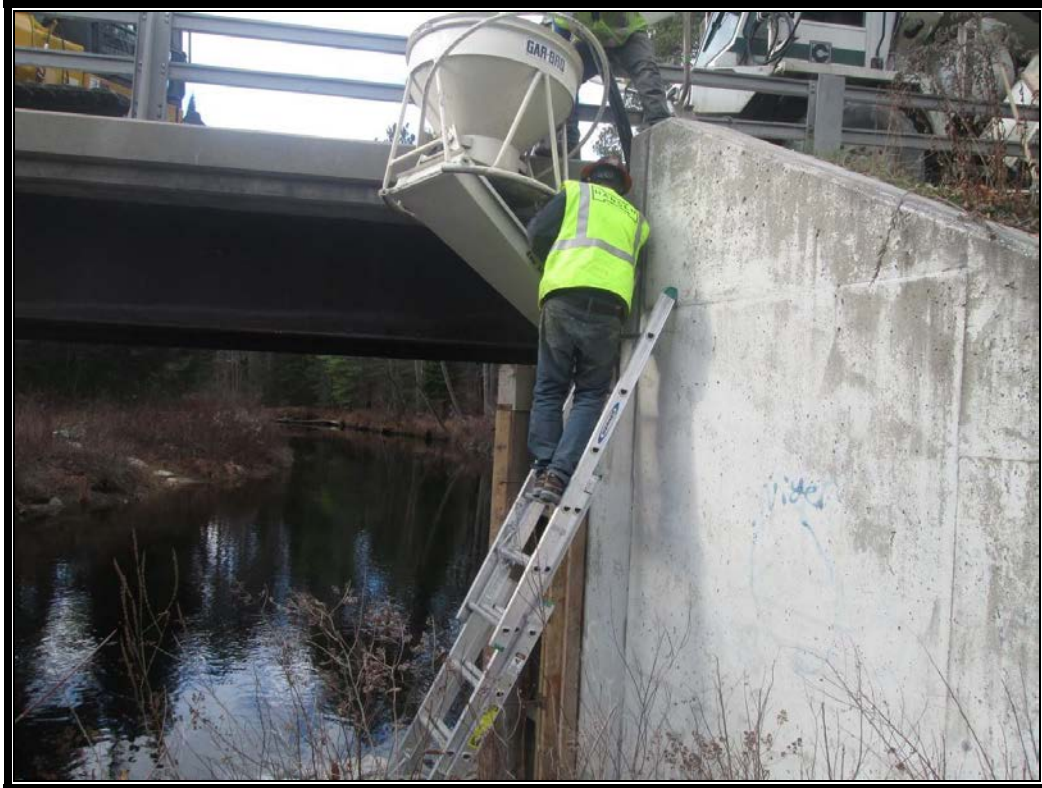
- Contractor continued placing concrete at the north abutment (see Photos 1 - 3). The concrete truck place the concrete into concrete bucket. The mini-crane lifted the bucket into place where it was release through the bottom discharge point, to an integrated chute, and into the forms. The concrete was then vibrated.

Photo 2: Contractor placing concrete in forms from the bucket.

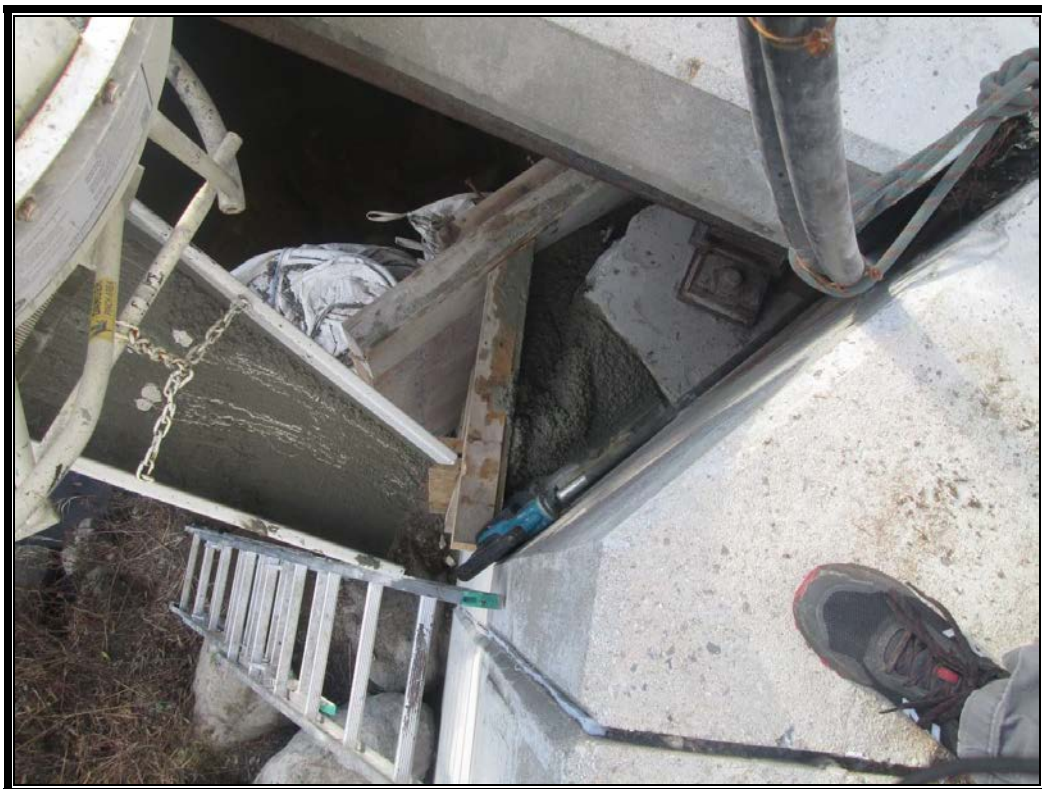
- The Contractor used a 3/8-inch NHDOT Class AA concrete for the repair (4,000 psi).
- When the forms were filled to about 1-foot from the top the Contractor vibrated the concrete. During vibration, the forms began to creak. Contractor stopped vibrating and did not vibrate the final placement due to concern of form failure. Contractor used a 2 x 4 to tamp the remaining concrete into place.

Photo 3: Concrete in forms prior to finishing surface.

- Contractor said they would remove the forms on Wednesday, November 18, 2020. They said if there is any unconsolidated concrete they would parge the surface with grout.
- Contractor said they will place concrete blankets over the new concrete until the forms are removed.
- Contractor plans to keep the bridge closed until the forms are removed. They will use the crane to remove the sand bags and forms.
- Contractor ordered 1-yard of concrete. Driver estimated there was less than ½-yard left over. Contractor and Engineer both estimated approximately 0.4 yards of concrete would be required for the repair.
- Contractor discussed the crack at the south abutment backwall. Contractor said they will not be able to fix this fall (2020) but could potentially do it during the work on Snow Road next spring/summer (2021).
