Date:	October 4, 2022	Project #:	2021-083	Page 1 of 5
To:	Town of Effingham 68 School Street Effingham, NH 03882	Project:	Bailey Road Culvert Replacement	
Email:	townofeffingham@effinghamnh.net	Location:	Effingham, NH	
Prepared By:	Christopher Fournier, PE	Owner:	Town of Effingham	
Weather Conditions:	60° Partly Cloudy	Contractor:	Jake Dawson's Excavation & Utility Services, LLC

SITE VISIT

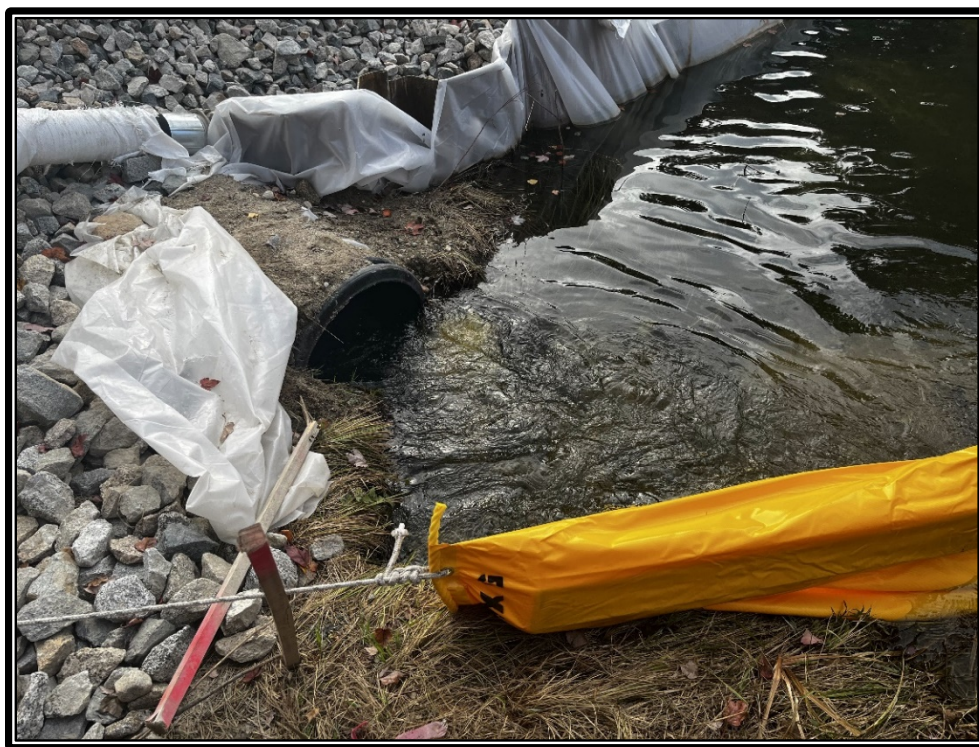
- » Traffic controls and signals appear to be functioning properly.
- » The Engineer and Contractor reviewed the existing water bypass, which is submerged at the inlet and half full at the outlet. This condition is not utilizing the full capacity of the bypass culvert. The Contractor reported the inlet elevation to be approximately 476.5 feet, slightly lower than the submitted invert elevation of 477 feet.
- » The fill over the bypass culvert at each end remains uncontained by the cofferdam or plastic nor is it stabilized by riprap (see Photo 1). The Engineer notified the Contractor to correct this so sediment is not transported within the waterbody. It appears any sediment that has mobilized was contained by the downstream sediment barrier.

Photo 1: The fill over the bypass culvert at each end remains uncontained by the cofferdam or plastic nor is it stabilized by riprap. The outlet is shown above.

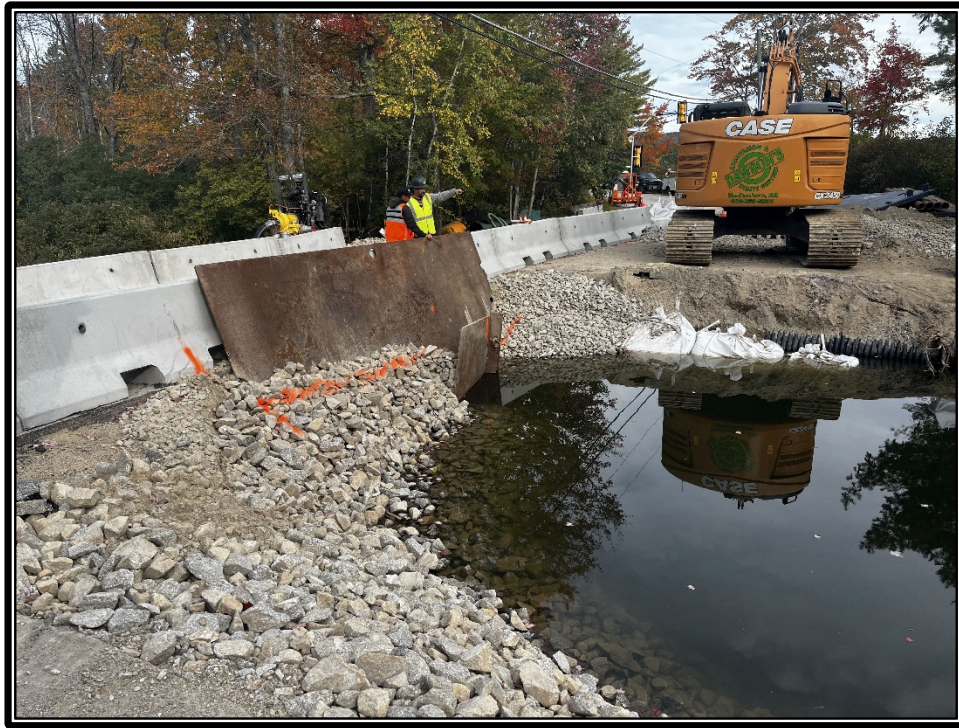
- » The Engineer inquired about the stability of the roadway at the boundary of the excavation, which is currently supported by a couple of road plates (see Photo 2). The Contractor admitted this to be a “band-aid” while the site is restored following the water diversion failure. The Engineer noted there is an outstanding need for a formal submittal to ensure the stability of the roadway and the safety of the public. The Contractor stated, they will be installing a large trench box at that location to accommodate the installation of the box culvert and will use road plates against the end of the trench box to support the roadway. Once the precast culvert is installed, the trench box will be removed and the plates will then bear against the precast culvert. The Contractor expects some roadway material will be lost and will cause temporary instability of the roadway, which will likely result in a closure of approximately 20 minutes, while it is stabilized. The Engineer will review this as part of the submittal process.

Photo 2: Southern side of roadway being supported by two road plates.

- » Erection plan submittal is needed to demonstrate the capability of roadway shoring (FR #002, 09/15/22).
- » Stabilize site in accordance with erosion control requirements (FR#005, 09/22/22).
- » Provide revised alternate water diversion submittal.
- » Install silt fence along the southern edge of the site.
- » Install sedimentation basin according to permitted detail.

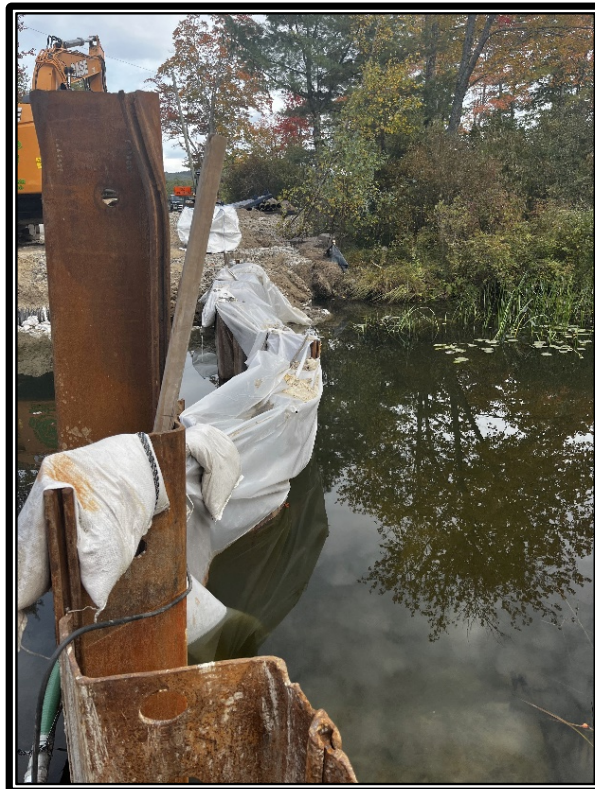
- » Upon site observation, the Engineer noted to the Contractor that silt fence along the southeast corner of the site has been destroyed and needs to be replaced to adhere with the erosion and sediment control requirements (see Photo 3). Additionally, the Engineer noted silt fence missing along the southwest corner of the site, where material had been relocated (see Photo 4).

Photo 3: The southeast corner silt fence has been destroyed.

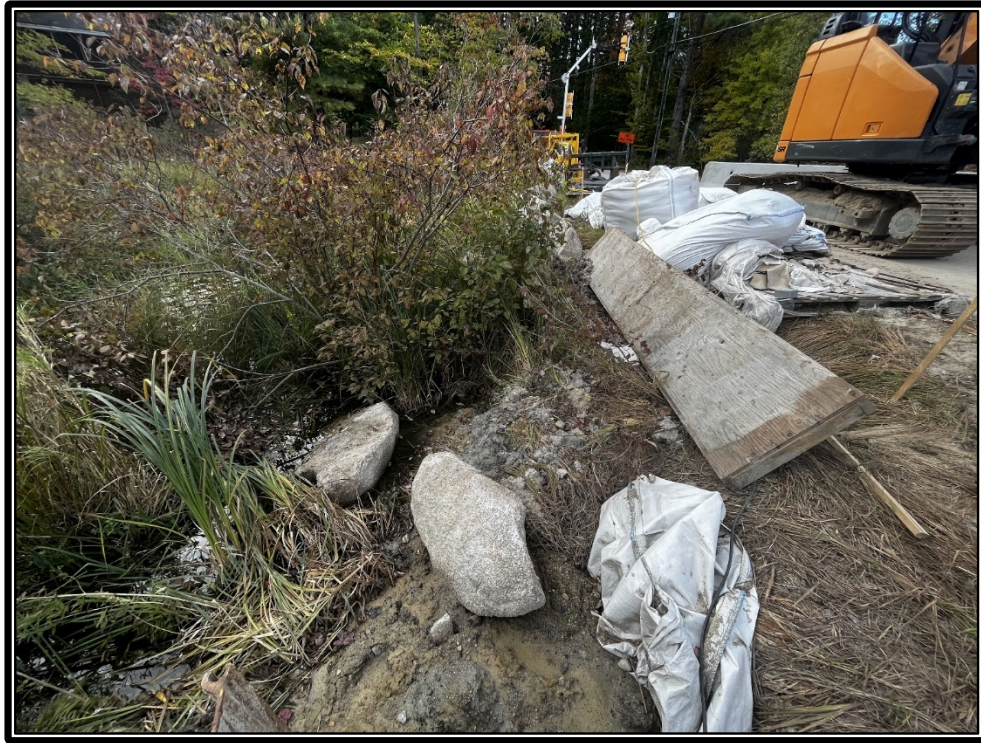
Photo 4: Southwest corner silt fence is missing.
