# FIELD REPORT #010

<b>Date:</b>	October 12, 2022	<b>Project #:</b>	2021-083	<b>Page 1 of 3</b>
<b>To:</b>	Town of Effingham 68 School Street Effingham, NH 03882	<b>Project:</b>	Bailey Road Culvert Replacement	
<b>Email:</b>	townofeffingham@effinghamnh.net	<b>Location:</b>	Effingham, NH	
<b>Prepared By:</b>	Eric Schroeder	<b>Owner:</b>	Town of Effingham	
<b>Reviewed &amp; Approved By:</b>	Christopher Fournier, PE	<b>Contractor:</b>	Jake Dawson's Excavation & Utility Services, LLC	
		<b>Weather Conditions:</b>	72° Sunny

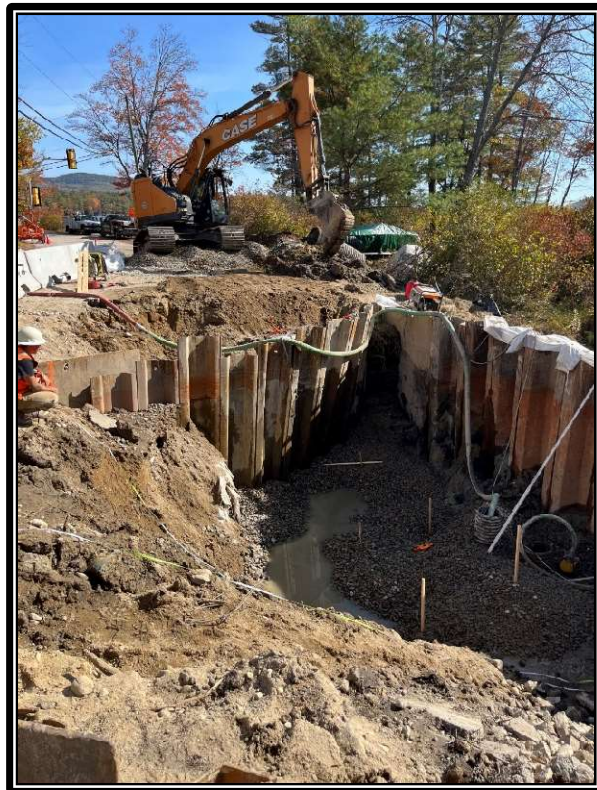
Photo 1: East wall of sheet pile is caving

into excavation.

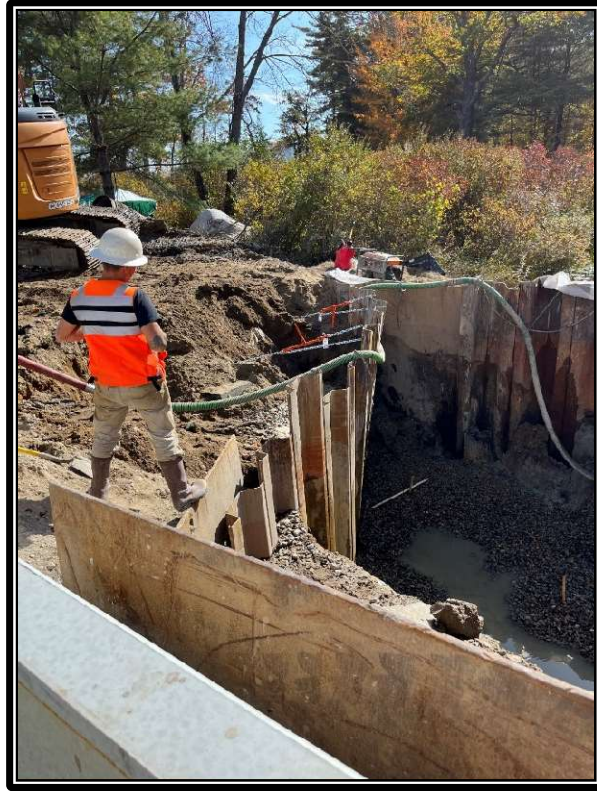
Photo 2: East sheet piles supported by deadmen anchors.
