FIELD REPORT #011

Date:	October 17, 2022	Project #:	2021-083	Page 1 of 3
To:	Town of Effingham 68 School Street Effingham, NH 03882	Project:	Bailey Road Culvert Replacement	
Email:	townofeffingham@effinghamnh.net	Location:	Effingham, NH	
Prepared By:	Eric Schroeder	Owner:	Town of Effingham	
Reviewed & Approved By:	Christopher Fournier, PE	Contractor:	Jake Dawson's Excavation & Utility Services, LLC	
		Weather Conditions:	50° Rainy

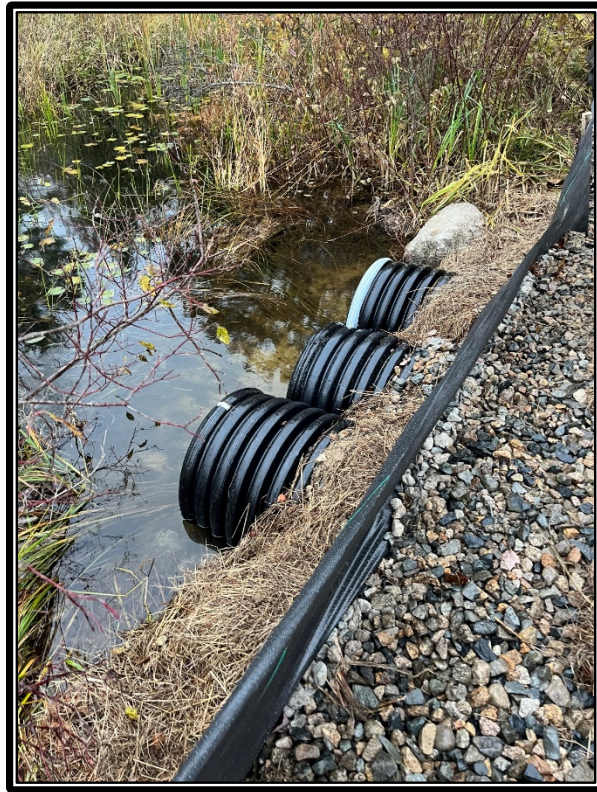
Photo 1: Water level has risen to approximately 14 inches from the bottom of the temporary bypass culvert's inlet.

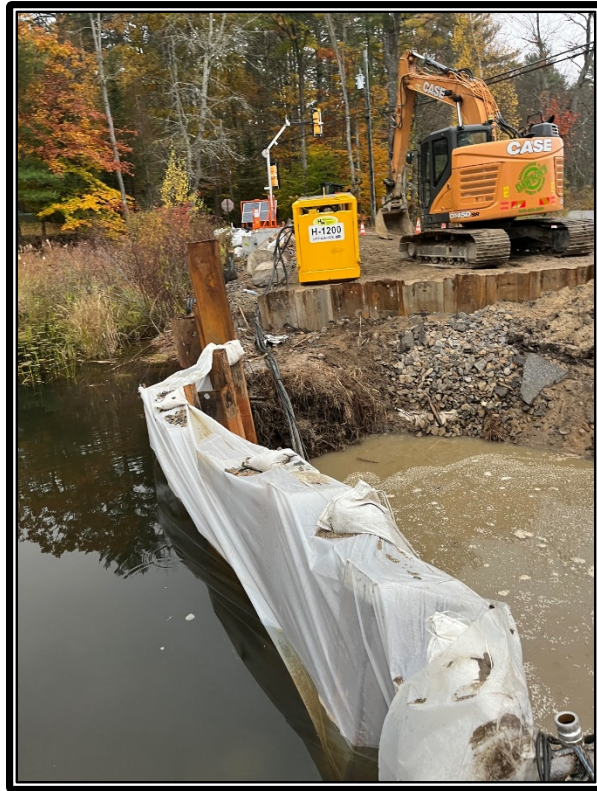
Photo 2: Water has penetrated into the excavation.
