# FIELD REPORT #015

<b>Date:</b>	October 31, 2022	<b>Project #:</b>	2021-083	<b>Page 1 of 3</b>
<b>To:</b>	Town of Effingham 68 School Street Effingham, NH 03882	<b>Project:</b>	Bailey Road Culvert Replacement	
<b>Email:</b>	townofeffingham@effinghamnh.net	<b>Location:</b>	Effingham, NH	
<b>Prepared By:</b>	Eric Schroeder	<b>Owner:</b>	Town of Effingham	
<b>Reviewed &amp; Approved By:</b>	Christopher Fournier, PE	<b>Contractor:</b>	Jake Dawson's Excavation & Utility Services, LLC	
		<b>Weather Conditions:</b>	60° Sunny

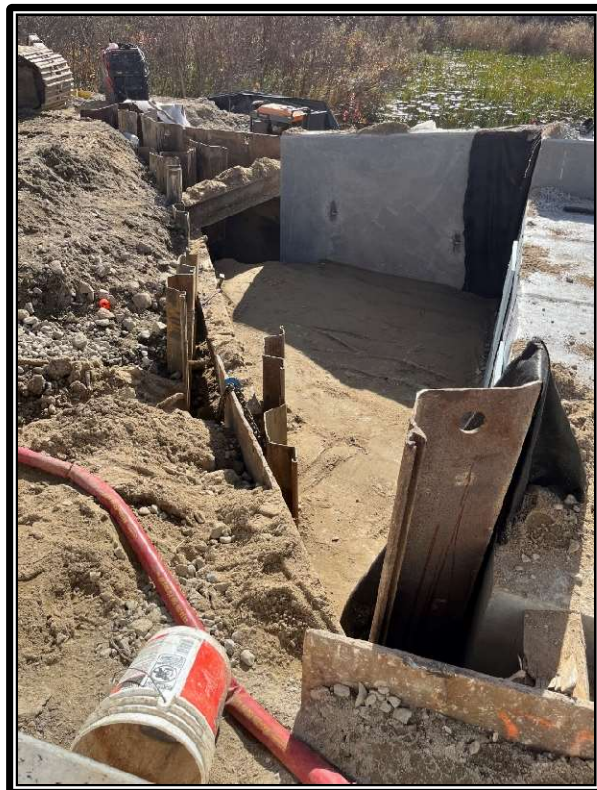
- » The Contractor had placed wingwalls on either side of the box culvert.
- » The Contractor had begun backfilling both sides of the box culvert with granular backfill (see Photo 1).
- » The Contractor installed barrier membrane to the top and sides of the culvert.

Photo 1: Contractor continued backfilling the box culvert.

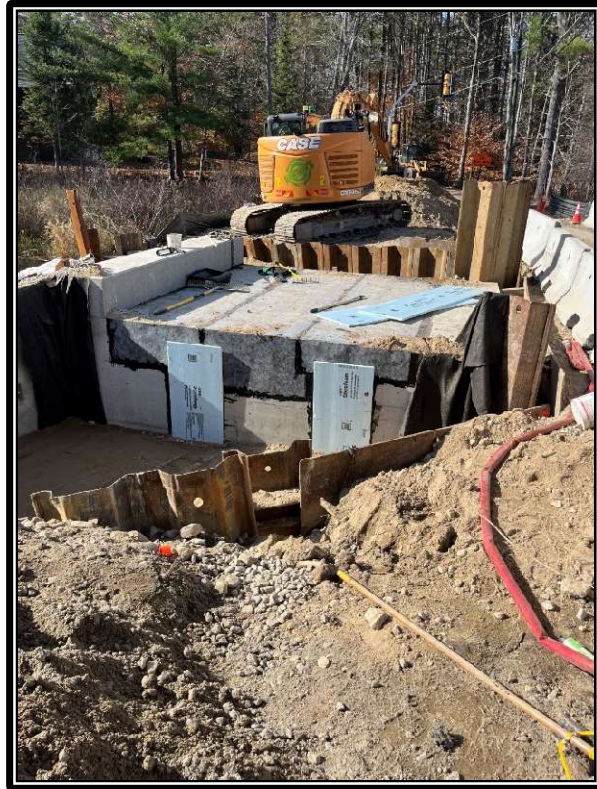
- » The Engineer observed that phase 1 of the box culvert had been installed according to the approved shop drawings from Concrete Systems Inc. (CSI) (see Photo 2). Jake Dawson confirmed that the wingwall was grouted to the footing and the mechanical connection from the wingwall to the box culvert was installed.
- » The Contractor stopped installing 8-inch lifts approximately 3.5 feet from the top of the box culvert on either side in order to have S.W. Cole test the top layers.
- » The barrier membrane installed by the Contractor is Royston 104 AHT Membrane which is an approved product on the New Hampshire Department of Transportation's (NHDOT) Qualified Products List.

Photo 2: The box culvert was installed according to approved shop drawings from CSI.
