Date:	November 18, 2022	Project #:	2021-083	Page 1 of 5
To:	Town of Effingham 68 School Street Effingham, NH 03882	Project:	Bailey Road Culvert Replacement	
Email:	townofeffingham@effinghamnh.net	Location:	Effingham, NH	
Prepared By:	Eric Schroeder	Owner:	Town of Effingham	
Reviewed & Approved By:	Christopher Fournier, PE	Contractor:	Jake Dawson's Excavation & Utility Services, LLC	
		Weather Conditions:	29° Partly Cloudy

SITE VISIT

- » To observe flooding downstream of the culvert.

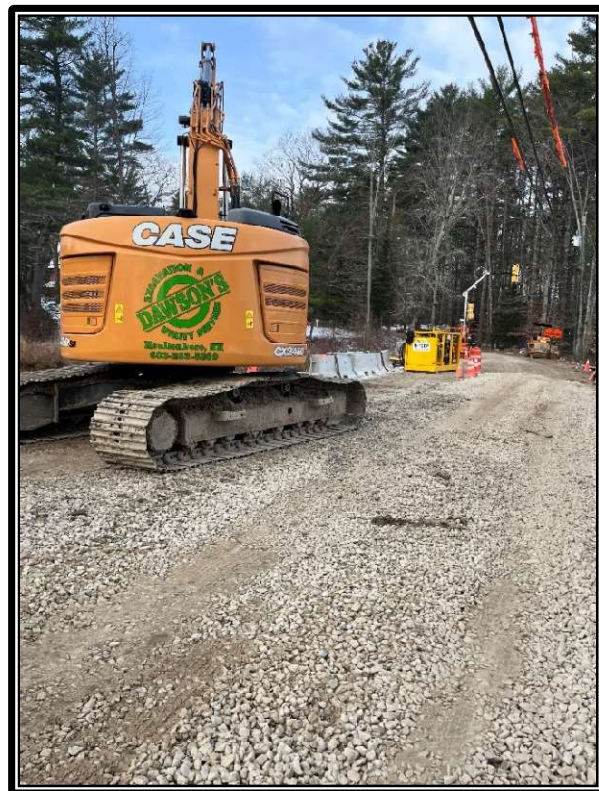
- » The Contractor had placed stone in an effort to stabilize the road (see Photo 1).
- » The Contractor removed sheet pile in the middle of the channel on the inlet side (see Photo 2).

Photo 1: Stone was placed to stabilize the roadway.

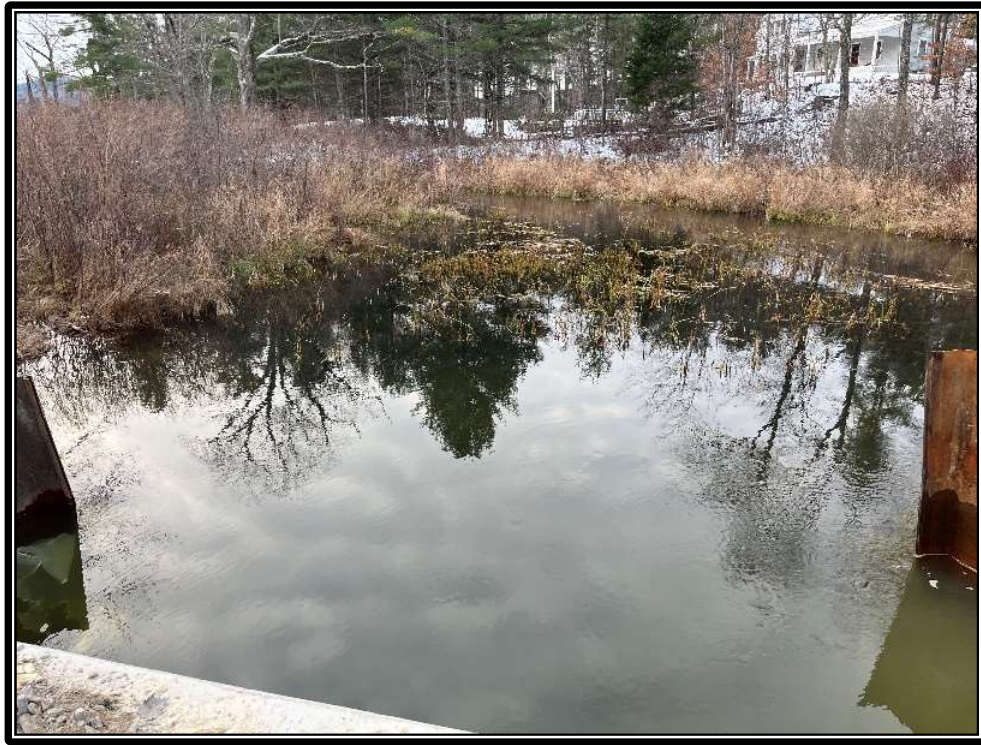
Photo 2: The middle sections of sheet pile were removed from the channel on the inlet side.

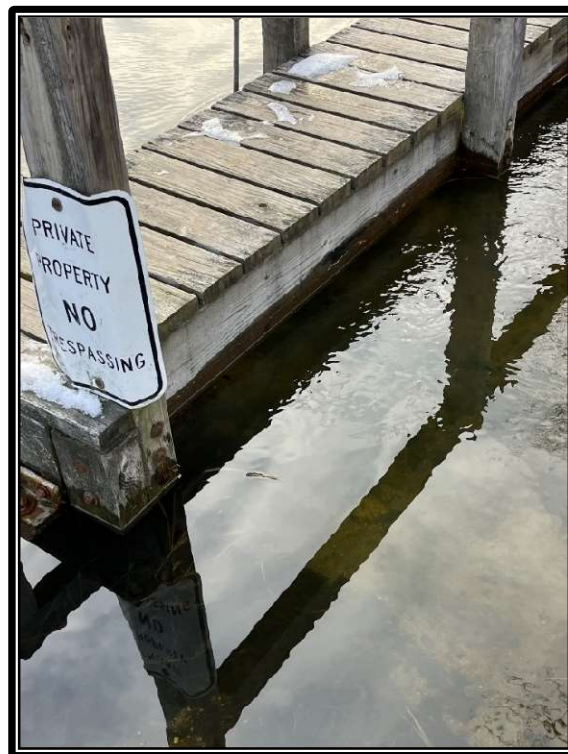
- » The Contractor called the Engineer and asked him to document the flooding on the site.
- » The Engineer observed watermarks on the dam bridge that indicated the water level had decreased on the inlet of the box culvert (see Photo 3).
- » The Engineer observed that water on the outlet side of the box culvert had risen and flooded areas around the channel. Water had risen past the sedimentation basin, almost to the tree line before the roadway.
- » From these observations, the Engineer and Contractor agreed that the cause of the flooding was most likely downstream.
- » The Engineer left the site and checked the stream conditions at the Granite Road, Province Lake Road, and Snow Road crossings.

Photo 3: Watermarks along the dam bridge indicate the water level has lowered.

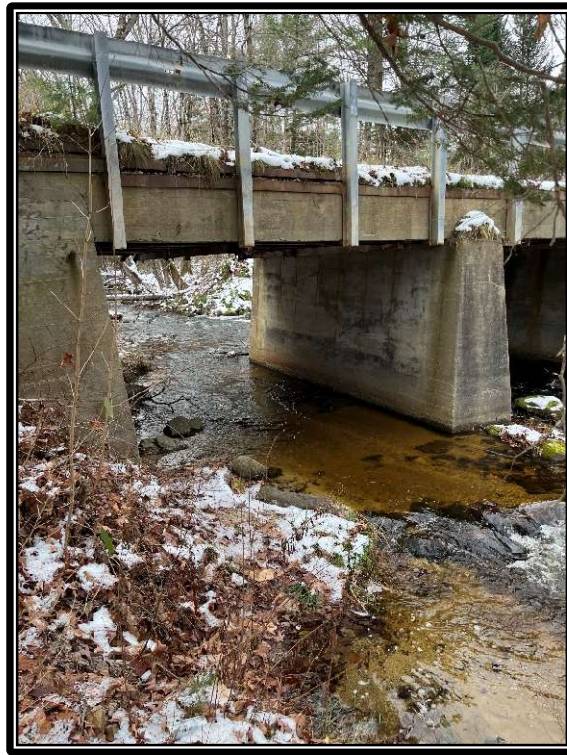
- » The Engineer observed that the water level appeared to be low at the Granite Road crossing (see Photo 4). The watermarks along the pier indicated that the water level was approximately 1-2 feet lower than it had been.
- » The Engineer observed that the water level also appeared to be slightly low at the Province Lake Road crossing (see Photo 5). The tops of the scour walls were covered with algae indicating that normally they would be underwater.
- » The Engineer observed that the water level appeared to be normal at the Snow Road Crossing (see Photo 6). There was evidence of vegetation sticking through the water in flow areas, this was observed as normal conditions during the 2021 Snow Road Bridge Replacement project.
- » The Contractor stated that they will be installing the bridge rail before the winter shutdown.

Photo 4: Granite Road crossing over the South River.

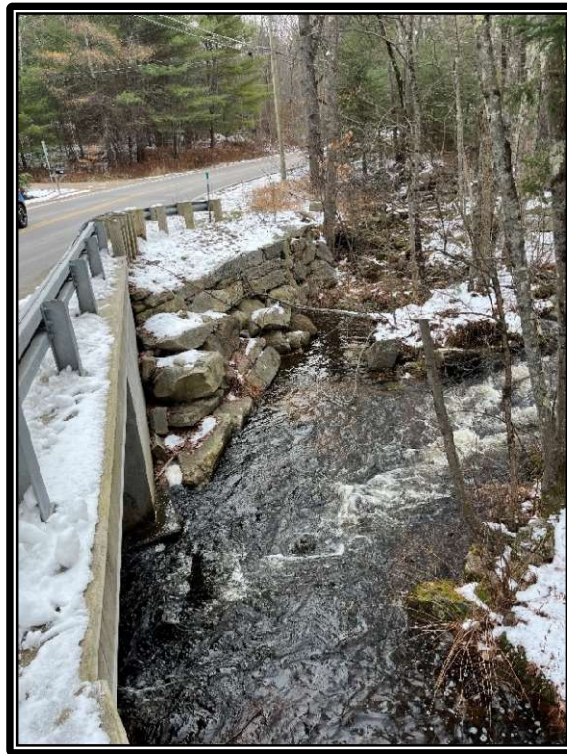
Photo 5: Province Lake Road crossing over the South River.

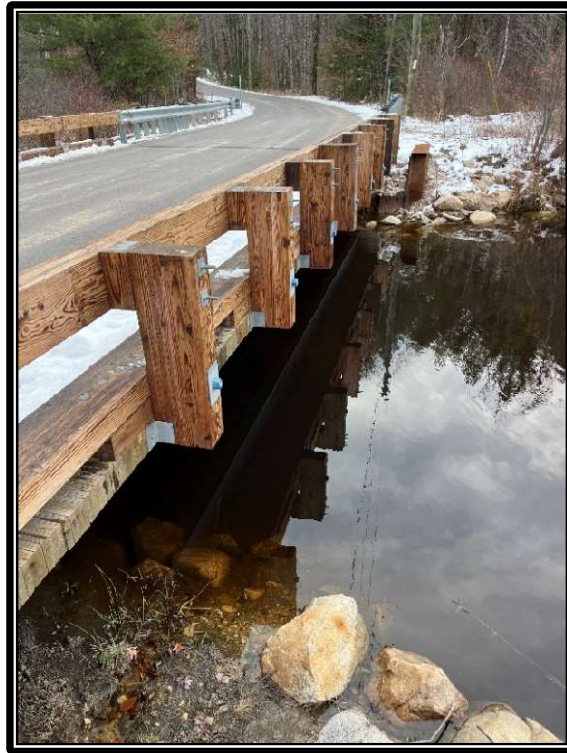
Photo 6: Snow Road crossing over the
South River.
