THE STATE OF NEW HAMPSHIRE  
DEPARTMENT OF TRANSPORTATION

Re: **BRIDGE DEFICIENCY**  
Effingham 165/112  
Snow Road over South River

# Bridge Inspection Report

## Effingham 165/112

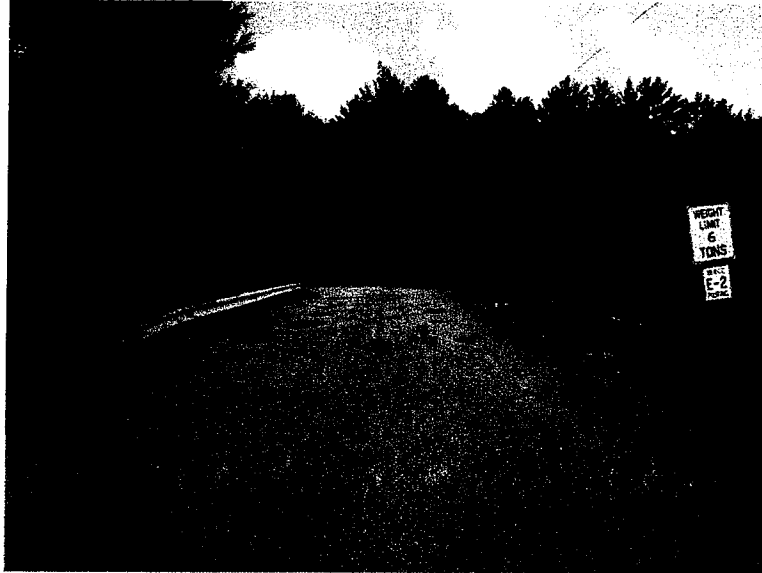
C538 62

WEST APPROACH. (RL)

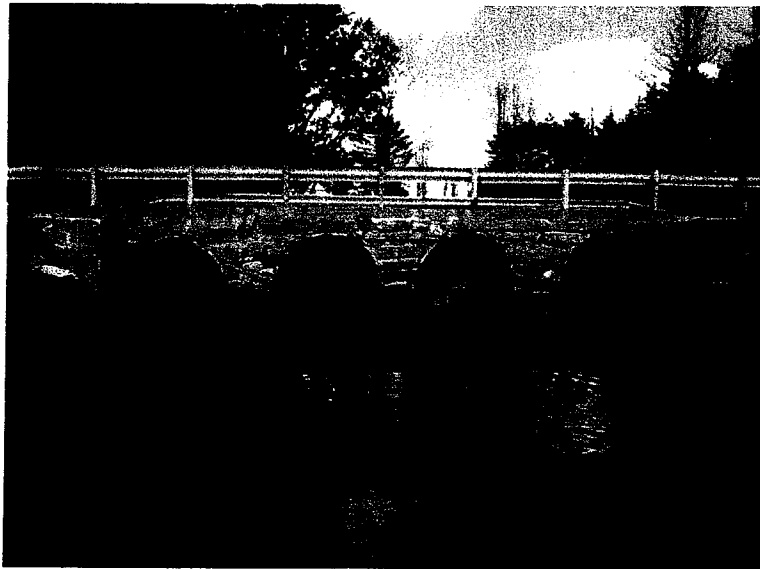
C538 61

SOUTH ELEVATION. (RL)

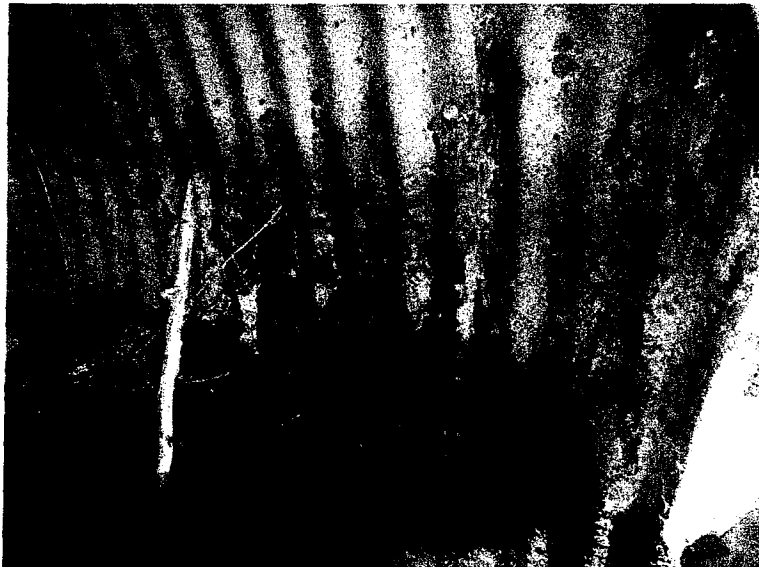
C538 59

This structure consists of four 6'-0" diameter corrugated steel culverts. The culverts exhibit widespread moderate corrosion and pitting, with scattered areas of heavy corrosion and corrosion holes. This deterioration is concentrated at and below the normal water elevation. In a few areas, the corrosion, pitting and holes result in section losses of up to 30%.

BARREL #3 IS THIN AND  
HOLED. TYPICAL OF  
BARREL #4. (RL)

**We recommend that this bridge continue to be posted "E-2" for the short-term. However, please note that corrugated steel culverts can deteriorate rapidly once corrosion has advanced to this level of severity. The municipality should monitor this structure closely for signs of further deterioration.**

This bridge has been added to the Department's Municipal Red List of deficient bridge structures. It is in need of complete replacement or extensive rehabilitation to provide the structural capacity to carry all legal loads.
