# FIELD REPORT #002

<b>Date:</b>	July 13, 2020	<b>Project #:</b>	2018-046	<b>Page 1 of 3</b>
<b>To:</b>	Michael Cahalane Town of Effingham 68 School St. Effingham, NH 03882	<b>Project:</b>	Elm Street Bridge Preservation	
<b>Email:</b>	effingham@roadrunner.com	<b>Location:</b>	Effingham, NH	
<b>Prepared By:</b>	Jonathan K. MacDougall, PE	<b>Owner:</b>	Town of Effingham	
<b>Reviewed &amp; Approved By:</b>	Christopher R. Fournier, PE	<b>Contractor:</b>	Hansen Construction	
		<b>Weather Conditions:</b>	Mostly Sunny 80's°F

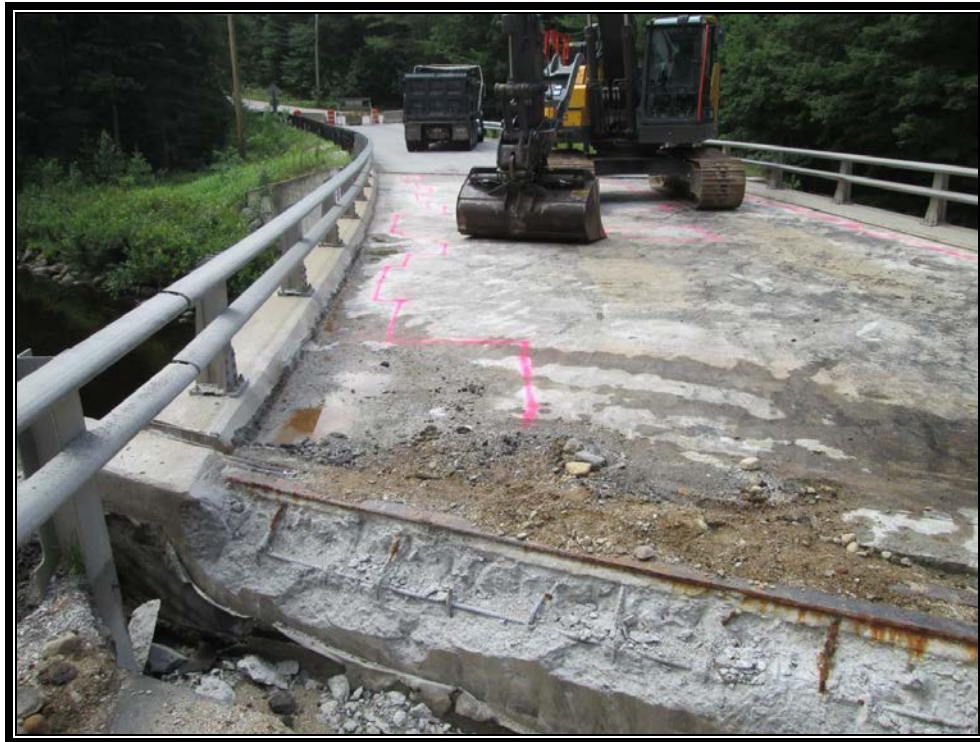
- Engineer chained the deck to locate areas of deteriorated concrete and spray painted the limits of the deck repairs (see Photos 1 and 2). Engineer measured and will calculate preliminary areas for deck repair.

Photo 1: Marked locations for deck repair along the east curb line.

- Contractor and Engineer reviewed the locations of the deck to receive partial depth repairs. Engineer noted that the partial deck repairs should remove concrete to  $\frac{3}{4}$ -inch below the top mat of reinforcing steel, according to the specifications. Engineer will review during a future site visit to determine if some areas of the partial depth repairs may require full depth repairs.

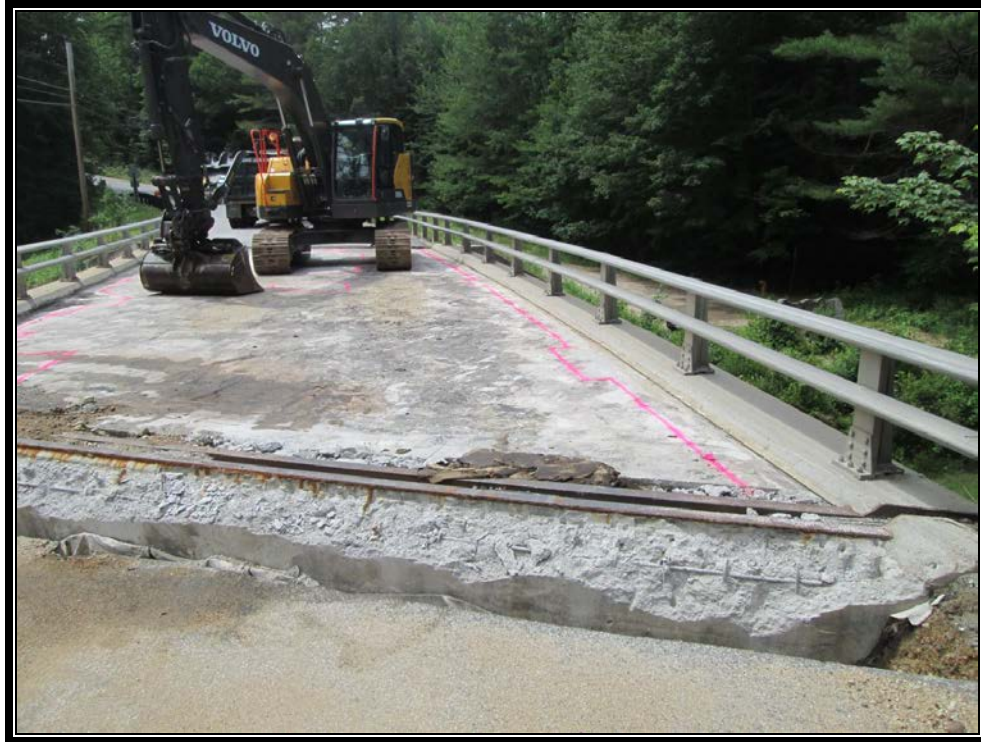
Photo 2: Marked locations for deck repair along the west curb line.

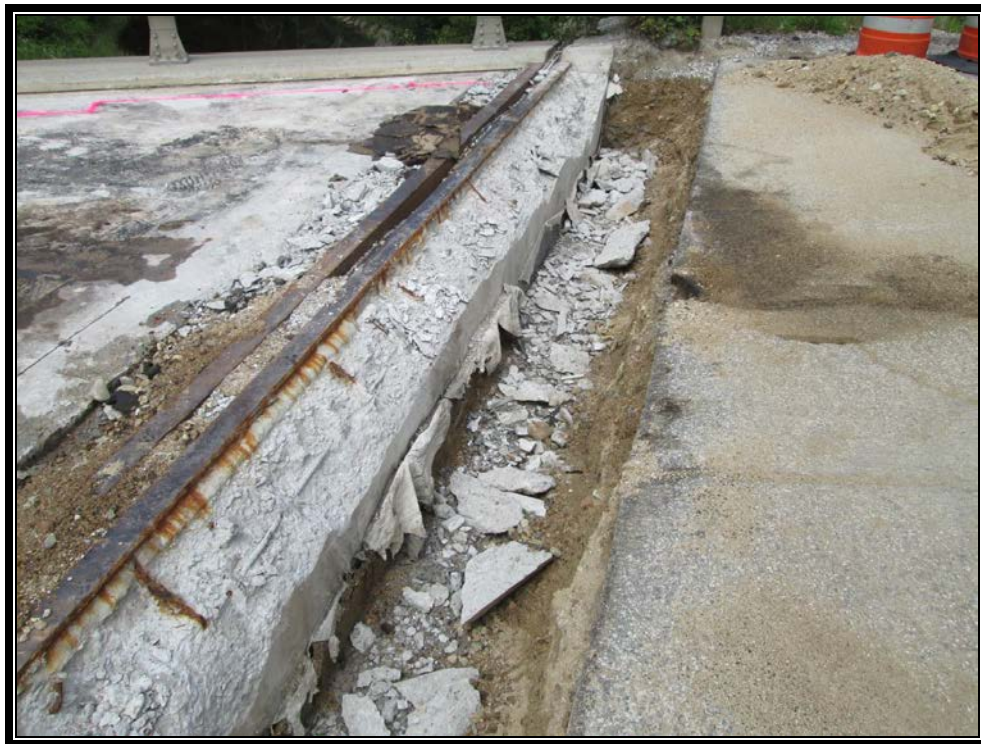
- Contractor sawcut pavement and excavated the north bridge approach to allow for demolition of the expansion joint. Contractor continued demolition of the backwall.
- Contractor removed loose concrete and barrier membrane on the deck.

Photo 3: Excavation and demolition at backwall.

- Engineer noted to the Contractor that there is no specific limit for demolition of the deck and backwall near the expansion joint, other than removal of any deteriorated concrete and enough to remove the existing and install the new expansion joint. The concrete removal at the joint is paid under the full depth repair item.
