Date:	July 20, 2020	Project #:	2018-046	<i>Page 1 of 3</i>
To:	Michael Cahalane Town of Effingham 68 School St. Effingham, NH 03882	Project:	Elm Street Bridge Preservation	
Email:	effingham@roadrunner.com	Location:	Effingham, NH	
Prepared By:	Jonathan K. MacDougall, PE	Owner:	Town of Effingham	
Reviewed & Approved By:	Christopher R. Fournier, PE	Contractor:	Hansen Construction	
		Weather Conditions:	Mostly Sunny 88°F

SITE VISIT

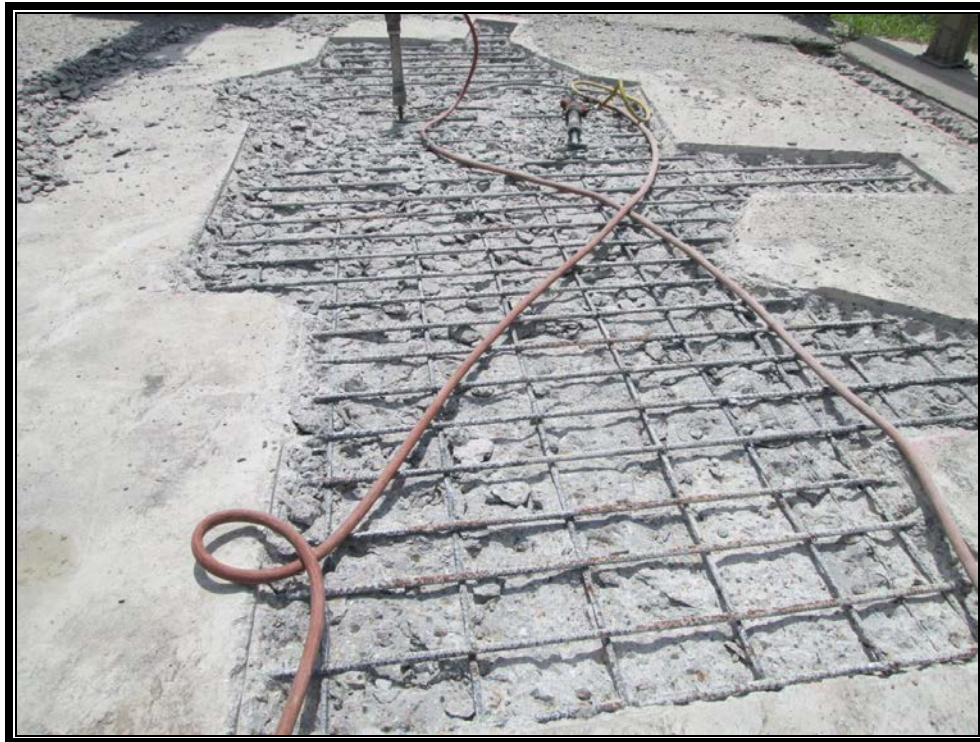
- Contractor continued to chip out concrete for partial depth repairs at the center of the bridge (see Photos 1- 3).

Photo 1: Partial depth repairs in the middle of the deck.

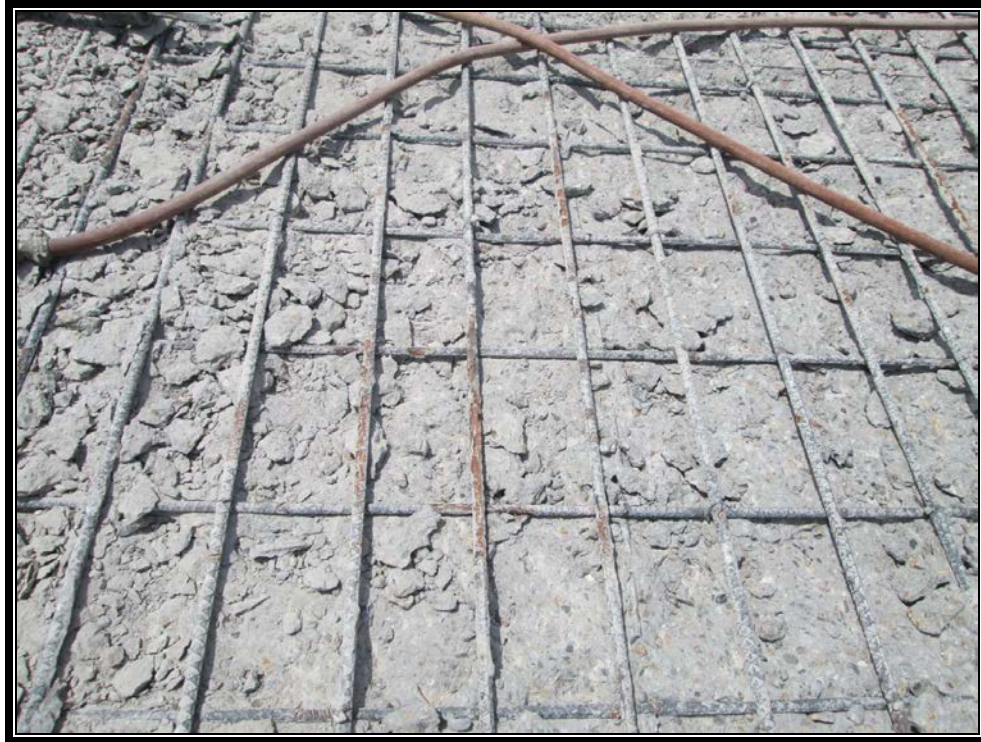
- In the middle area of the deck, there is some rusted reinforcing steel in the with section loss that will require cleaning and additional bars installed to reinforce.

Photo 2: Reinforcing steel with section loss.

- Contractor hooked two (2) bars in the deck with the excavator bucket while cleaning debris, bending them and breaking one. Contractor should use caution not to damage the existing reinforcing and should repair the damage by installing additional reinforcing.

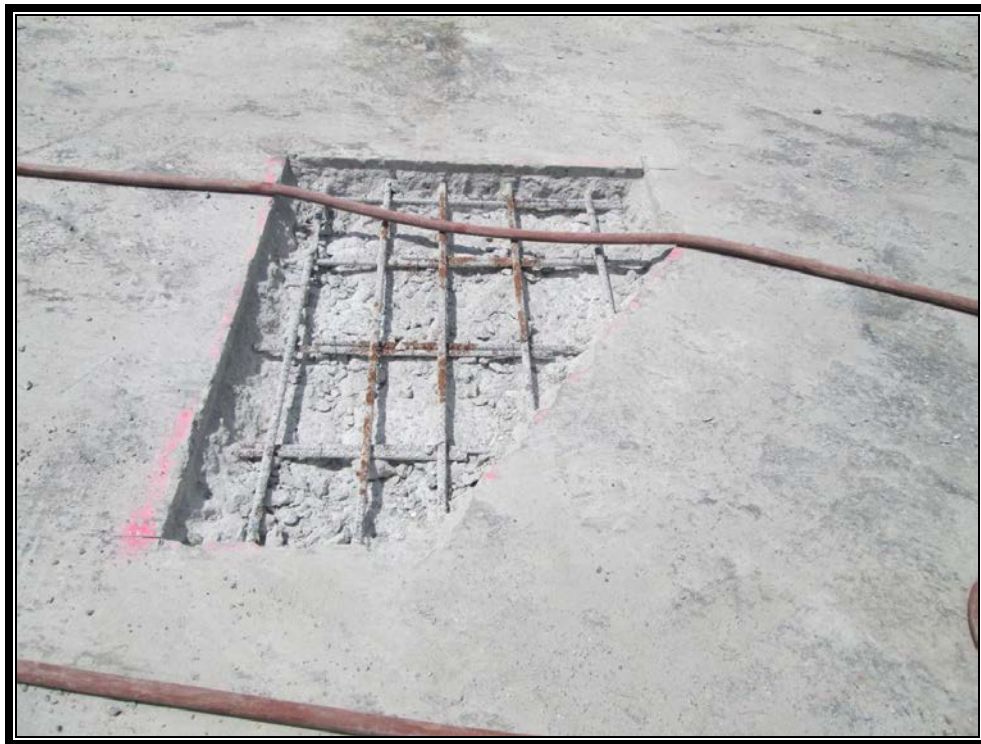
Photo 3: Partial depth repair in middle of deck.
