FIELD REPORT #005

Date:	July 23, 2020	Project #:	2018-046	Page 1 of 4
To:	Michael Cahalane Town of Effingham 68 School St. Effingham, NH 03882	Project:	Elm Street Bridge Preservation	
Email:	effingham@roadrunner.com	Location:	Effingham, NH	
Prepared By:	Jonathan K. MacDougall, PE	Owner:	Town of Effingham	
Reviewed & Approved By:	Christopher R. Fournier, PE	Contractor:	Hansen Construction	
		Weather Conditions:	Overcast 60's°F

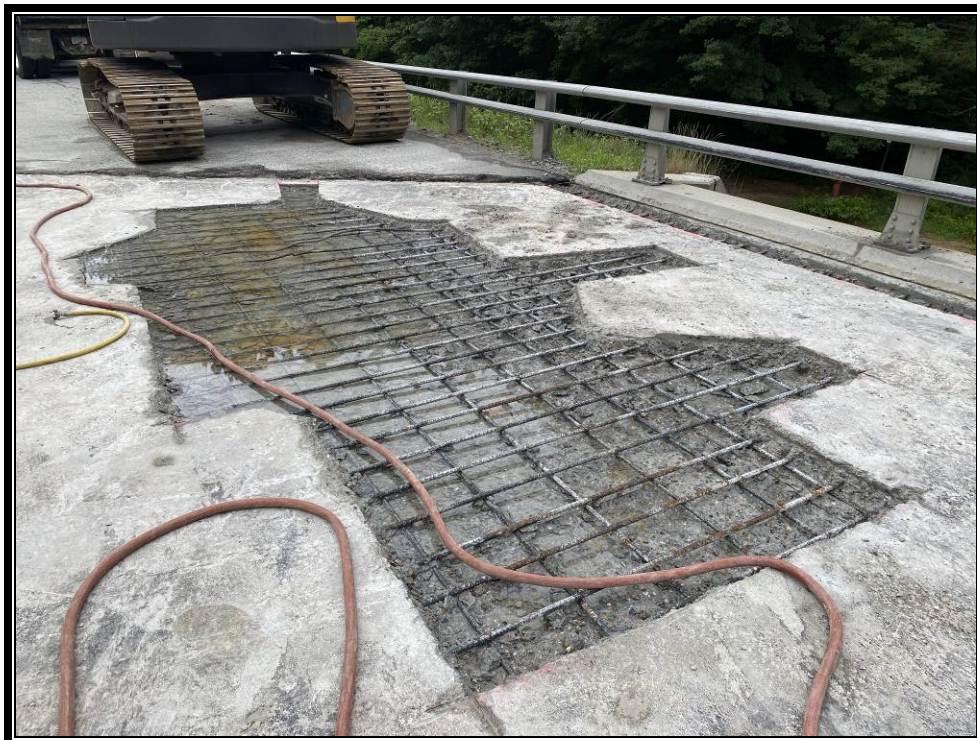
- Contractor completed chipping concrete for partial depth repairs at the center of the bridge (see Photo 1).
- Contractor began chipping deck concrete along the east curb line (see Photo 2).

- The newly exposed deck reinforcement appears to have minimal section lost due to rust. There are some rust locations that will require cleaning for placing the deck concrete.

Photo 1: Deck along the east curb prepared for partial depth repairs.

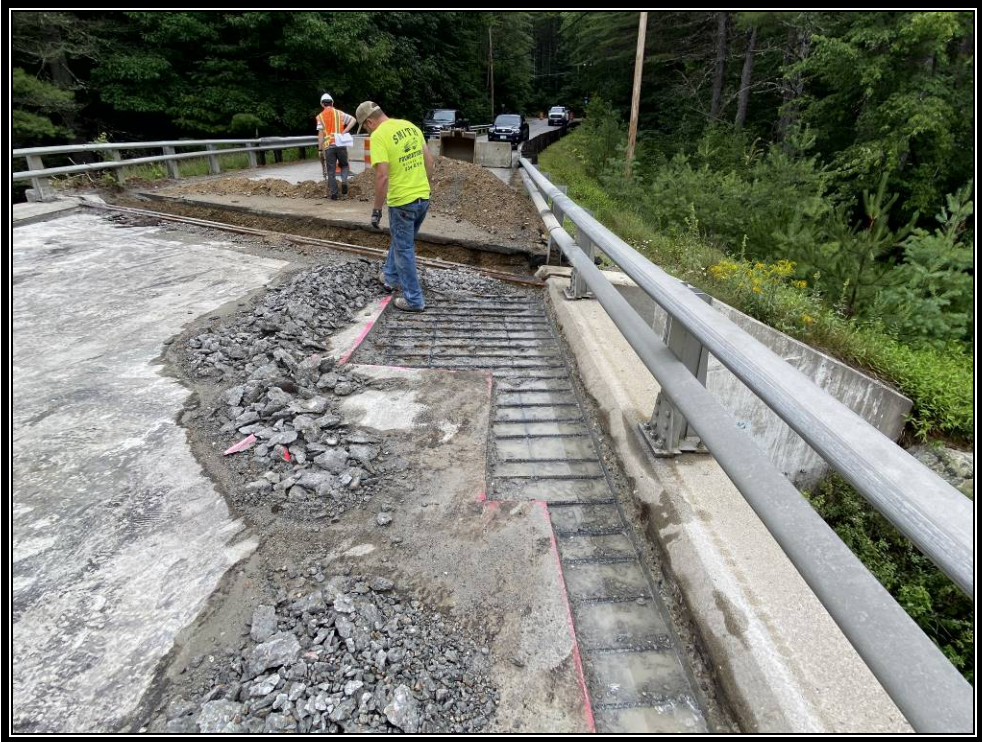
Photo 2: Deck along the east curb prepared for partial depth repairs.

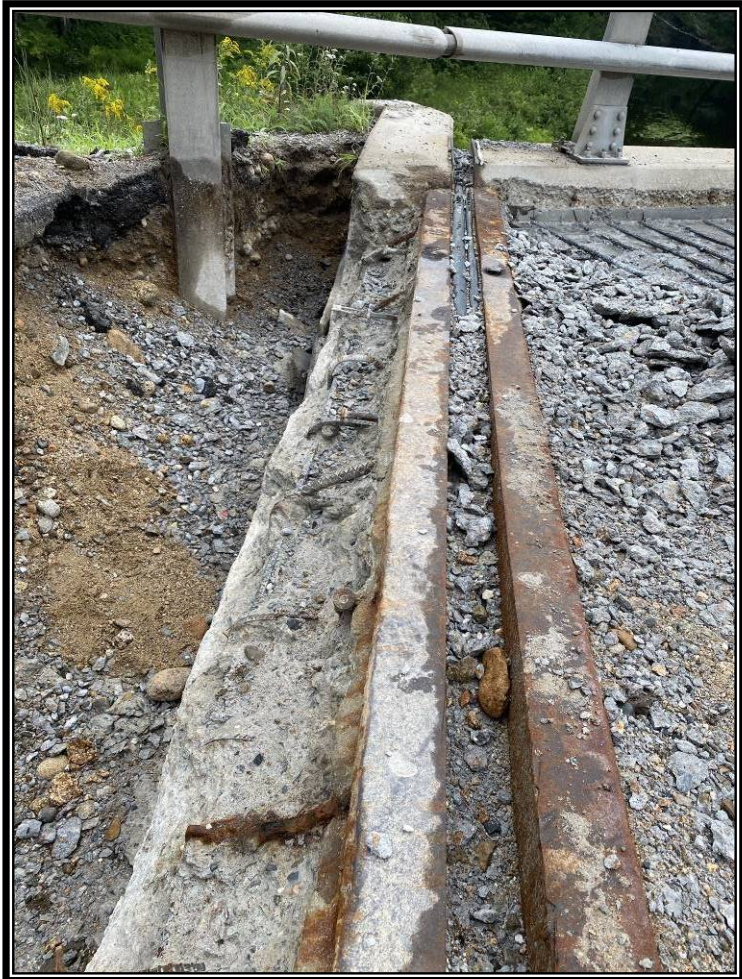
- Contractor asked if they could use a chipping hammer on a skid-steer to demo concrete at the backwall because it was taking a long time to remove with hand equipment (see Photo 3). Engineer expressed concern about damaging the reinforcing within the backwall with the larger hammer. Contractor and Engineer agree to try it with the small skid steer hammer (250-lbs) and see how it works. The equipment is expected to arrive on site Friday morning (July 24, 2020). Engineer will be on site to observe.

Photo 3: Expansion joint and backwall.
