**FIELD REPORT  
 #006**

<b>Date:</b>	July 24, 2020	<b>Project #:</b>	2018-046	<b>Page 1 of 3</b>
<b>To:</b>	Michael Cahalane Town of Effingham 68 School St. Effingham, NH 03882	<b>Project:</b>	Elm Street Bridge Preservation	
<b>Email:</b>	effingham@roadrunner.com	<b>Location:</b>	Effingham, NH	
<b>Prepared By:</b>	Jonathan K. MacDougall, PE	<b>Owner:</b>	Town of Effingham	
<b>Reviewed &amp; Approved By:</b>	Christopher R. Fournier, PE	<b>Contractor:</b>	Hansen Construction	
		<b>Weather Conditions:</b>	Mostly Sunny 70's°F

**SITE VISIT**

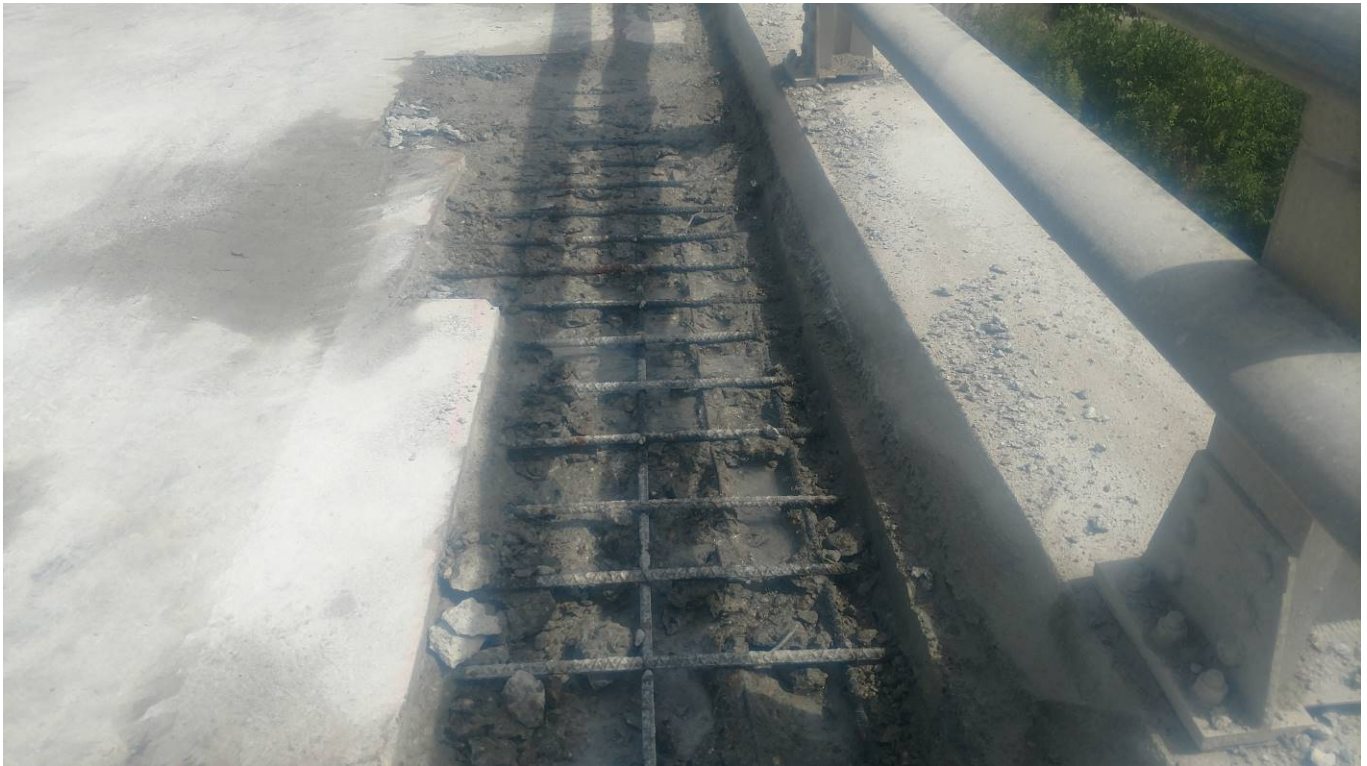
- Contractor continued chipping concrete along the east curb line (Photo 1).

- The further exposed deck reinforcement along the east curb line appears to have minimal section lost due to rust. There are some rust locations that will require cleaning for placing the deck concrete.
- Contractor began chipping concrete with the skid steer but was limited due to the articulation of the bucket not allowing enough angle to effectively get under the expansion joint. Contractor contacted Coleman rental to trailer the skid steer to the other side of the bridge and were expected to arrive within an hour or two. They were able to chip some concrete along the top of the wall to get a sense of how the process would work. Contractor and Engineer reviewed the progress and agreed they should be able to remove substantial

Photo 1: Deck along the east curb prepared for partial depth repairs.

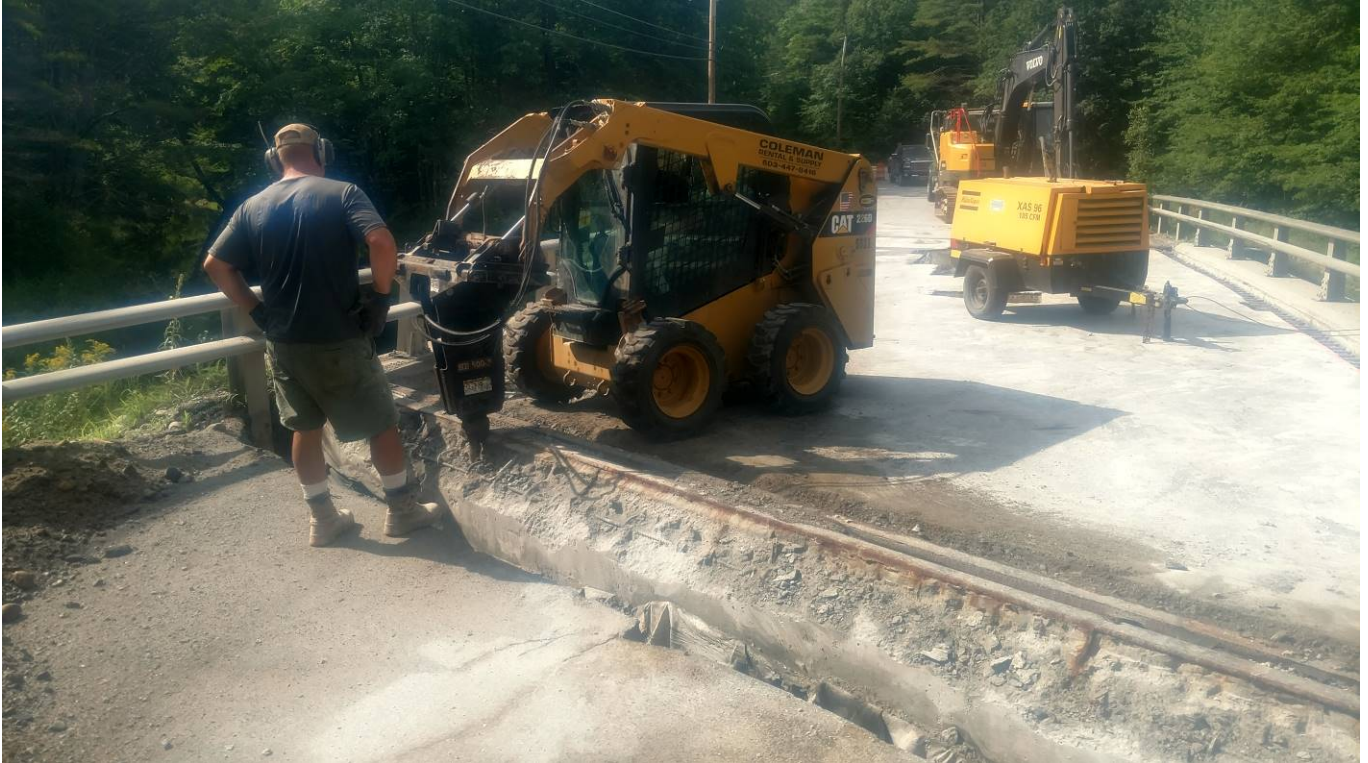
- Contractor assisted with delivery of Bobcat and chipping hammer from Coleman Rental.
- Contractor began chipping the backwall with the skid steer and hammer (Photo 2), as well as chipping concrete with hand operated pneumatic hammers.

Photo 2: Skid-steer with hammer at the bridge backwall.

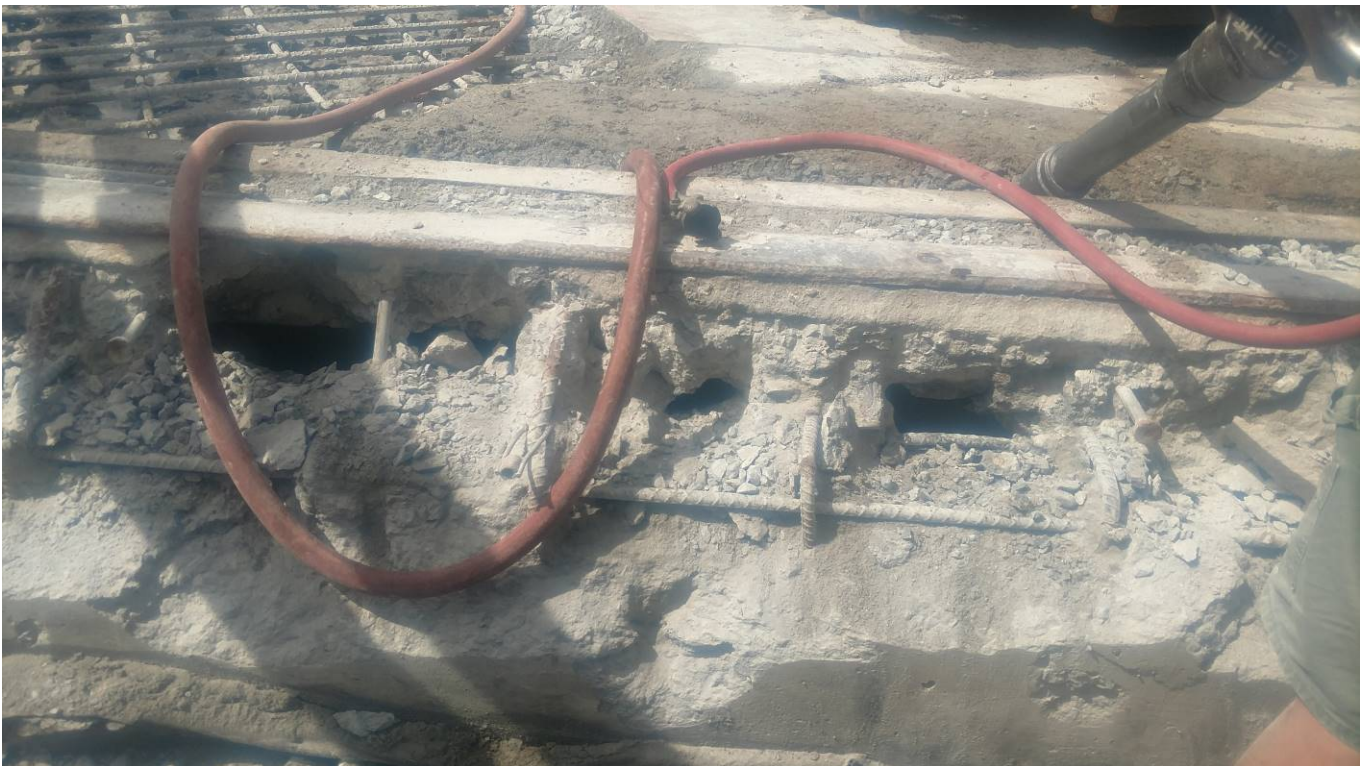
- Contractor was able to open a hole below the expansion joint using hand held chipping hammers and began to make good progress chipping concrete under the joint at that point (Photo 3).
- Engineer noted to be aware of concrete that is falling below the deck while chipping the backwall. No debris shall fall in the water and all debris must be cleaned up.

Photo 3: Hole below expansion joint in backwall.
