FIELD REPORT #009

Date:	July 30, 2020	Project #:	2018-046	Page 1 of 3
To:	Michael Cahalane Town of Effingham 68 School St. Effingham, NH 03882	Project:	Elm Street Bridge Preservation	
Email:	effingham@roadrunner.com	Location:	Effingham, NH	
Prepared By:	Jonathan K. MacDougall, PE	Owner:	Town of Effingham	
Reviewed & Approved By:	Christopher R. Fournier, PE	Contractor:	Hansen Construction	
		Weather Conditions:	Mostly Sunny 70-80°F

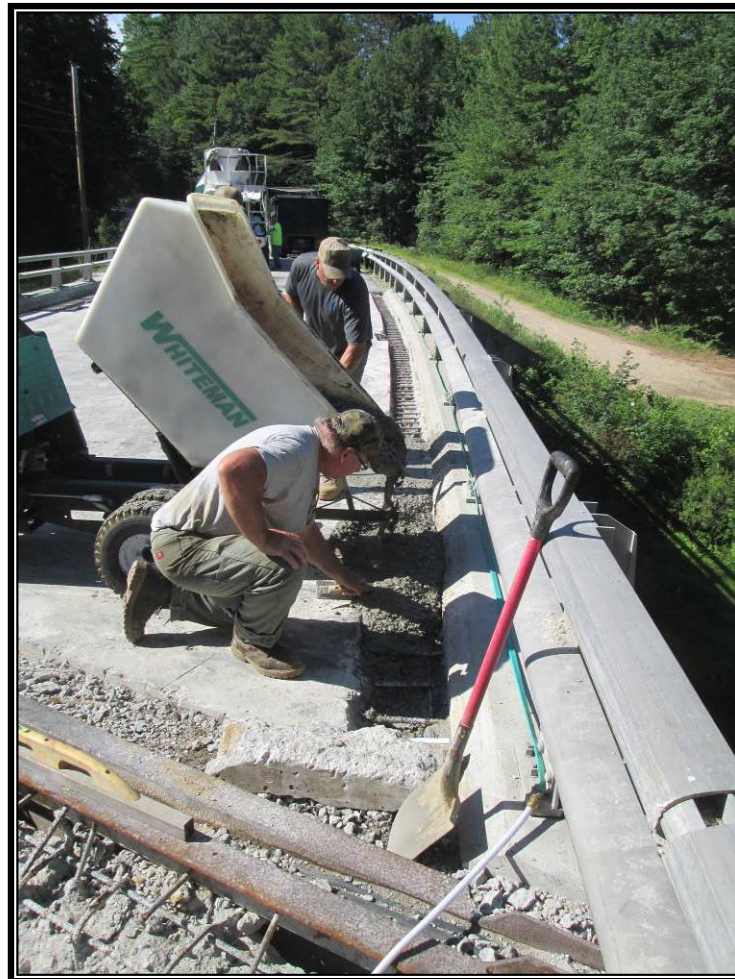
Photo 1: View of concrete from wheelbarrow.

- Contractor placed concrete for the concrete deck repairs. The NHDOT Class AA concrete was batch at 8:56 AM and arrived on site at 9:20 AM. The truck park at the end of the bridge and placed the concrete in powered wheelbarrow. The wheelbarrow was driven around the deck and dumped into the concrete (see Photo 1). Contractor used rakes to move the concrete around and consolidate it (see Photo 2). Once in place, they began finishing with a magnesium trowel and bull float. A battery-operated pencil vibrator was used in some locations to consolidate the concrete. Placement was complete by 10:30 AM. Once the concrete was finished and began to set up, wet burlap was placed over the concrete (see Photo 3).
- The Technician from Alvin J. Coleman & Son, Inc. took cylinders for testing.

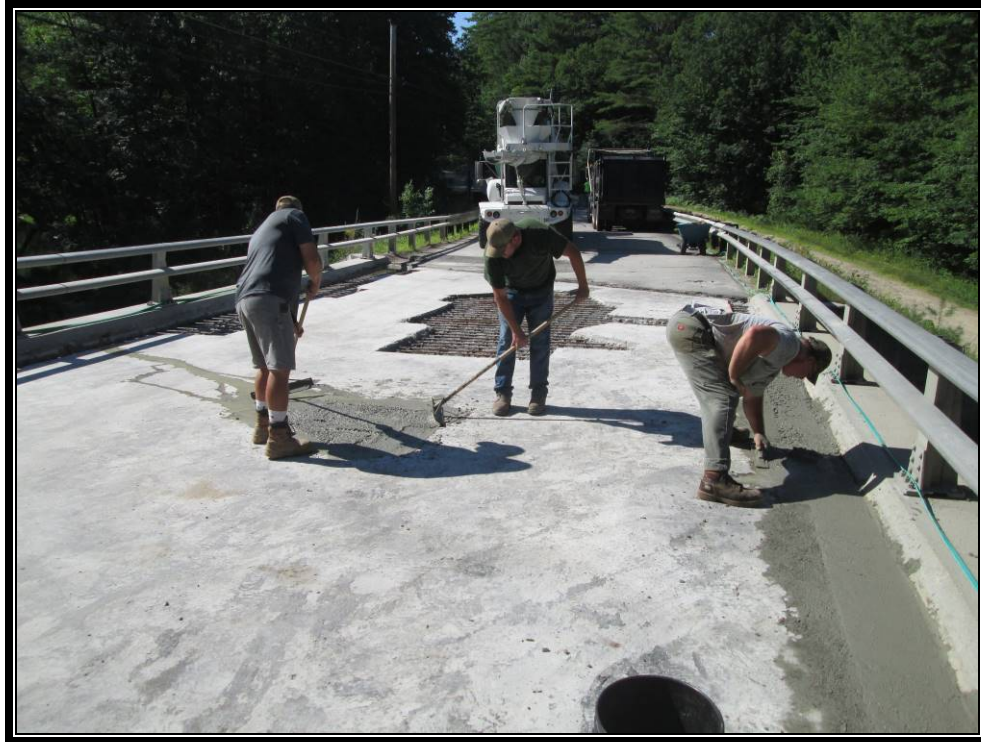
Photo 2: View of crew raking and consolidating concrete.

- Contractor said they wanted to use the concrete rakes to consolidate rather than the pencil vibrator. The Contractor thought it would work better to get the aggregate under the bars. The pencil vibrator did end up being used in some locations.

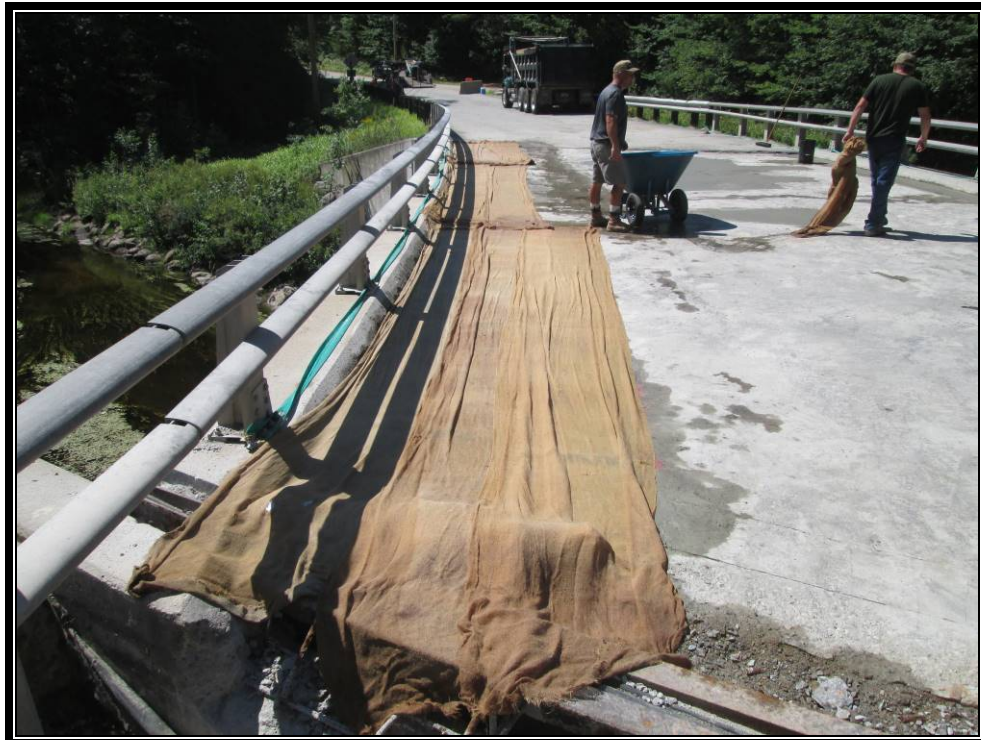
Photo 3: View of wet burlap placed over concrete.

- Contractor said they would place the weeper hoses on the wet burlap and install a poly tarp over all the burlap and hoses.
- Contractor and Engineer discussed containment for further demo of the bridge joint. Contractor said they would come up with something. Engineer also noted that the loose concrete block at the corner of the abutment is bigger than initially assumed. Contractor said it would be fine to repair.
- Contractor and Engineer discussed the plan for the use of the Snooper inspection truck. Contractor would like to have the truck on site within a week. They will test cylinders to help determine strengths before putting on the bridge.
