FIELD REPORT #013

Date:	August 13, 2020	Project #:	2018-046	Page 1 of 2
To:	Michael Cahalane Town of Effingham 68 School St. Effingham, NH 03882	Project:	Elm Street Bridge Preservation	
Email:	effingham@roadrunner.com	Location:	Effingham, NH	
Prepared By:	Jonathan K. MacDougall, PE	Owner:	Town of Effingham	
Reviewed & Approved By:	Christopher R. Fournier, PE	Contractor:	Hansen Construction	
		Weather Conditions:	85°F, sunny

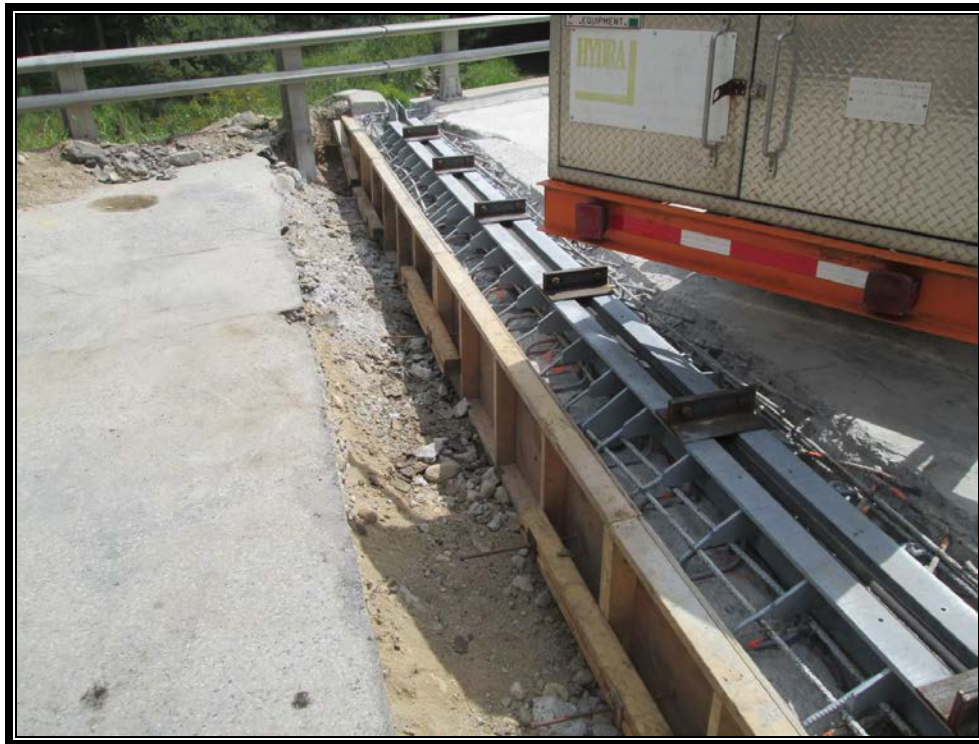
- Contractor continued working on the concrete forms at the backwall and end of deck (see Photo 1).

Photo 1: Form installed at backwall.

- Engineer noted the concrete demolition at the wingwalls should be cut square to a depth of 1½ inches.
- The top of the concrete form at the backwall is installed 2¼ inches below the top of the expansion joint. Contractor and Engineer reviewed the NHDOT Standard Detail to show the concrete on each side of the joint must be installed level with the top of the joint angle as well as contain a chamfer. Contractor said they would raise the backwall forms and add a chamfer strip. Contractor proposed constructing the deck end side with a slope coming off the back of the angle, similar to over the backwall in detail Abutment B Expansion Joint on sheet S5.12. Engineer initially agreed, but upon leaving the site immediately called Mike Hansen and

explained that it must be installed as shown in the NHDOT Standard Detail included in the plans. An email was later sent highlighting the detail.

- Engineer noted the following items must be completed prior placing concrete: relocate reinforcing bar, chip deteriorated concrete at deck end, finish installing forms, install chamfer strips, and cut square all edges of demolition.
