FIELD REPORT #015

Date:	August 17, 2020	Project #:	2018-046	Page 1 of 3
To:	Michael Cahalane Town of Effingham 68 School St. Effingham, NH 03882	Project:	Elm Street Bridge Preservation	
Email:	effingham@roadrunner.com	Location:	Effingham, NH	
Prepared By:	Jonathan K. MacDougall, PE	Owner:	Town of Effingham	
Reviewed & Approved By:	Christopher R. Fournier, PE	Contractor:	Hansen Construction	
		Weather Conditions:	70°F, sunny

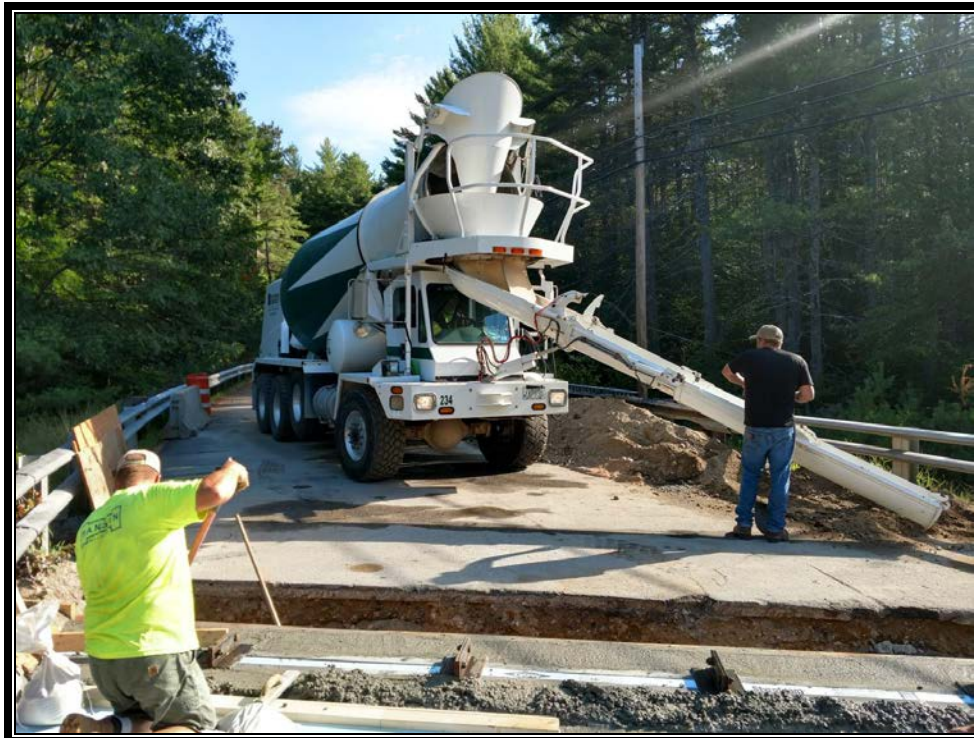
Photo 1: Contractor preparing to place concrete.

- Concrete truck 234 arrived on site at 7:45 AM with 4.5cy of NHDOT Class AA concrete (see Photo 1).
- Contractor wet the backwall and end of deck to place concrete against. Contractor began placing concrete at the backwall at 8 AM. Contractor tamped the concrete in place with hand tools as consolidated with a battery-operated pencil vibrator. Once the backwall was complete, the Contractor proceeded to the end of the deck (see Photos 2 & 3).
- Contractor vibrated and mounded up concrete at the joint angle, once the entire deck end was mostly full of concrete the workers began finishing the deck. At locations where the deck was finished, they would set 1-inch rigid foam insulation over the deck concrete and attached 2x4s were attached to form the step in the concrete.

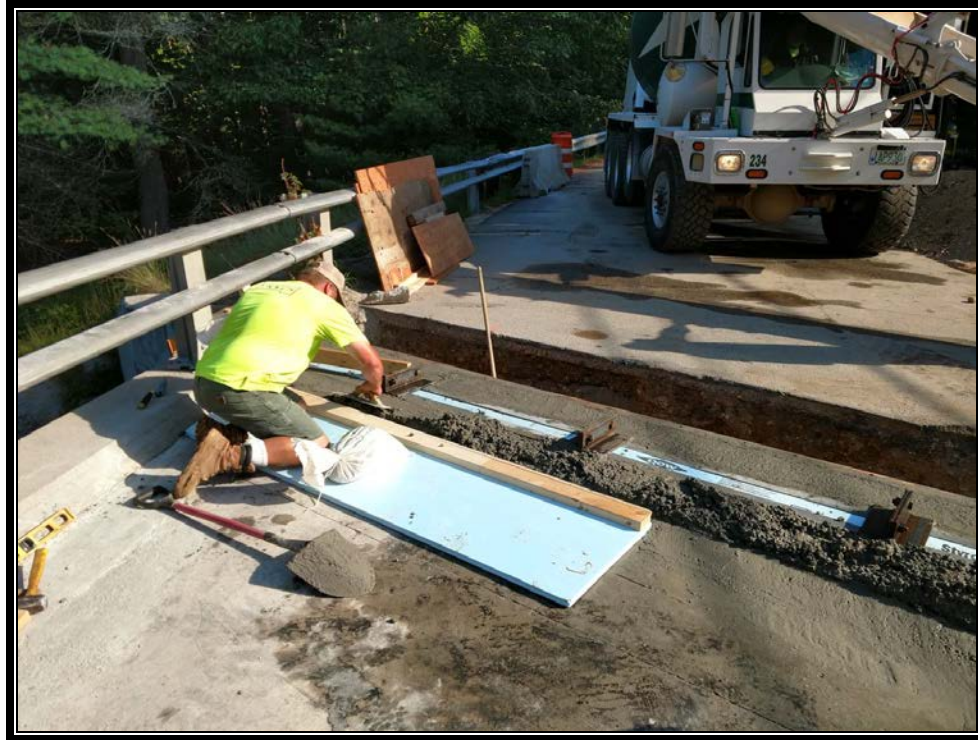
Photo 2: Contractor finishing the end of deck concrete.

The exposed portion of concrete was then finished. The concrete was placed ~ ¼-inch below the top of the chamfer to match the elevation of the top of the joint angle. By 8:30 AM, placement of the concrete was completed from the truck and finishing of the exposed surface was completed by 9:40 AM.

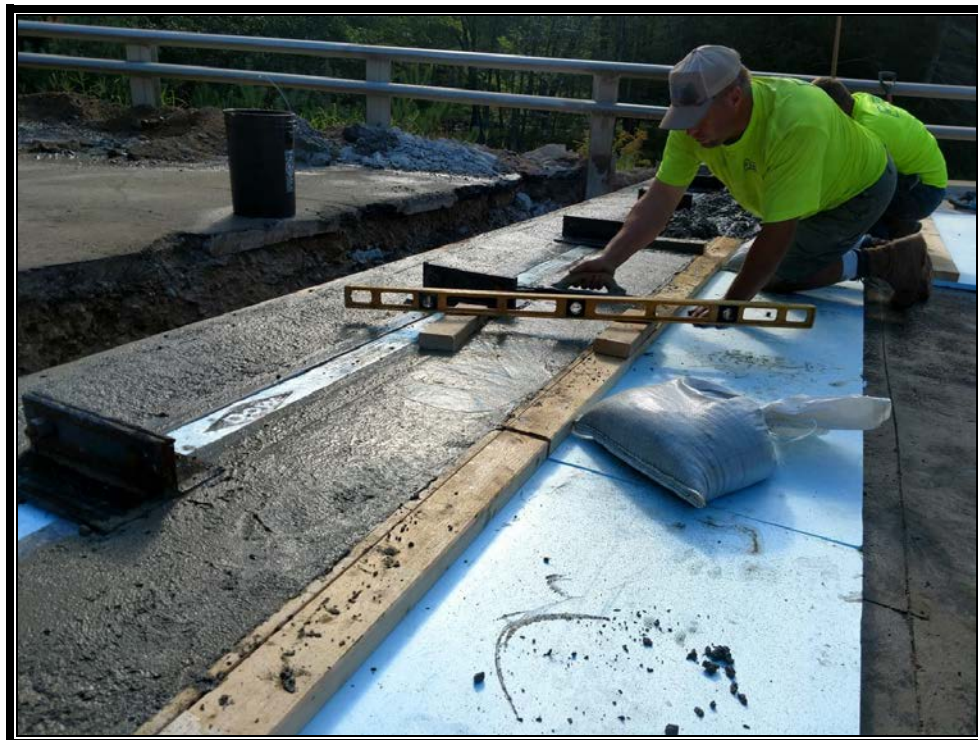
Photo 3: Contractor finishing the end of deck concrete.
