FIELD REPORT #021

Date:	November 10, 2020	Project #:	2018-046	<i>Page 1 of 2</i>
To:	Michael Cahalane Town of Effingham 68 School St. Effingham, NH 03882	Project:	Elm Street Bridge Preservation	
Email:	effingham@roadrunner.com	Location:	Effingham, NH	
Prepared By:	Jonathan K. MacDougall, PE	Owner:	Town of Effingham	
Reviewed & Approved By:	Christopher R. Fournier, PE	Contractor:	Hansen Construction	
		Weather Conditions:	Sunny, 70°F

SITE VISIT

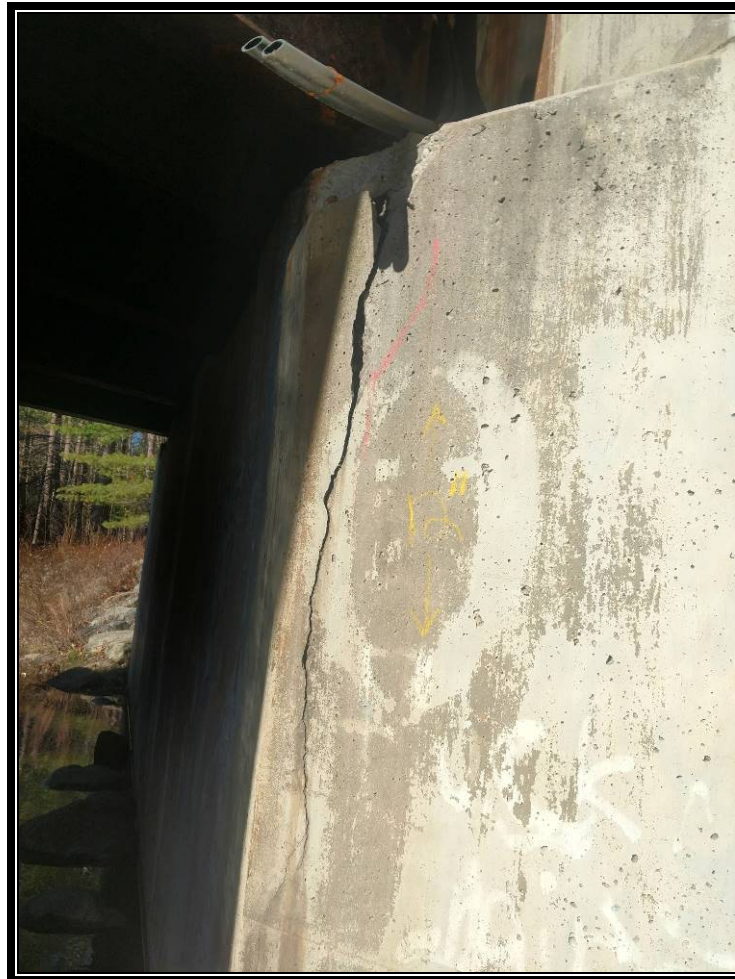
- Contractor and Engineer reviewed the location of the concrete repair at the north abutment (see Photo 1).
- Contractor and Engineer sounded the concrete at the eastern end of the north abutment with a hammer. Contractor and Engineer agreed the proposed limits should be from the bridge seat down to just above ground level (8 feet 6-inch height), extend under the bridge 32 inches from the corner, and 12 inches toward the wing wall from the corner. Contractor will saw cut the limits 1 ½-inch deep and then chip down behind the reinforcing steel or deeper if the concrete does not appear to be in good condition.
- Contractor will place sandbags at the corner of the bridge to act as a foundation for their work platform.
- Contractor will be closing the road to complete the repair.
- Contractor will take pictures to review demolition with Engineer.

Photo 1: Area of repair at the northeast corner of the abutment.
