<b>Date:</b>	June 1, 2021	<b>Project #:</b>	2018-087	<b>Page 1 of 3</b>
<b>To:</b>	Town of Effingham 68 School Street Effingham, NH 03882	<b>Project:</b>	Snow Road Bridge Replacement	
		<b>Location:</b>	Effingham, NH	
<b>Email:</b>	townofeffingham@effinghamnh.net	<b>Owner:</b>	Town of Effingham	
<b>Prepared By:</b>	Eric V. Schroeder, EIT	<b>Contractor:</b>	Hansen Bridge LLC	
<b>Reviewed &amp; Approved By:</b>	Christopher R. Fournier, PE	<b>Weather Conditions:</b>	72°F Partly Cloudy

**SITE VISIT**

P:\Jobs\2018\2018-087 Effingham - Snow Road Bridge #165-112 over South River, Effingham, NH\Construction Observation\Field Reports\Snow Road Bridge - Field Report #006 06-01-21.doc

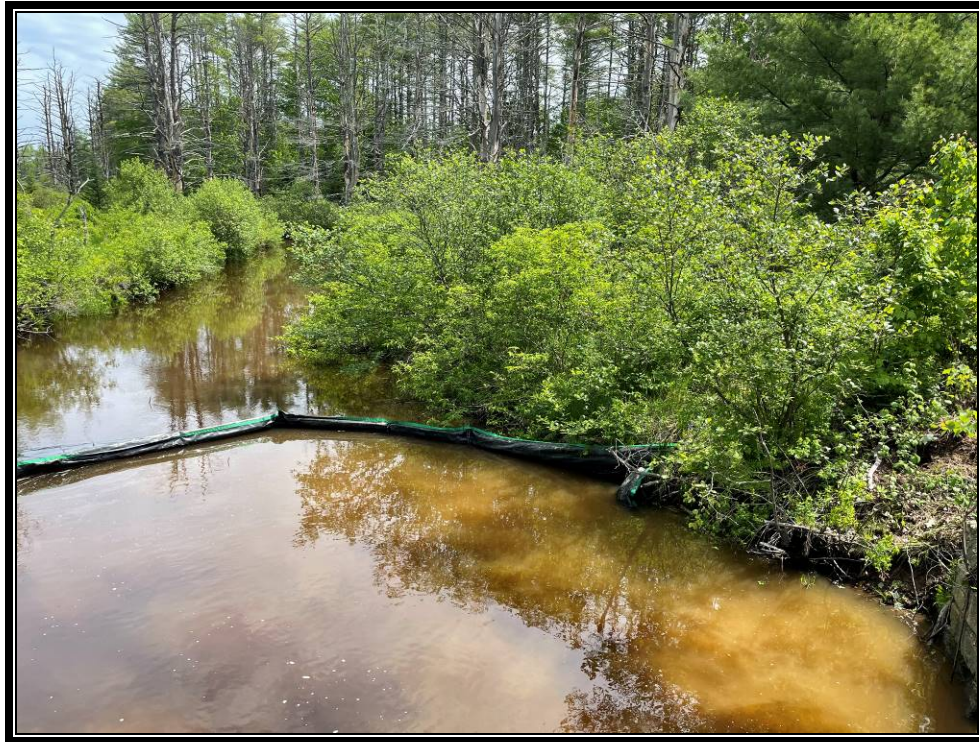
- A turbidity curtain was installed on the downstream side of the bridge (see Photo 1).

Photo 1: Turbidity curtain downstream of the culverts.

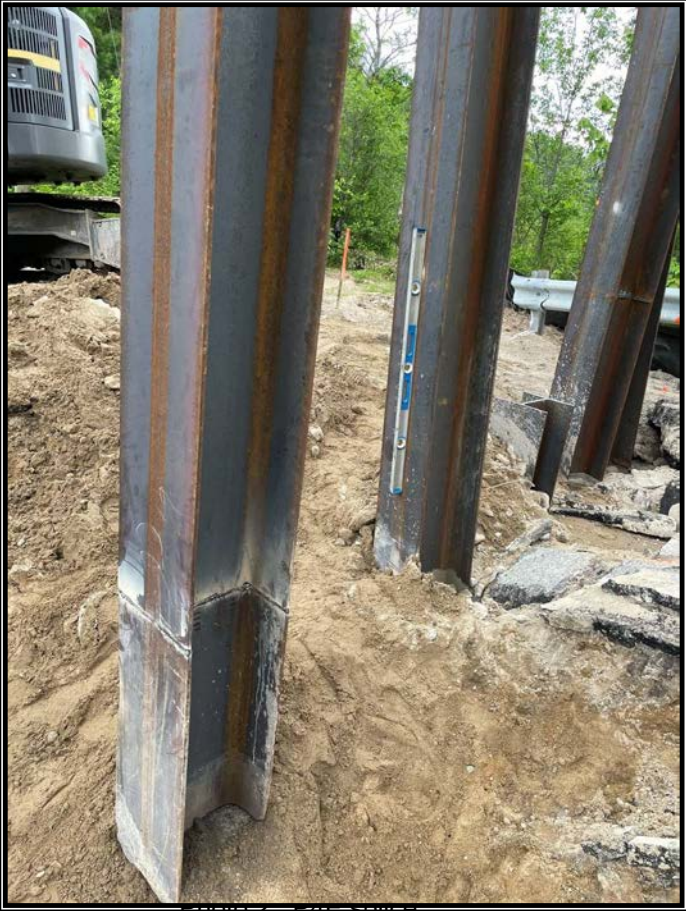
- The Contractor tried to excavate a large boulder on the east side in the location of P5E. This attempt was unsuccessful because the boulder appeared to go under the existing culverts. GM2 (Hansen subconsultant) was contacted for an alternative solution to driving P5E to the designed depth.
- The Contractor attempted to drive piles P1E and P3E with the larger ICE vibratory hammer but was unsuccessful.
- The Contractor then spliced P4E. They then tried to drive the pile to full depth, but a hose blew on their vibratory hammer so they ended for the day. P4E remains at approximately 19 feet below roadway (see Photo 2).

PHOTO 2: I-4L Splice.

- The Contractor needs to provide revised GM2 design information regarding differing pile conditions.
