Date:	June 2, 2021	Project #:	2018-087	Page 1 of 3
To:	Town of Effingham 68 School Street Effingham, NH 03882	Project:	Snow Road Bridge Replacement	
		Location:	Effingham, NH	
Email:	townofeffingham@effinghamnh.net	Owner:	Town of Effingham	
Prepared By:	Eric V. Schroeder, EIT	Contractor:	Hansen Bridge LLC	
Reviewed & Approved By:	Christopher R. Fournier, PE	Weather Conditions:	81°F Partly Cloudy

SITE VISIT

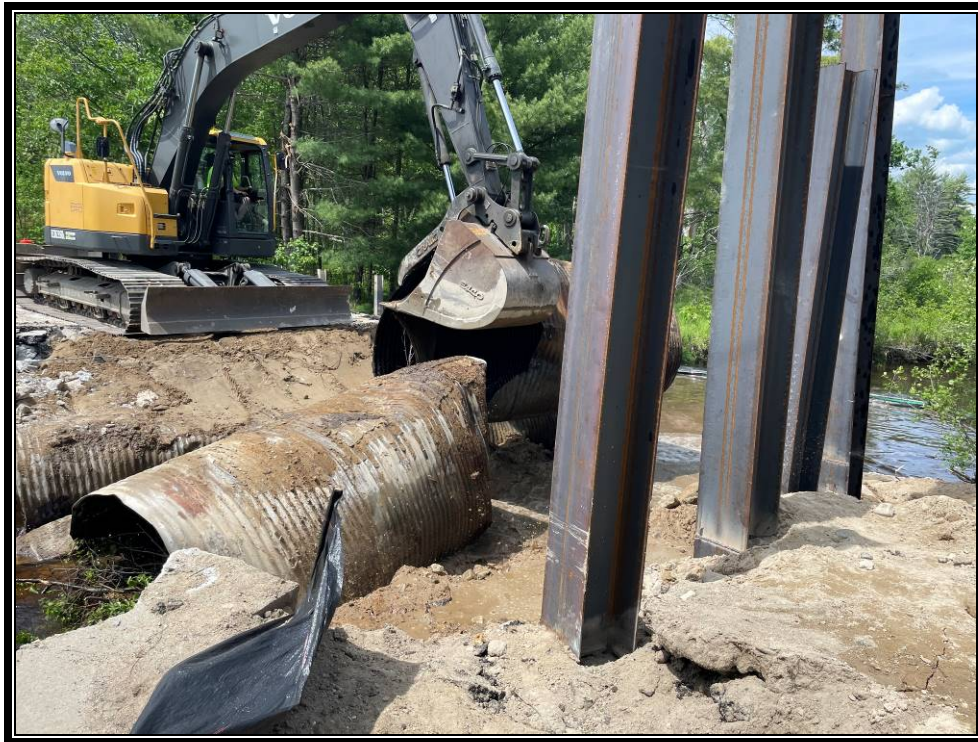
- After the Contractor was done driving the pile for the day, they began excavating the culverts, starting with the easternmost culvert (see Photos 1 and 2). This significantly reduced the water level upstream and increased velocity through the site, which mobilized sediment. The downstream turbidity curtain captured most of the sediment, but not all, as the bottom of the curtain lifted due to the velocity. Repair/enhancement of the downstream sediment control is likely necessary before additional culverts are removed.

Photo 1: Removal of the easternmost culvert.

- The Contractor needs to provide revised GM2 design information regarding differing pile conditions (FR #006, 06-01-21).
- Repair/enhancement of the downstream sediment control is likely necessary before additional culverts are removed.

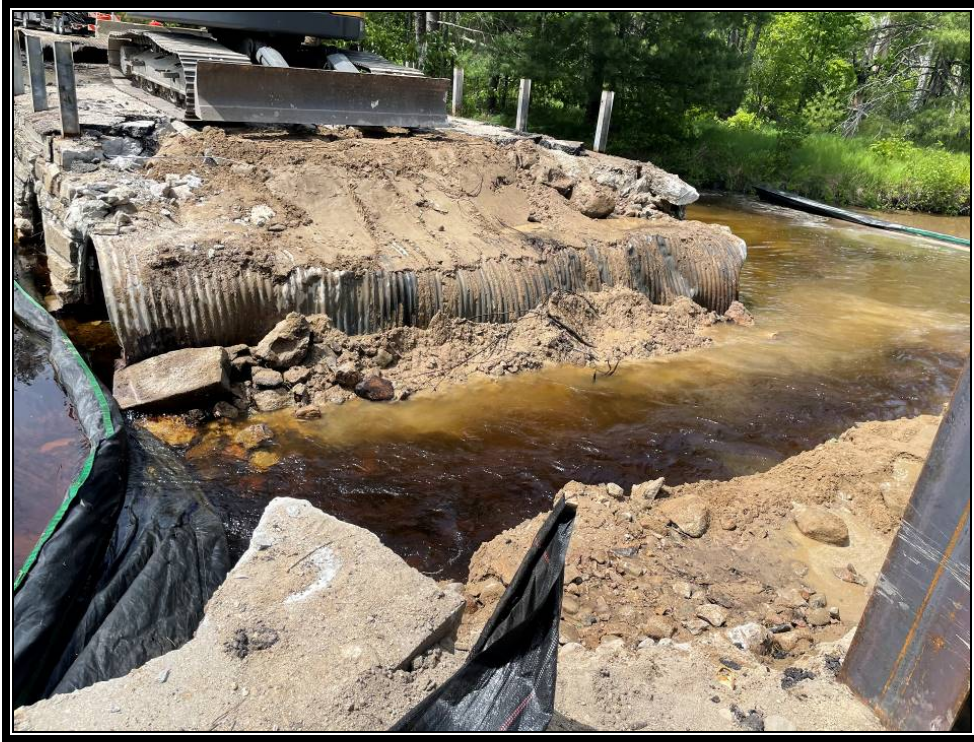
Photo 2: The channel created by removing the culvert.
