Date:	June 17, 2021	Project #:	2018-087	Page 1 of 3
To:	Town of Effingham 68 School Street Effingham, NH 03882	Project:	Snow Road Bridge Replacement	
		Location:	Effingham, NH	
Email:	townofeffingham@effinghamnh.net	Owner:	Town of Effingham	
Prepared By:	Eric V. Schroeder, EIT	Contractor:	Hansen Bridge LLC	
Reviewed & Approved By:	Christopher R. Fournier, PE	Weather Conditions:	74°F Partly Cloudy

SITE VISIT

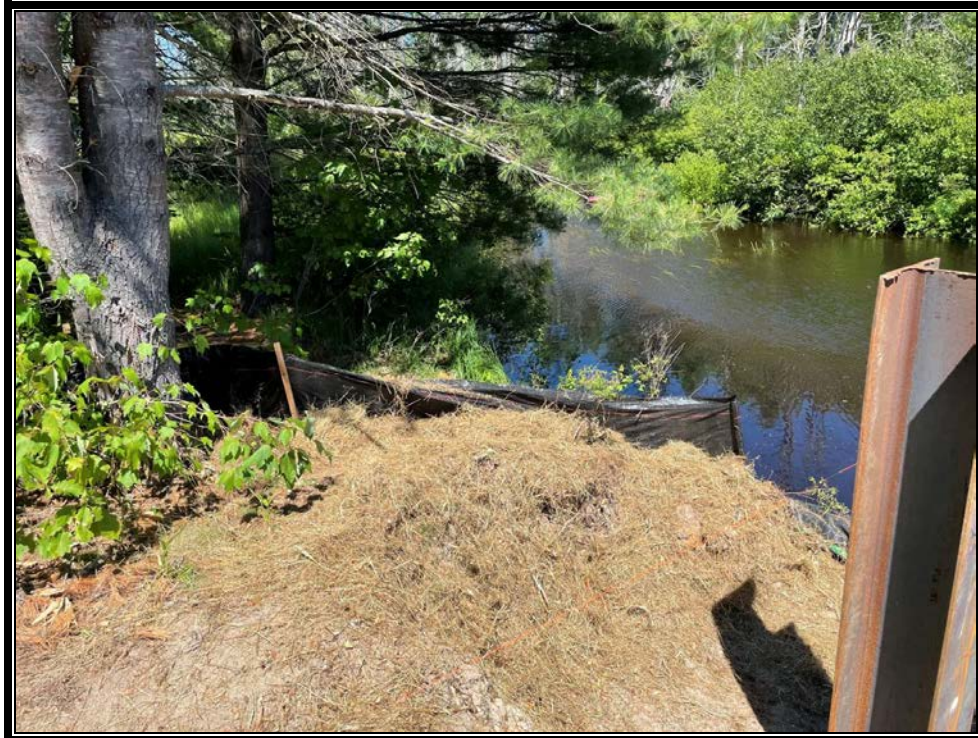
- The Contractor continued splicing new sections onto the previously driven piles. By the end of the day, they had spliced sections onto P4W and P5W.
- Once the sections were spliced onto P4W and P5W, the piles were driven to an approximate depth of 26 feet and 34 feet respectively (see Phot0 1). All piles on the west side have been driven until refusal.
- Engineer reminded the Contractor to maintain erosion controls. The Contractor ensured all sections of the silt fence were toed in and spread hay onto disturbed areas (see Photo 2).
- Engineer reminded Contractor to prepare a sedimentation basin for dewatering at the west abutment.

Photo 1: P5W driven to approximately 34 feet and hay spread on disturbed areas.

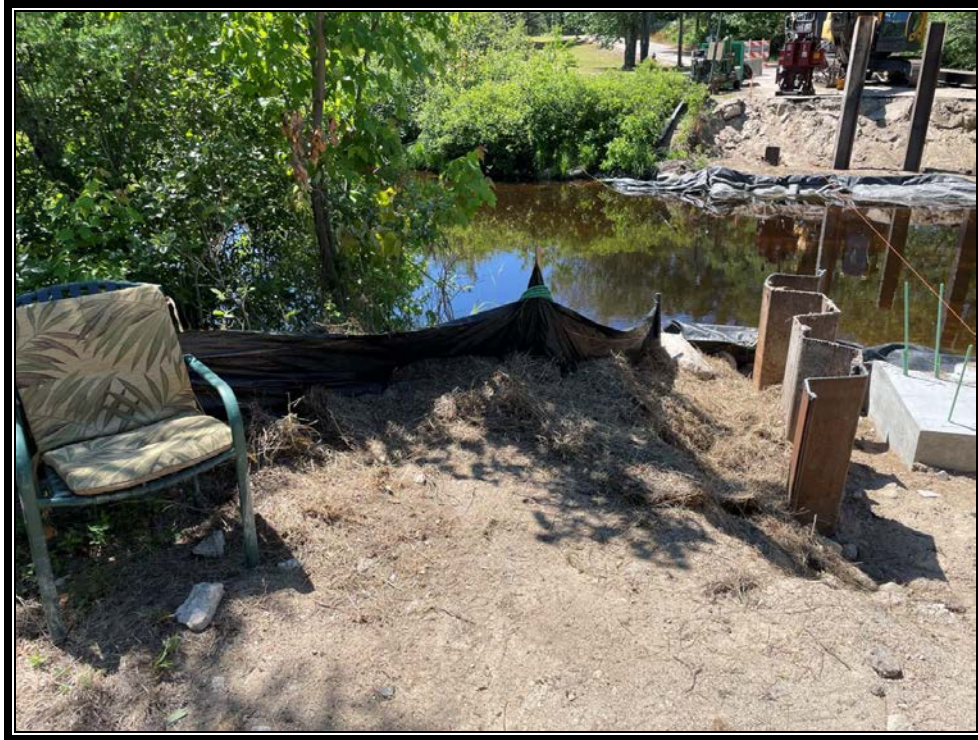
Photo 2: Silt fence maintenance.
