# FIELD REPORT #021

<b>Date:</b>	June 30, 2021	<b>Project #:</b>	2018-087	<b>Page 1 of 3</b>
<b>To:</b>	Town of Effingham 68 School Street Effingham, NH 03882	<b>Project:</b>	Snow Road Bridge Replacement	
<b>Email:</b>	townofeffingham@effinghamnh.net	<b>Location:</b>	Effingham, NH	
<b>Prepared By:</b>	Eric V. Schroeder, EIT	<b>Owner:</b>	Town of Effingham	
<b>Reviewed &amp; Approved By:</b>	Christopher R. Fournier, PE	<b>Contractor:</b>	Hansen Bridge LLC	
		<b>Weather Conditions:</b>	88°F Sunny/Thunderstorms

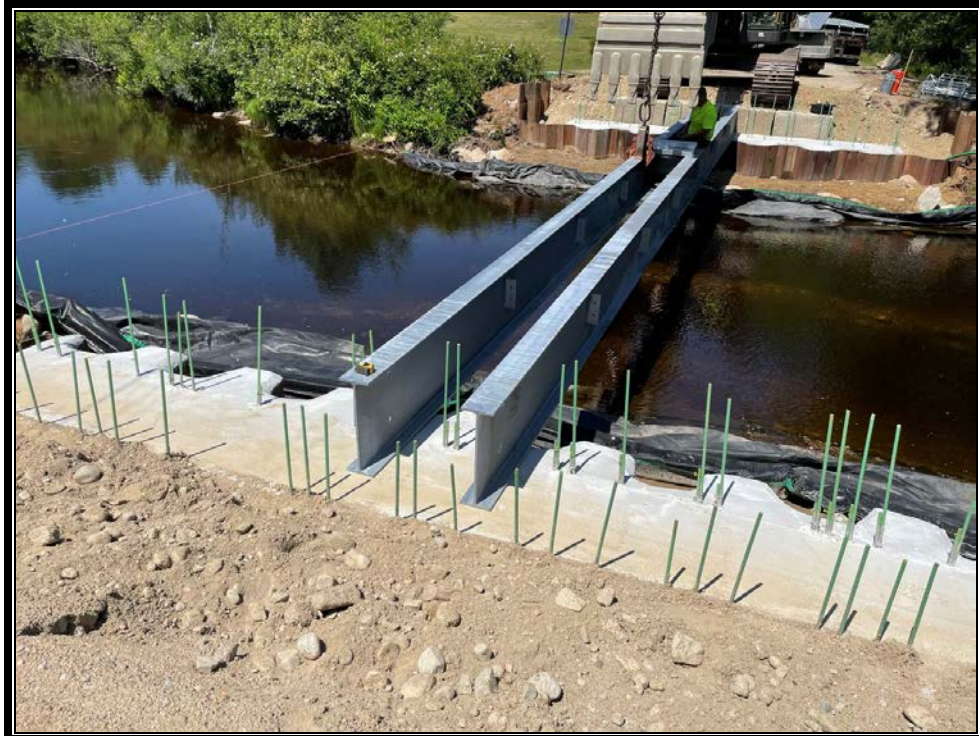
- The Contractor began setting beams starting with the center beams. The Contractor centered the beams using the pins placed by GM2 and connected the lateral bracing with bolts. Each beam's end was set on an elastomeric bearing pad and then adjusted again in each direction (see Photos 1 and 2).
- Work was halted early due to thunderstorms creating unsafe work conditions in the afternoon.

Photo 1: The first two beams being put into rough position.

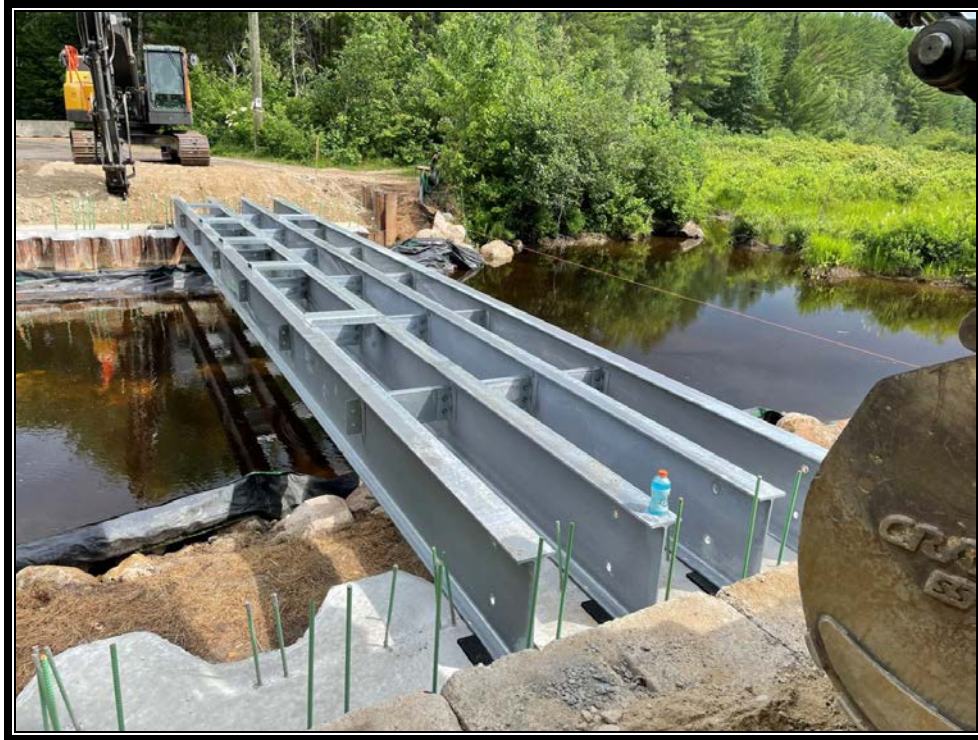
Photo 2: Four out of ten beams placed on bearing pads.
