Date:	September 21, 2022	Project #:	2021-083	Page 1 of 3
To:	Town of Effingham 68 School Street Effingham, NH 03882	Project:	Bailey Road Culvert Replacement	
Email:	townofeffingham@effinghamnh.net	Location:	Effingham, NH	
Prepared By:	Eric Schroeder	Owner:	Town of Effingham	
Reviewed & Approved By:	Christopher Fournier, PE	Contractor:	Jake Dawson's Excavation & Utility Services, LLC	
		Weather Conditions:	55° Cloudy

SITE VISIT

- » To observe shoring installation.

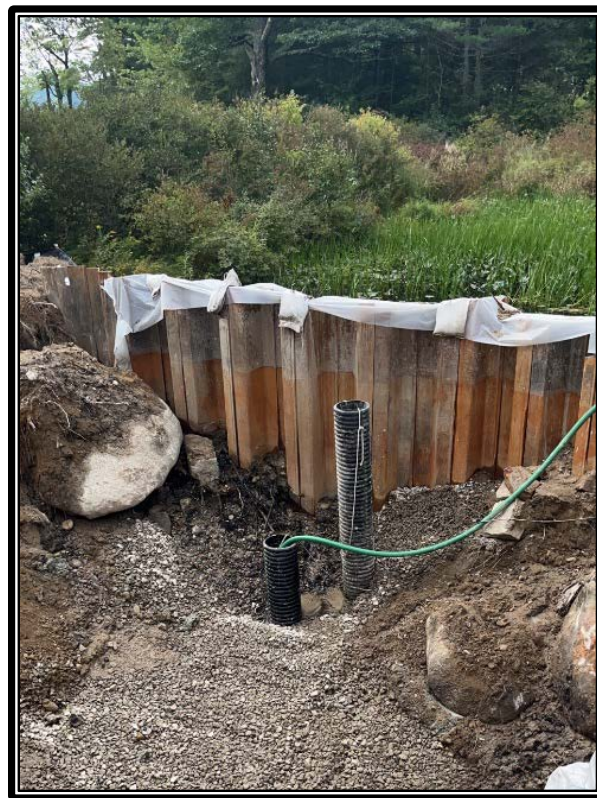
- » The Contractor placed crushed stone at the bottom of the excavation in order for the laborers to access the bottom of the excavation.
- » The Contractor installed a second sump pump below the bottom of the concrete elevation using a corrugated HDPE culvert pipe (see Photo 1). This pipe is located just north of the first sump pump pipe. The first pipe remains in place but the pump was relocated to the new pipe.

Photo 1: Second sump pump installed to assist dewatering.

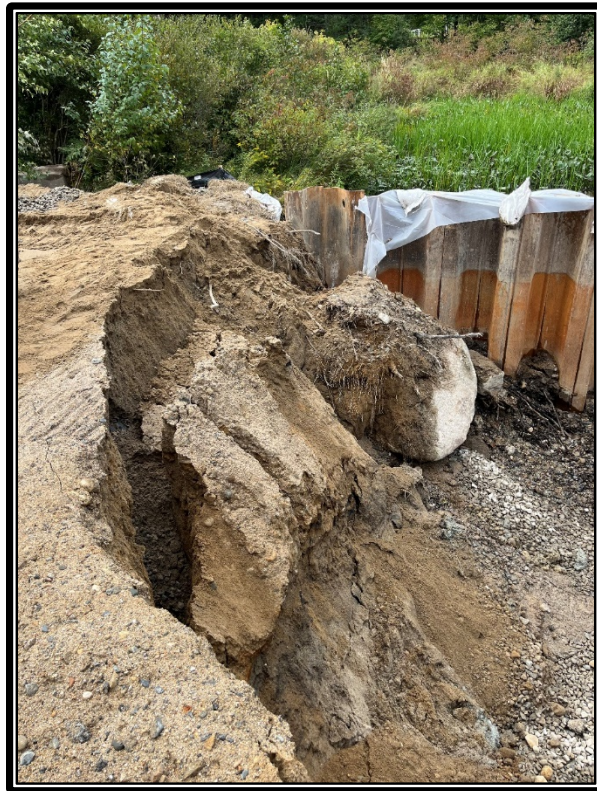
- » The Contractor stated that they were not ready to install the shoring due to the instability of the excavation. The Contractor intends to ramp down the sides of the excavation by removing more pavement and creating a shallower slope.
- » The Engineer observed that the walls of the excavation are unstable and have begun to cave in (see Photo 2).
- » The Contractor stated that the shoring installation would take place sometime later this week (09/23/22).

Photo 2: The walls of the excavation are unstable.

- » Erection plan submittal needed to demonstrate the capability of roadway shoring. (FR #002, 09/15/22)
