HEB Engineers, Inc. • [www.hebengineers.com](http://www.hebengineers.com)

| <b>Date:</b> | September 22, 2022 | <b>Project #:</b> | 2021-083 | <b>Page 1 of 4</b> |
| <b>To:</b> | Town of Effingham<br>68 School Street<br>Effingham, NH 03882 | <b>Project:</b> | Bailey Road Culvert Replacement | |

### **SITE VISIT**

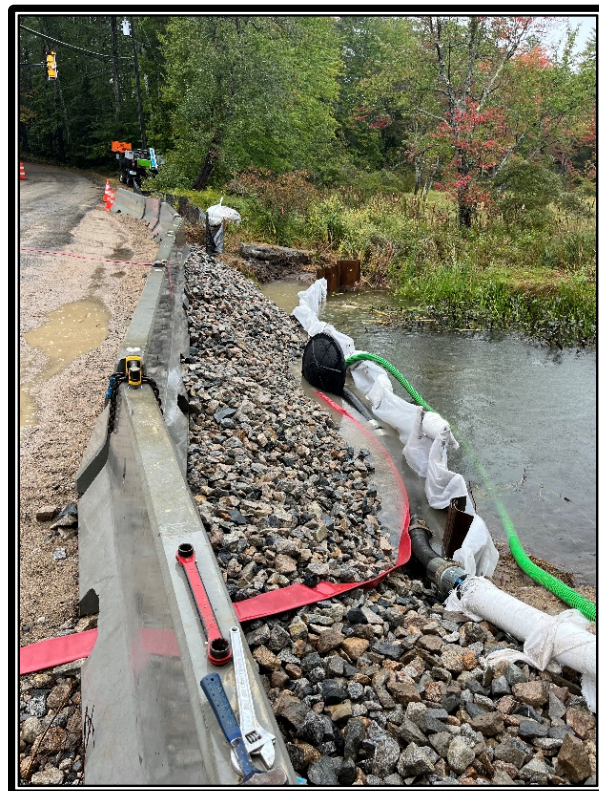
Photo 1: North side of roadway is stabilized with riprap.

- » Due to the storm event that started on Wednesday night (09/21/22) and continued throughout the day on Thursday (09/22/22) the temporary culvert bypass had failed. The Contractor called the Engineer and informed him of the situation.
- » The Contractor had stabilized the north side of the road with riprap. The Contractor stated that this side was the first to show signs of erosion and was quickly stabilized to prevent the road from collapsing. The Contractor then stabilized the excavation side because the 2–3-foot buffer of roadway material had eroded away.
- » After the roadway was stabilized the Contractor added fill and riprap over the bypass culvert. At the inlet, the Contractor use two lard sandbags in an attempt the seal the inlet.

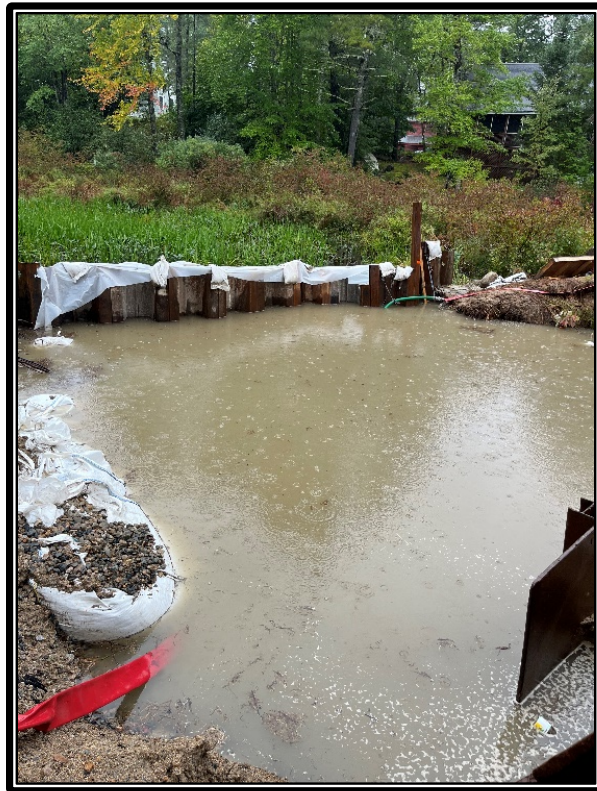
- » The Engineer observed the water had risen and had flowed around the sheet pile cofferdam into excavation. In addition, the Engineer suspects the water observed flowing outside of the bypass culvert's outlet (FR 003), had eroded the backfill material holding the culvert in place due to improper sealing of the inlet. The Contractor had placed sandbags and roadway materials over top of the inlet to secure it back into place. The Engineer observed sinkholes directly over the culvert becoming enlarged, demonstrating that water was continuing to flow around the bypass culvert.
- » The Contractor asked the Engineer if HEB would design the new water diversion system. The Engineer replied that it would have to be designed by a third party and then submitted to HEB for approval as it was previously.

Photo 2: The excavation is completely flooded.

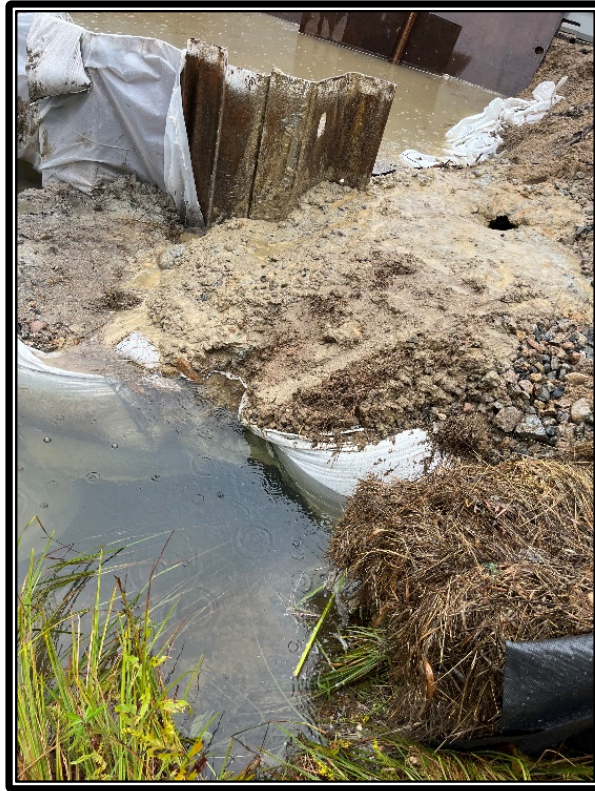
Photo 3: The inlet of the bypass culvert is being held in place by sandbags and roadway material.
