HEB Engineers, Inc. • www.hebengineers.com

Date:	September 23, 2022	Project #:	2021-083	Page 1 of 3
To:	Town of Effingham 68 School Street Effingham, NH 03882	Project:	Bailey Road Culvert Replacement	
Email:	townofeffingham@effinghamnh.net	Location:	Effingham, NH	
Prepared By:	Eric Schroeder	Owner:	Town of Effingham	
Reviewed & Approved By:	Christopher Fournier, PE	Contractor:	Jake Dawson's Excavation & Utility Services, LLC	
		Weather Conditions:	45° Partly Cloudy

SITE VISIT

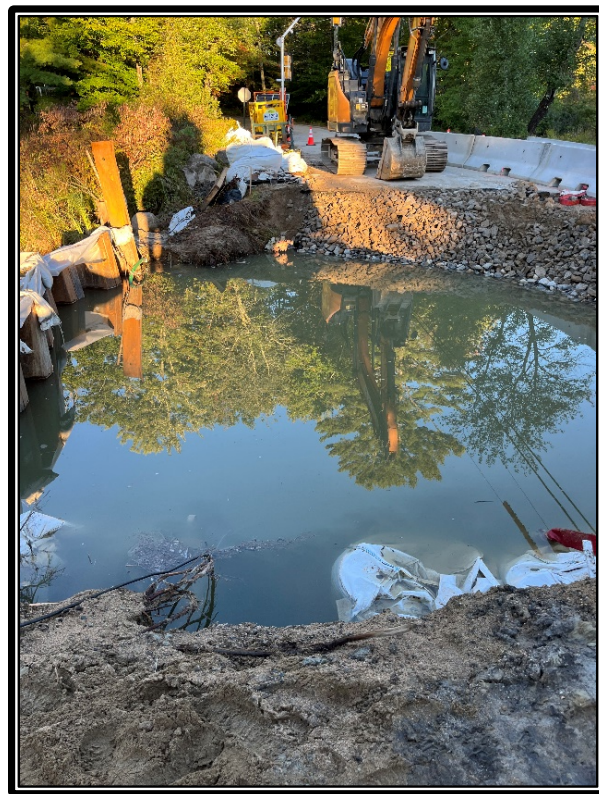
Photo 1: Water elevation has slightly declined.

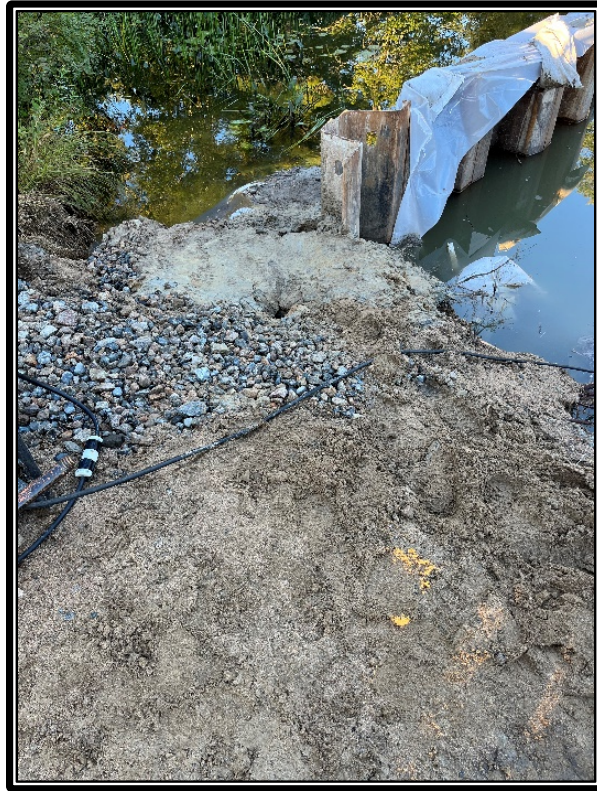
- » The roadway has been supported by riprap and some of the water has receded naturally from the excavation area as the pumps were not active.
- » The Contractor restated they would not continue work until a revised water diversion submittal is approved. The Engineer confirmed that he would review the revised submittal once received.
- » The water continues to undermine the backfill surrounding the bypass culvert because the inlet is not sealed. (see Photo 2). Further stabilization of the bypass inlet is needed for continued use.

Photo 2: Sinkhole overtop of the bypass culvert.
