Date:	October 26, 2022	Project #:	2021-083	Page 1 of 7
To:	Town of Effingham 68 School Street Effingham, NH 03882	Project:	Bailey Road Culvert Replacement	
Email:	townofeffingham@effinghamnh.net	Location:	Effingham, NH	
Prepared By:	Christopher Fournier, PE	Owner:	Town of Effingham	
		Contractor:	Jake Dawson's Excavation & Utility Services, LLC	
		Weather Conditions:	60° Cloudy / Drizzle

SITE VISIT

- » To observe the first phase of precast concrete box culvert installation.

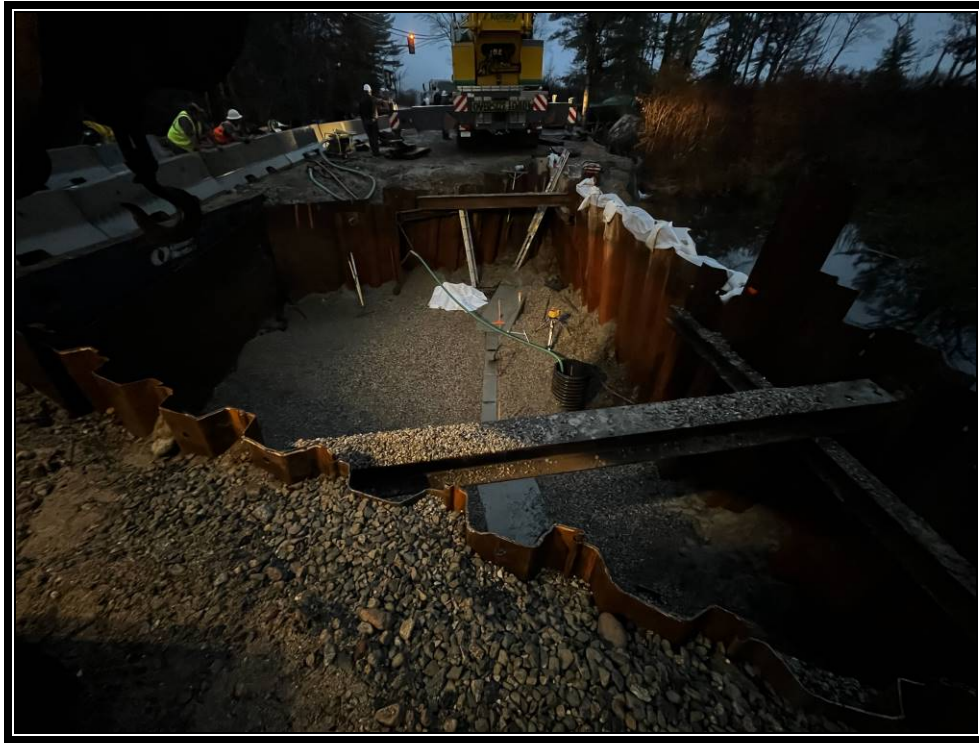
- » The excavation appears to be dry and ready for the box culvert installation (see Photo 1).
- » The remaining traffic lane has slumped and created a dip where the underlying material has moved but stabilized against the shoring (see Photo 2).
- » Keeley unloaded counterweights from their flatbed and prepared the crane for use.
- » The Contractor stated power will not be shut off for this installation since the line is protected and the crane will be approximately 13 feet away.

Photo 1: Excavation ready for box culvert installation.

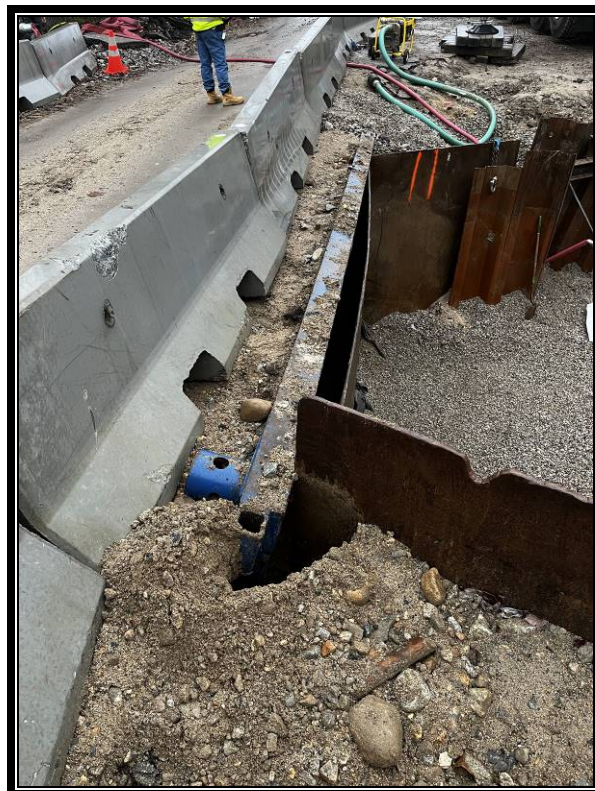
Photo 2: Trench box wall supporting existing roadway.

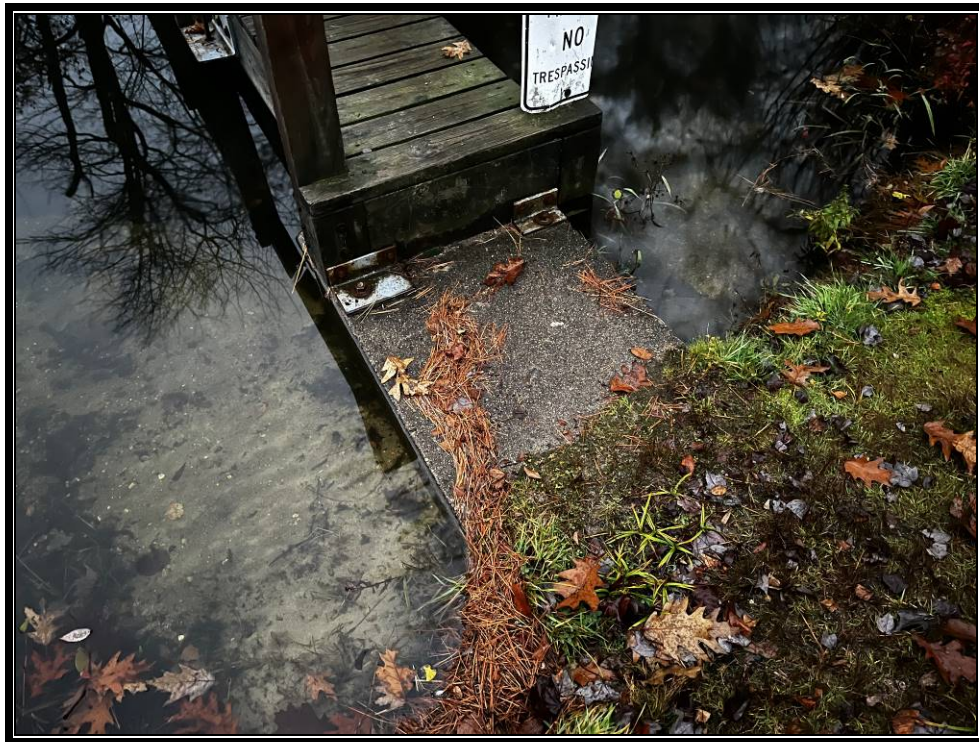
- » The Engineer observed the water elevation nearly to the top of the slab at the footbridge (see Photo 3).
- » The Contractor notified the Engineer that the surveyor's report notes a difference in the prepared elevation of approximately 1.5 inches. The Engineer stated this was within an acceptable tolerance, but requested the Surveyor verification of the horizontal placement. The Contractor stated they would follow up with their Surveyor.

Photo 3: Water elevation at upstream dam.

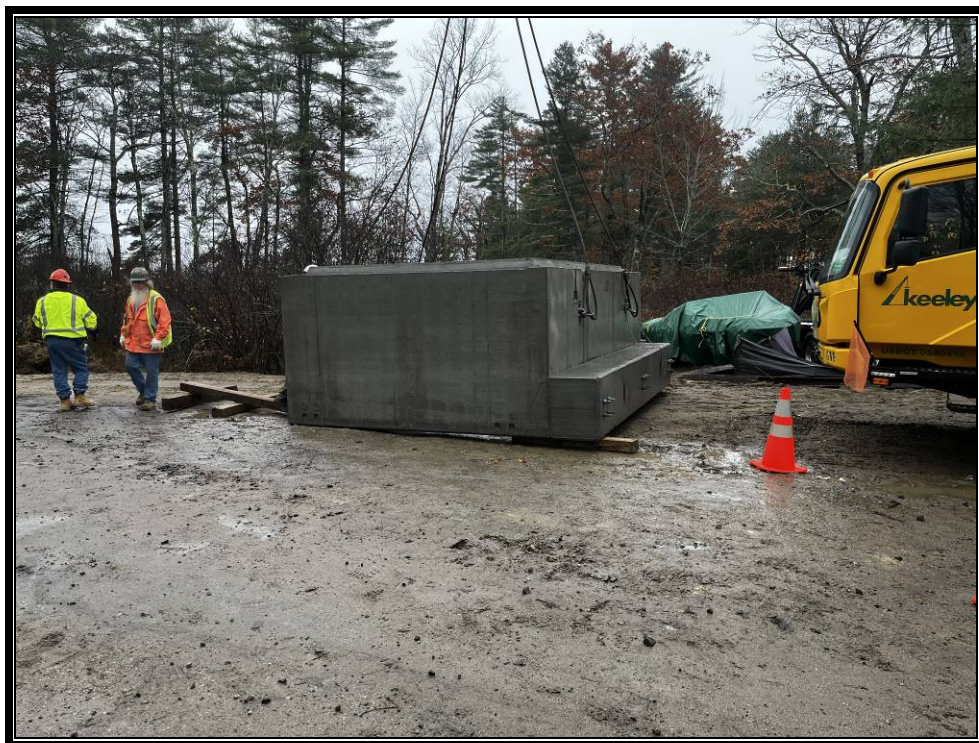
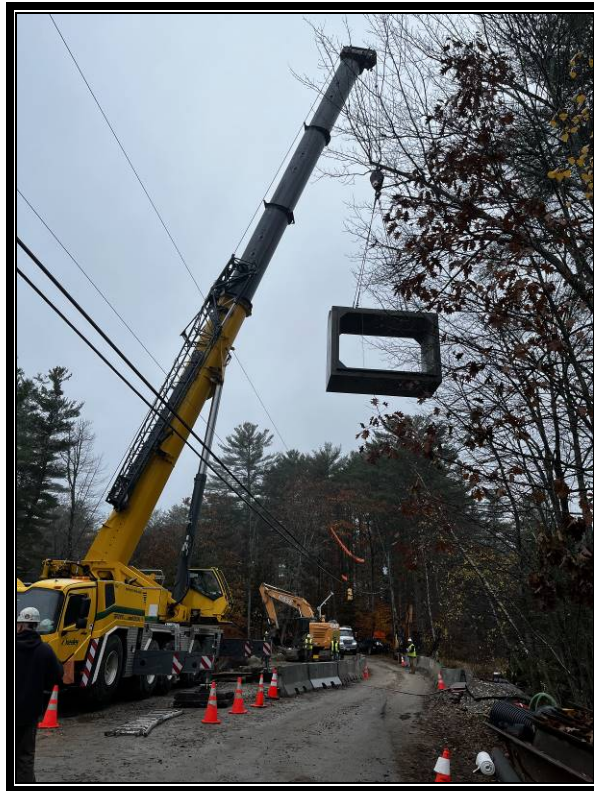
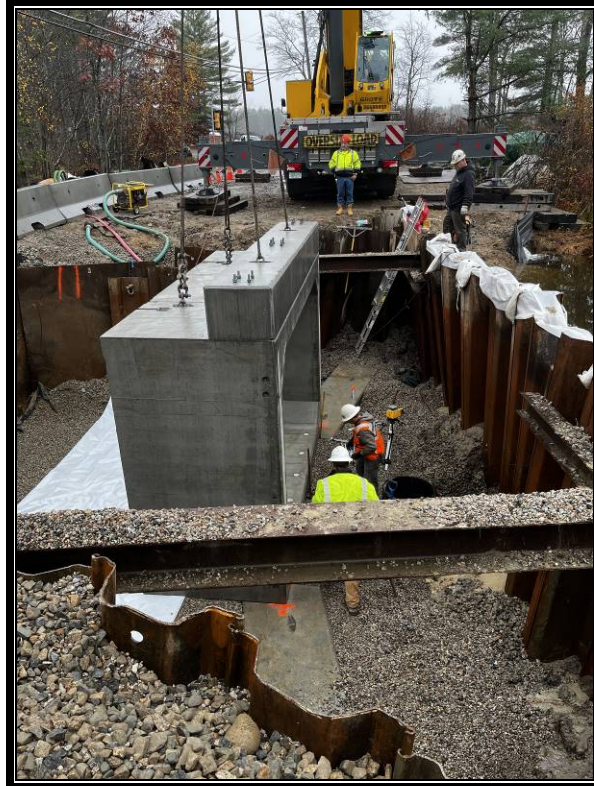
- » The first segment of the precast box culvert arrived on site at 8:50 AM. The Contractor and their Subcontractors worked to stand the piece up for installation. The piece was set in place at 10:30 AM. Traffic was closed for a period of 15 minutes to accommodate the trucks and equipment (see Photos 4 – 6).

Photo 4: First box culvert segment.

Photo 5: First box culvert segment being craned in.

Photo 6: First box culvert segment in place.

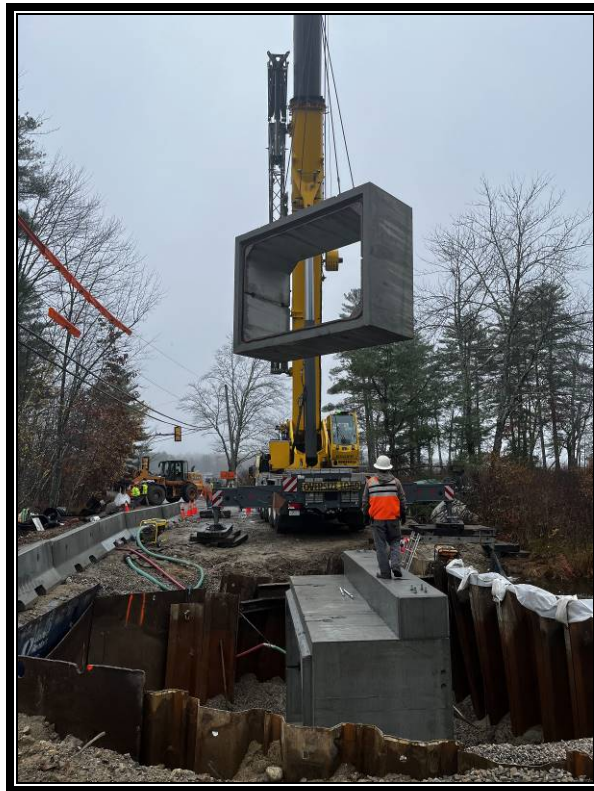
- » The Contractor notified the Engineer. They will request a four-hour road closure for the next phase of precast concrete installation.
- » The Engineer observed flexible gaskets pre-installed on the “female” end of the box culvert segments (see Photo 7).

Photo 7: Second box culvert segment
being craned in.

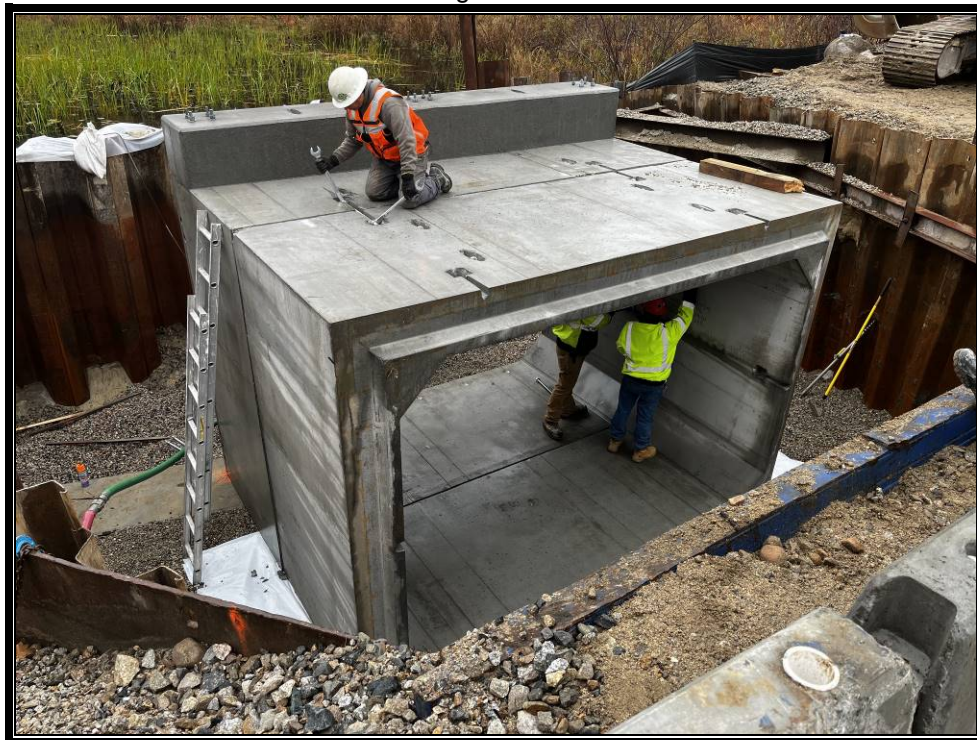
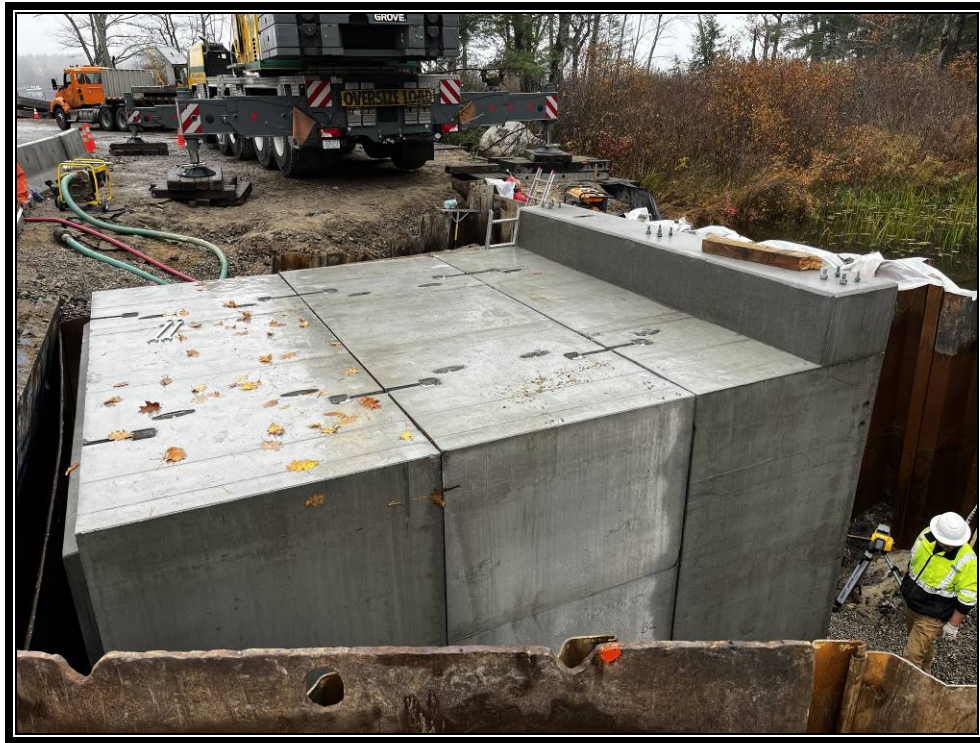
- » The second box culvert piece was placed at 10:45 AM and the third piece at 11:15 AM. The Contractor made the mechanical connections (see Photos 8 and 9).

Photo 8: Second box culvert segment in place.

Photo 9: First phase of box culvert installation complete.
