FIELD REPORT #020

Date:	August 26, 2020	Project #:	2018-046	Page 1 of 3
To:	Michael Cahalane Town of Effingham 68 School St. Effingham, NH 03882	Project:	Elm Street Bridge Preservation	
Email:	effingham@roadrunner.com	Location:	Effingham, NH	
Prepared By:	Jonathan K. MacDougall, PE	Owner:	Town of Effingham	
Reviewed & Approved By:	Christopher R. Fournier, PE	Contractor:	Hansen Construction	
		Weather Conditions:	70°F, sunny

SITE VISIT

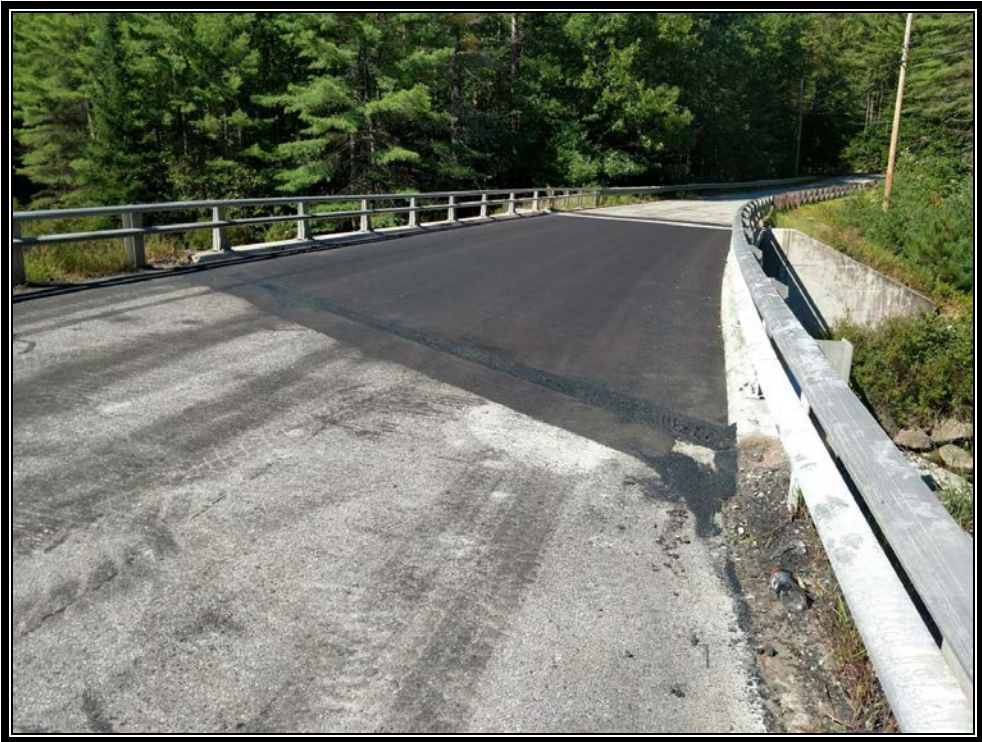
- Contractor removed all equipment and road closure signs from the bridge (see Photo 1).
- Contractor installed the asphaltic plug for crack control at the south end of the bridge (see Photos 2 & 3).

Photo 1: Bridge open to traffic.

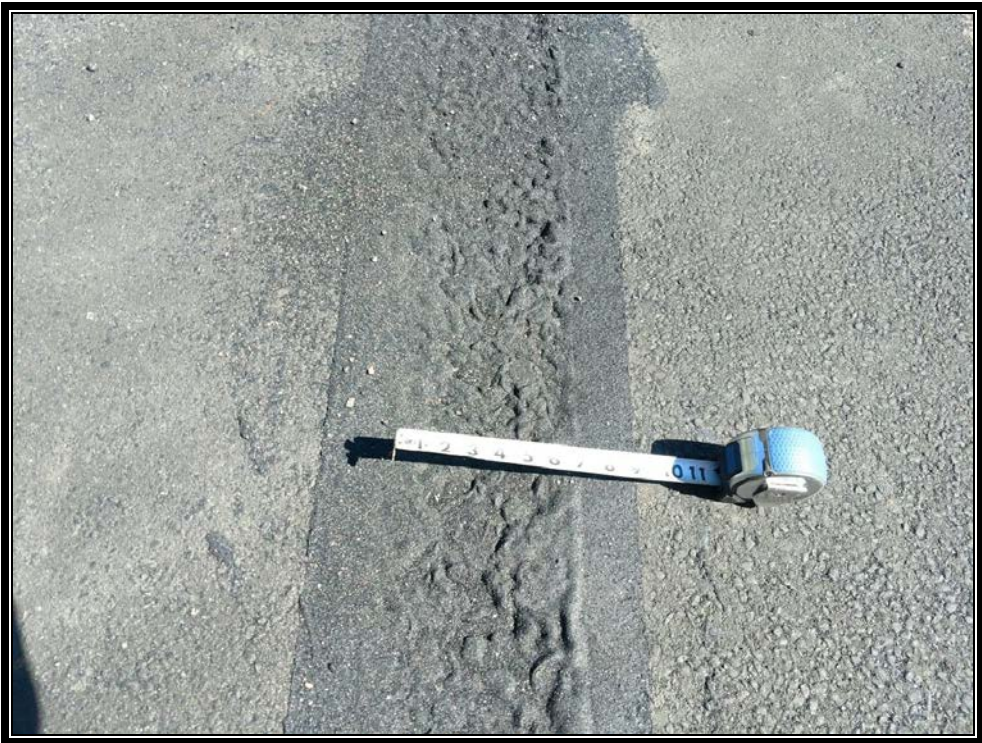
- The asphaltic plug is installed 6-inch-wide at the end of the deck. The top of the joint is slightly below the surface of the pavement. The asphaltic binder settled into the aggregate creating an uneven surface. The top surface had a fine grit applied for traction and wear.

Photo 2: 6-inch-wide plug joint.

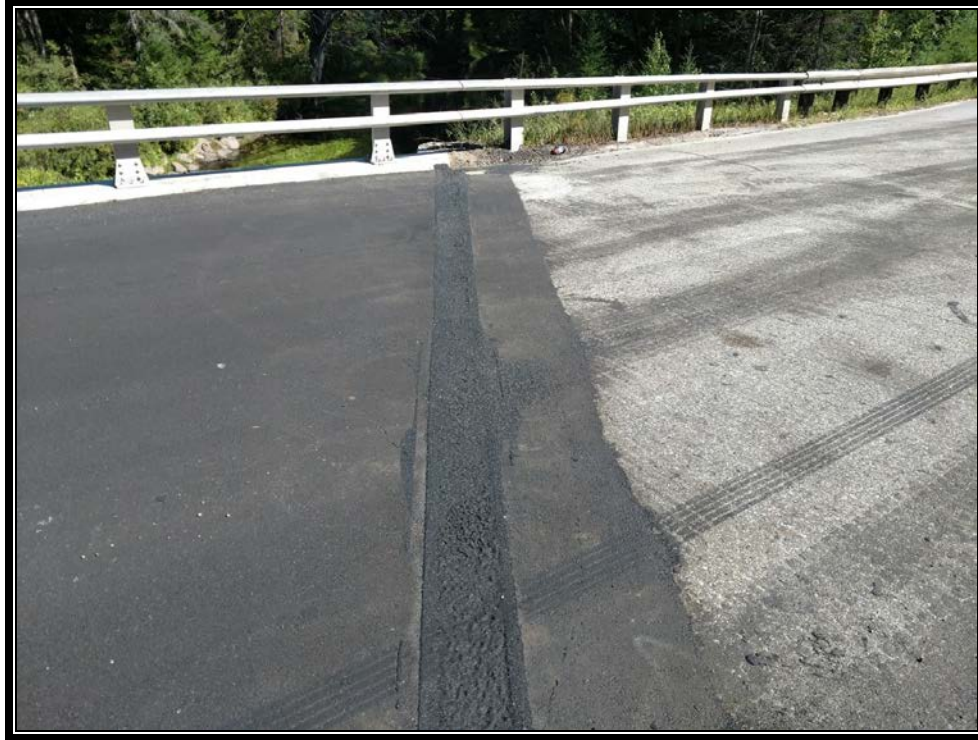
Photo 3: Asphaltic plug joint.
